Severe turbulence involving Airbus A330, B-5921

near Sydney, New South Wales, 29 November 2016

ATSB Transport Safety Report
Aviation Occurrence Investigation
AO-2016-165
Final – 24 March 2017

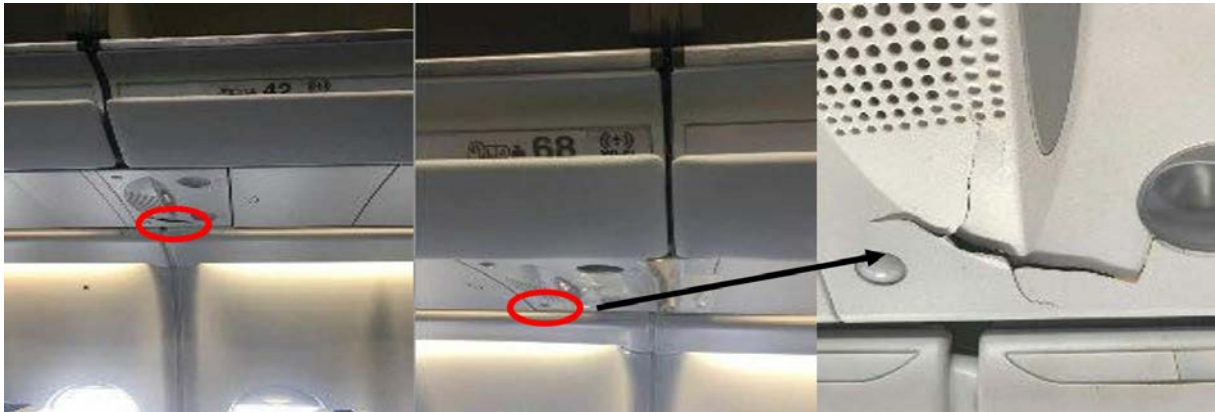
Figure 1: Damage to cabin (row 42, and 68 passenger service unit)

After landing, at around 0314 UTC, a cabin crewmember informed the flight crew that there were eleven people who were injured, including three cabin crew. The aircraft sustained minor damage to the interior cabin above row 42, 64, 65, and 68 (Figure 1).

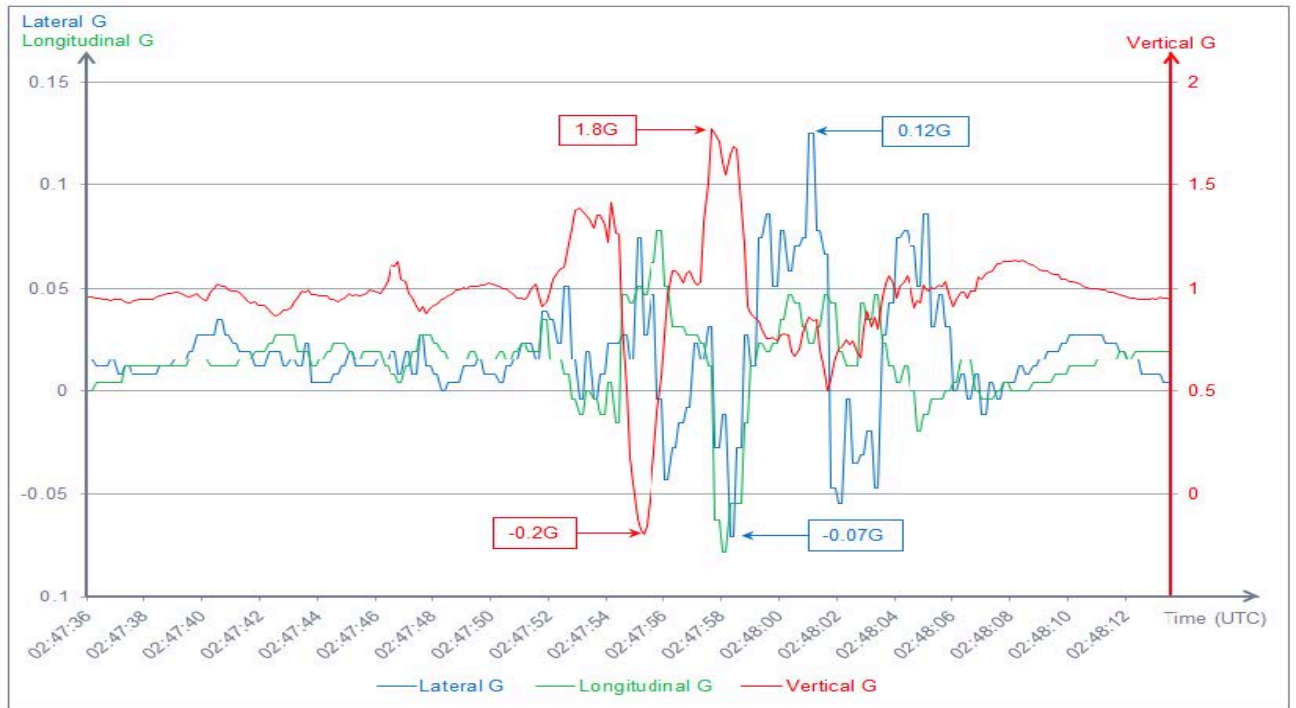
Figure 2: G Loadings during turbulence

The aircraft manufacturer provided the ATSB with a report of the data extracted from the digital flight data recorder (DFDR). The data shows that when the aircraft encountered the turbulence, the vertical G⁴ loadings varied between -0.20 G and 1.8 G and the lateral G loadings varied

between -0.07 G and 0.12 G (Figure 2). The calculated longitudinal wind varied between around 15 kt tailwind and 5 kt headwind and the lateral wind varied between 20 kt right and 5 kt left. The vertical wind reached a maximum of about 3,100 feet per minute updraft (Figure 3). During the turbulence, the autopilot stayed engaged and the load factors experienced during the turbulence did not exceed the limits of the aircraft.

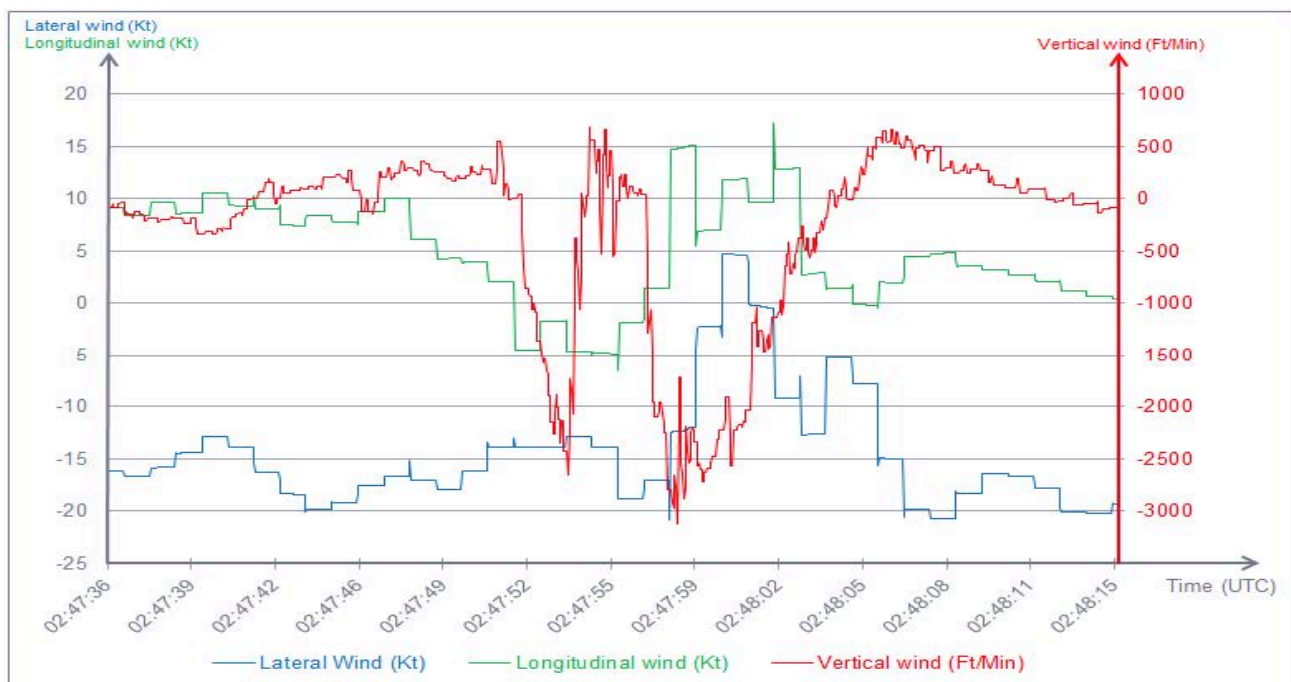
Figure 3: Wind variation during turbulence

The rapid changes to wind speed and direction confirm the aircraft encountered turbulence conditions.
