# Aviation Short Investigations Bulletin

Issue 58

**ATSB Transport Safety Report**  
Aviation Short Investigations  
AB-2017-027  
Final – 24 March 2017

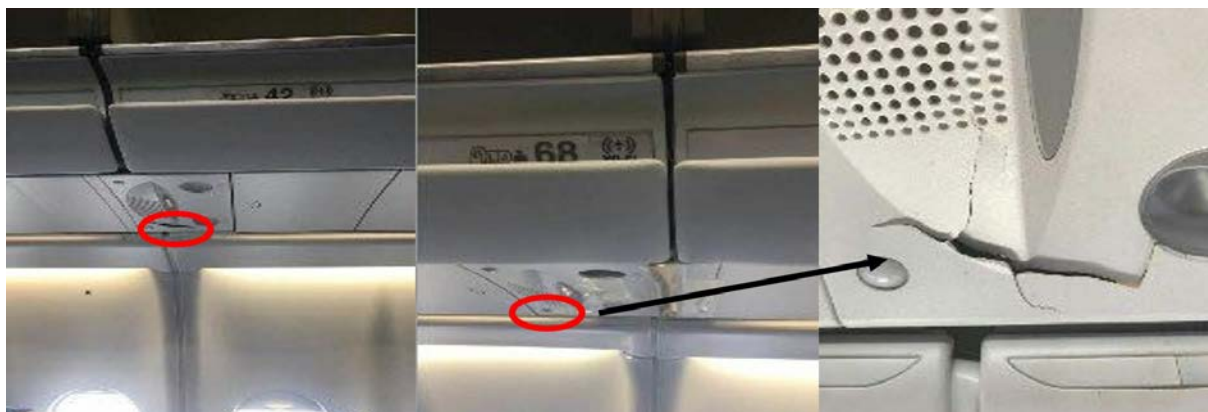
**Figure 1: Damage to cabin (row 42, and 68 passenger service unit)**

After landing, at around 0314 UTC, a cabin crewmember informed the flight crew that there were eleven people who were injured, including three cabin crew. The aircraft sustained minor damage to the interior cabin above row 42, 64, 65, and 68 (Figure 1).

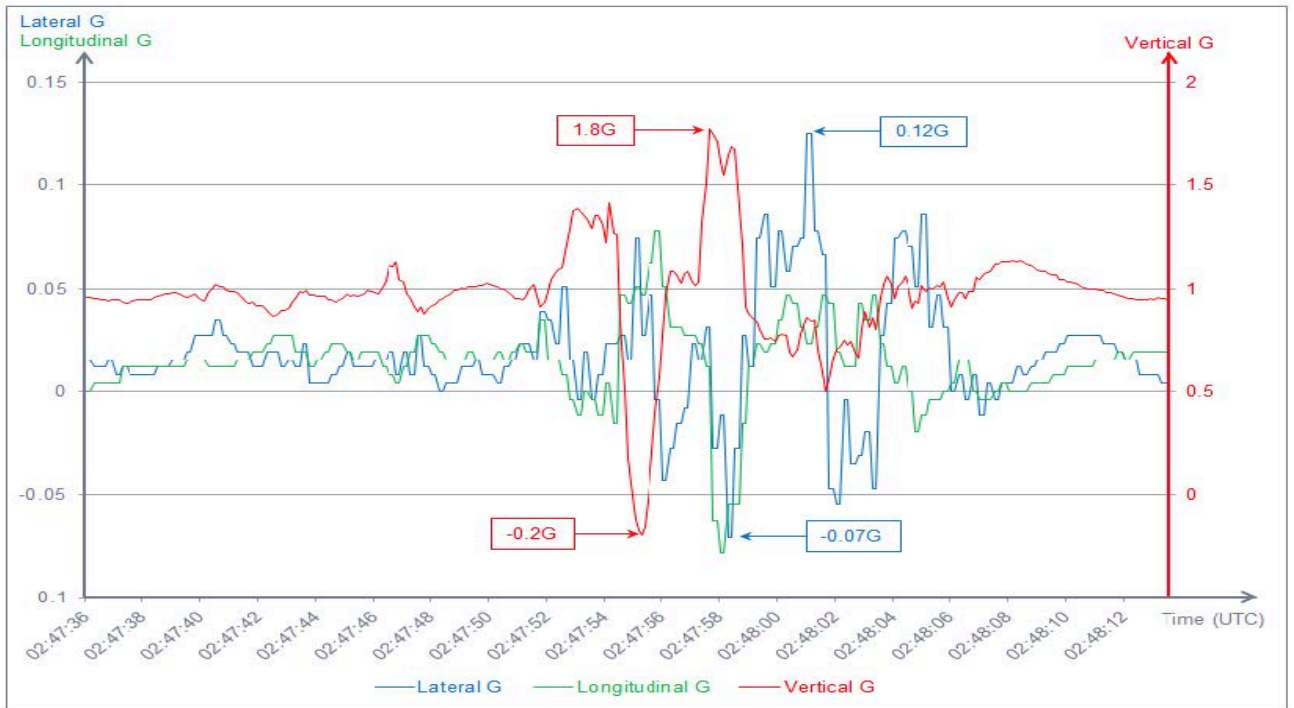
**Figure 2: G Loadings during turbulence**

The rapid changes to wind speed and direction confirm the aircraft encountered turbulence conditions.

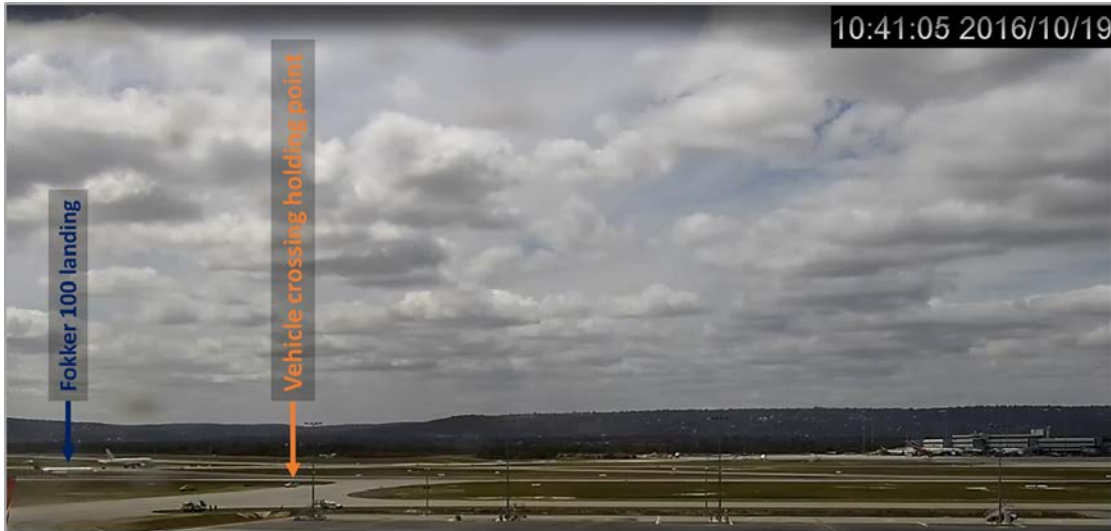
**Figure 3: Location of Fokker 100 aircraft landing on runway 21 and vehicle as it crossed back over the taxiway delta holding point for runway 21**

stopped about 20 m before the white gable markers that denote the runway strip. The vehicle did a hard right turn and crossed back over the holding point at about 10:41:05 (Figure 3). About 3 seconds later, the Fokker 100 aircraft that had just landed on runway 21, passed the vehicle position. At this time, the estimated distance between the vehicle and the Fokker 100 was about 100 m. The crew of the Fokker 100 did not notice the vehicle.

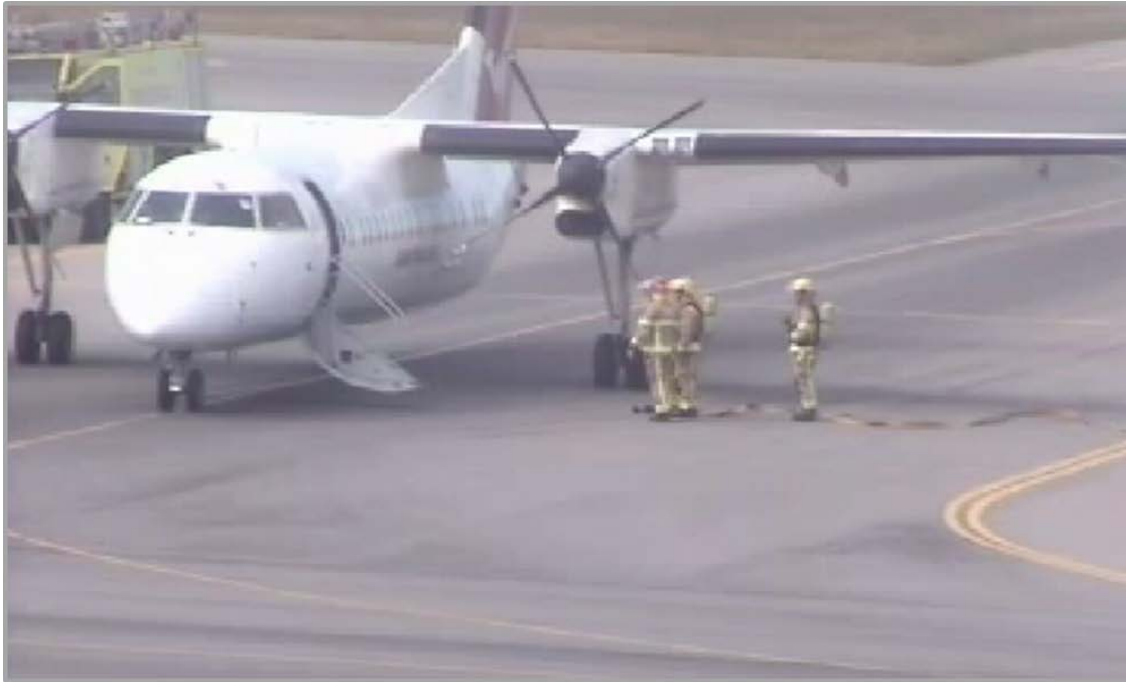
**Figure 1: SBB parked on taxiway E after the crew and passengers had disembarked**

The aircraft operator reported that the electronic attitude director indicator (EADI) had failed. The fumes were caused by damage to a circuit card assembly due to a blown resistor on the video driver. There was no damage to any other aircraft parts or components.

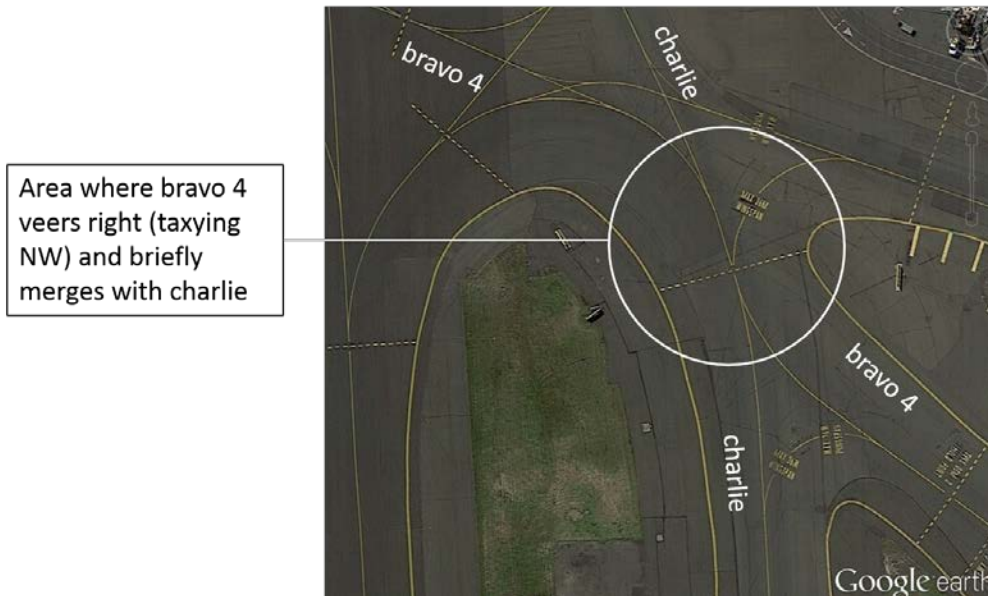
**Figure 3: Taxiway intersection showing the area where bravo 4 veers right (taxying NW) and bravo 4 and charlie merge for a short distance**

The potentially confusing characteristics of the taxiway junction would have been exacerbated at night. At the time of the occurrence, additional vehicle lights were moving about the area, some steady (head/tail lights) and some flashing, and the partially established worksite lighting would have further complicated the environment. The pilot expected that some lights may have already been covered or turned off, which added to the potential for confusion over taxiway identification.

At the time of the occurrence, the lead-in lighting to charlie and the charlie taxiway lighting had not yet been covered. This may have given the impression that the taxiway was still available, perhaps further reinforcing in the pilot’s mind that they had already passed charlie, and reached bravo. The taxiway signage was not affected by the works and was illuminated at the time of the occurrence. The pilot commented that their mental picture of the area was different to what they encountered at the time of the occurrence.

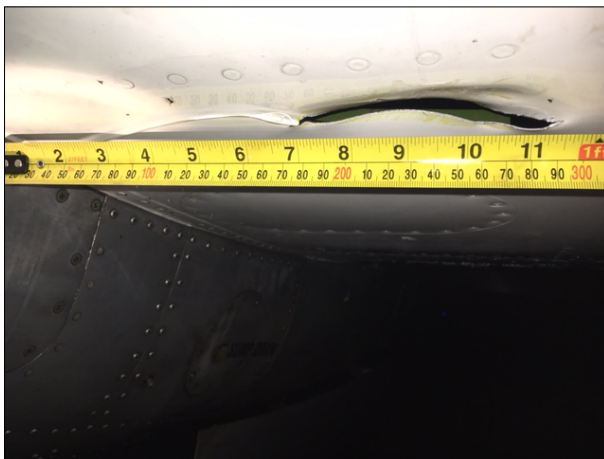
**Figure 1: Damage to the underside of wing**

The landing was completed and after parking the aircraft on the apron, a passenger reported to the pilot that the right wing was leaking fuel. On inspection, the pilot found a puncture to the underside of the right wing, just outboard from the right engine nacelle, which had breached the fuel tank (Figure 1). They concluded it was probably the result of debris from the damaged runway light flicked up by the right main wheel tyre. There were no injuries and the aircraft received minor damage.

- The pilot flew an approach path with a low runway threshold height, which combined with a downdraft from local convective activity on short final, resulting in a runway undershoot, collision with the runway light and damage to the aircraft wing.

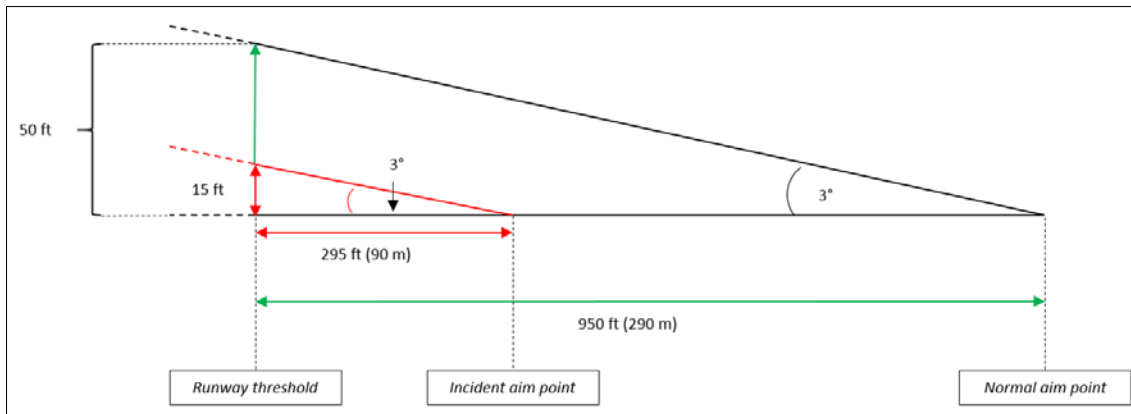
**Figure 2: Runway threshold heights**

The landing distance required (LDR) begins at a height of 50 ft from over the runway threshold. The pilot reported flying a standard 3° approach path angle. However, a 3° approach path, with a threshold height of 50 ft is based on a landing aim point about 290 m from the runway threshold. Using the same approach path angle with an aim point 90 m from the runway threshold will reduce the threshold height to about 15 ft (Figure 2).

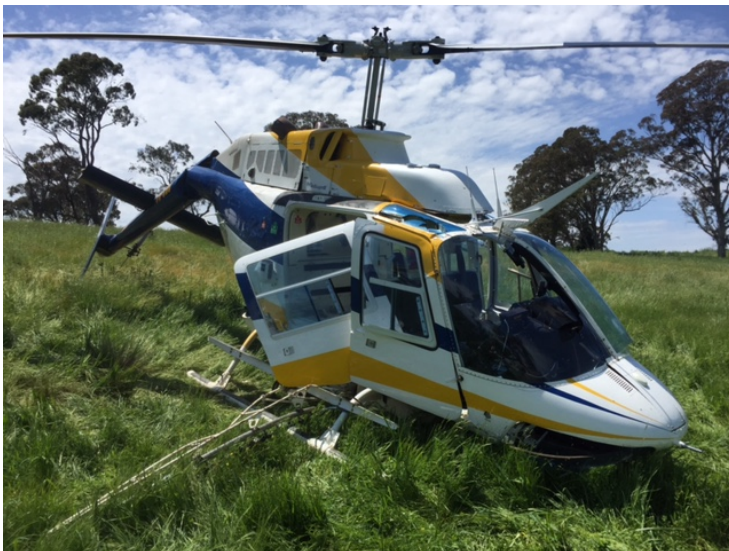
**Figure 1: Accident site showing damage to VH-CHO**

The electronic locator beacon activated on impact. The pilot and passenger sustained minor injuries and the helicopter was substantially damaged (Figure 1).

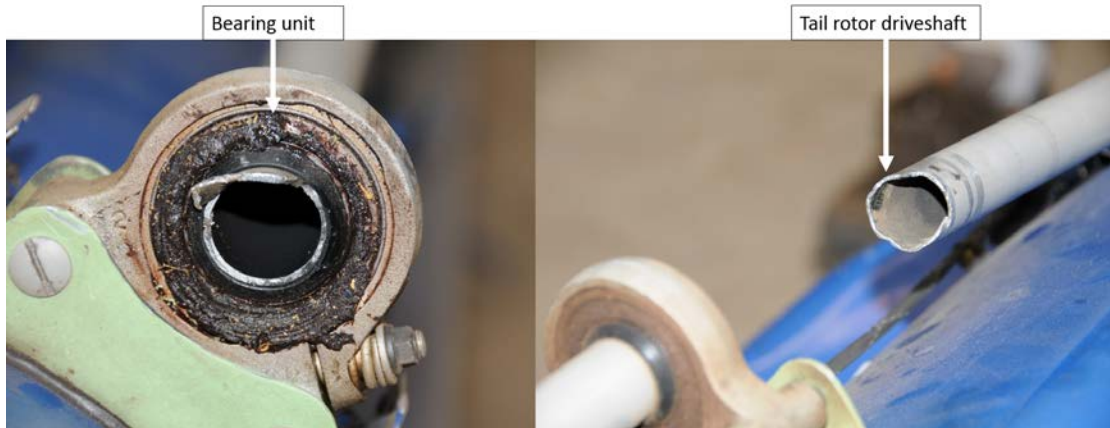
**Figure 2: Fractured tail rotor driveshaft**

The tail rotor driveshaft had fractured at the No. 2 bearing (Figure 2).

There was no evidence of oil leakage, overheating, corrosion or vibration of the tail rotor driveshaft system.
