ATC information error involving a Department of Defence Boeing CH-47 Chinook and Cessna 172S, VH-PFU

Townsville Airport, Queensland | 27 May 2014

ATSB Transport Safety Report
Aviation Occurrence Investigation
AO-2014-096
Final – 5 December 2016

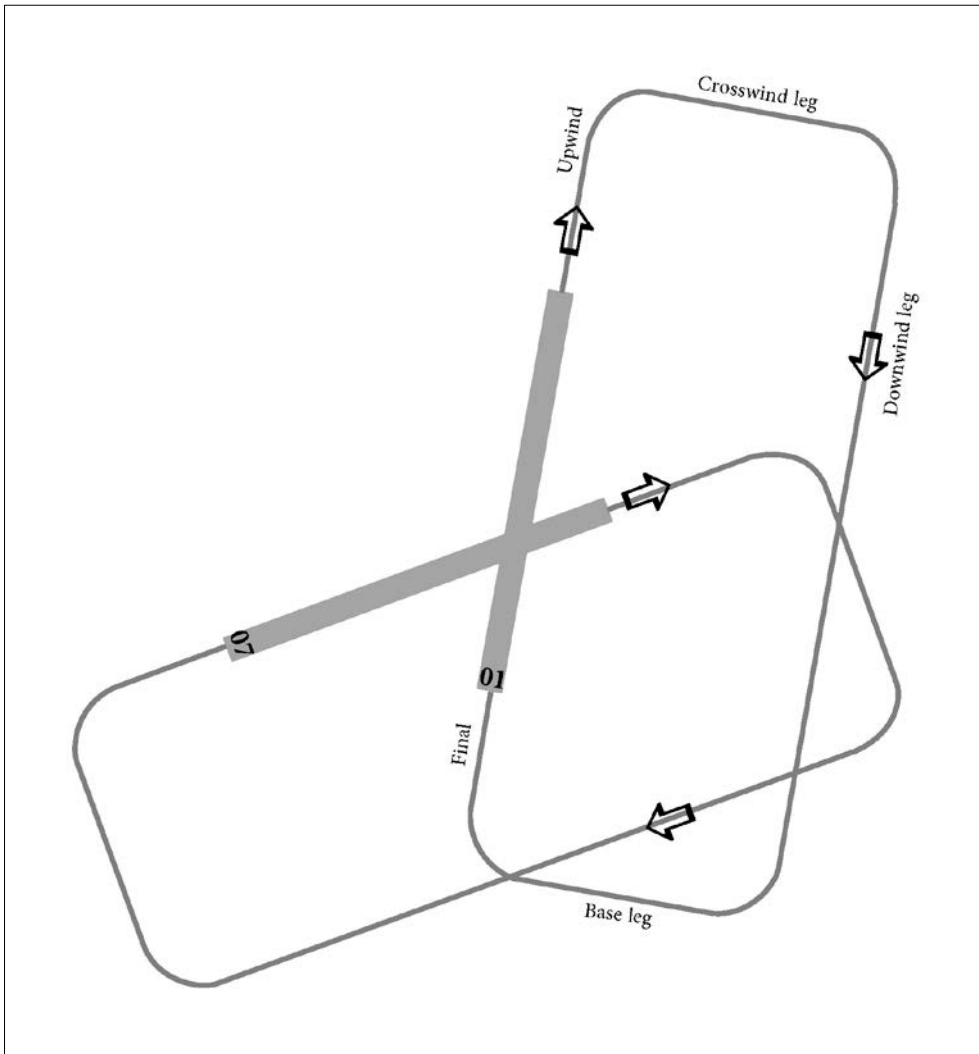
Figure 2: Diagram showing the legs of a circuit

As the crosswind on runway 01 was up to 15 kt, PFU was conducting circuits on runway 07. The pilot of the King Air was conducting circuits on runway 01 (Figure 2). Both aircraft were conducting right-hand circuits, which maintained them to the east and south of Townsville Airport. To manage the sequence between the two aircraft, and to facilitate the other traffic operating within the area, the tower controller issued instructions at different times to extend various legs of the circuit. The mix of traffic under the tower controller's jurisdiction resulted in a high workload and a high level of radio transmissions on the tower frequency.

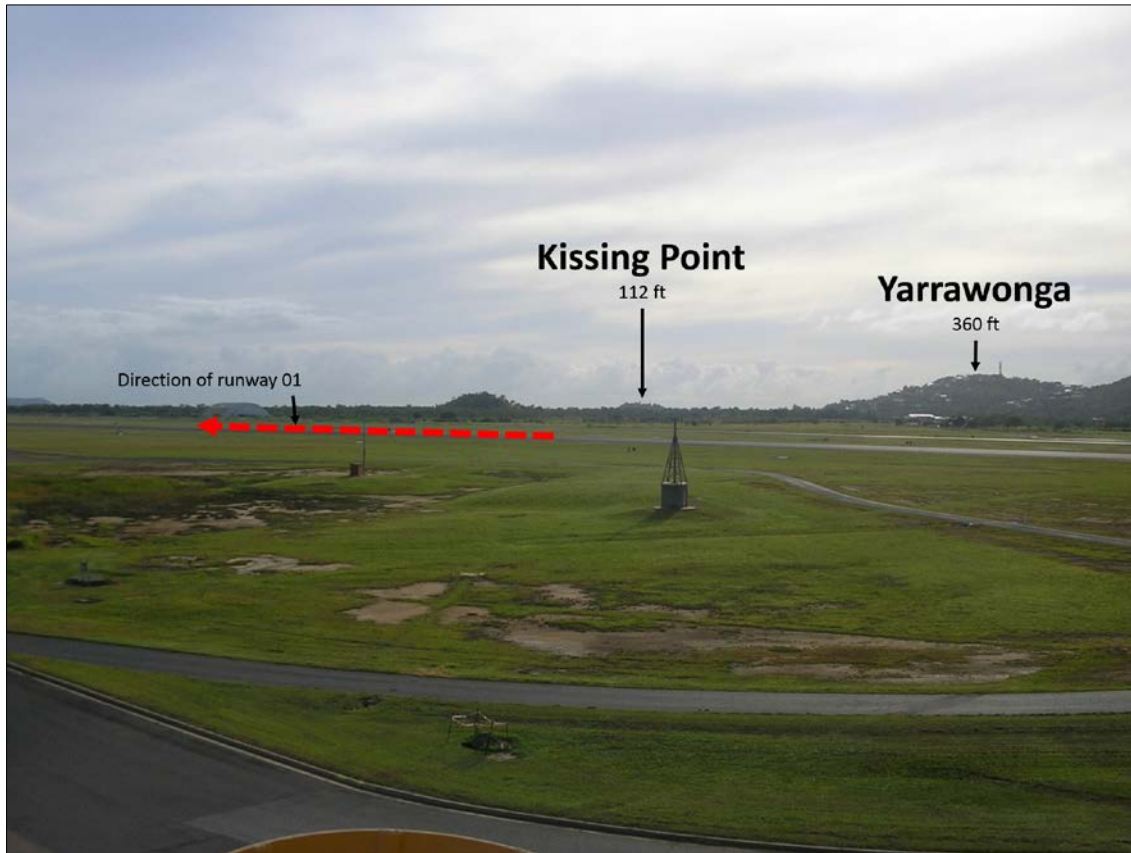
Figure 3: The tower controller’s view east-north-east towards Kissing Point, including relevant terrain height and the direction of runway 01

Of note, due to the topography to the east and north-east of the airport (Figure 3), and the operating height of the helicopter, the tower controller was unable to see the occurrence CH-47 until just prior to its arrival at Kissing Point. This was the first time the tower controller was aware that the occurrence CH-47 had an external load, requiring the controller to amend their traffic plan. The plan had been for the aircraft to track south of the airfield and fly over the city of Townsville, then to cross the upwind centreline of runway 01. With an external load, the aircraft was required to track to the west of the airport to a helipad just to the north of runway 07. This kept the occurrence CH-47 away from built-up areas.
