Smoke in the cockpit involving Bombardier DHC-8-315 VH-SBG

57 km from Canberra Airport, ACT | 29 July 2013

ATSB Transport Safety Report
Aviation Occurrence Investigation
AO-2013-120
Final – 7 April 2017

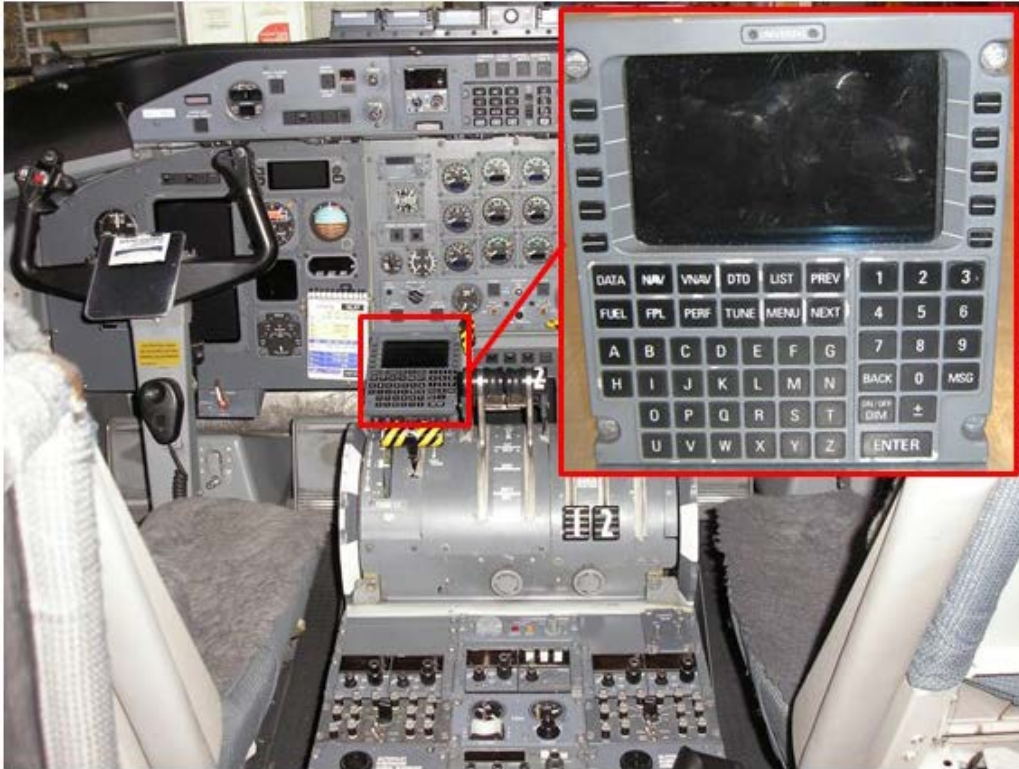
Figure 1: DHC-8-315 instrument panel showing the location of the FMS on the captain's side of the centre console (detailed view of the FMS at inset)

The flight management system (FMS) was a fully-integrated navigation management system designed to provide the crew with computer-based flight planning, fuel management and centralised control for the aircraft's navigation sensors. The aircraft incorporated a single FMS unit located on the left side of the centre console, adjacent to the captain's seat (Figure 1).

The FMS unit was sent to the manufacturer for examination. That examination found that there had been a dielectric breakdown⁵ of a capacitor, which then acted as a low resistance load. This resulted in self-heating that led to the failure of that capacitor, of an adjacent capacitor and of a diode. Other signs of excessive heating were visible on a number of circuit boards, including the display circuit board and connector ribbons within the unit.

The circuit board containing the failed capacitors and diode was in original condition and had not been modified. The capacitors were of a different rating, which did not meet the manufacturer's post-1998 specifications.

In October 2013, as a result of this occurrence, the FMS manufacturer issued a service bulletin for the optional incorporation of different capacitors to unmodified in-service FMS units.

QantasLink undertook a number of safety actions in response to this occurrence. This included installing modified FMS units to all aircraft in its Dash 8 fleet. QantasLink has also implemented a number of improvements to crew training, including improved oxygen mask and smoke goggle training and identifying alternate stowage for the flight deck fire extinguisher.
