Aviation Short Investigations Bulletin

Issue 59

ATSB Transport Safety Report
Aviation Short Investigations
AB-2017-036
Final – 27 April 2017

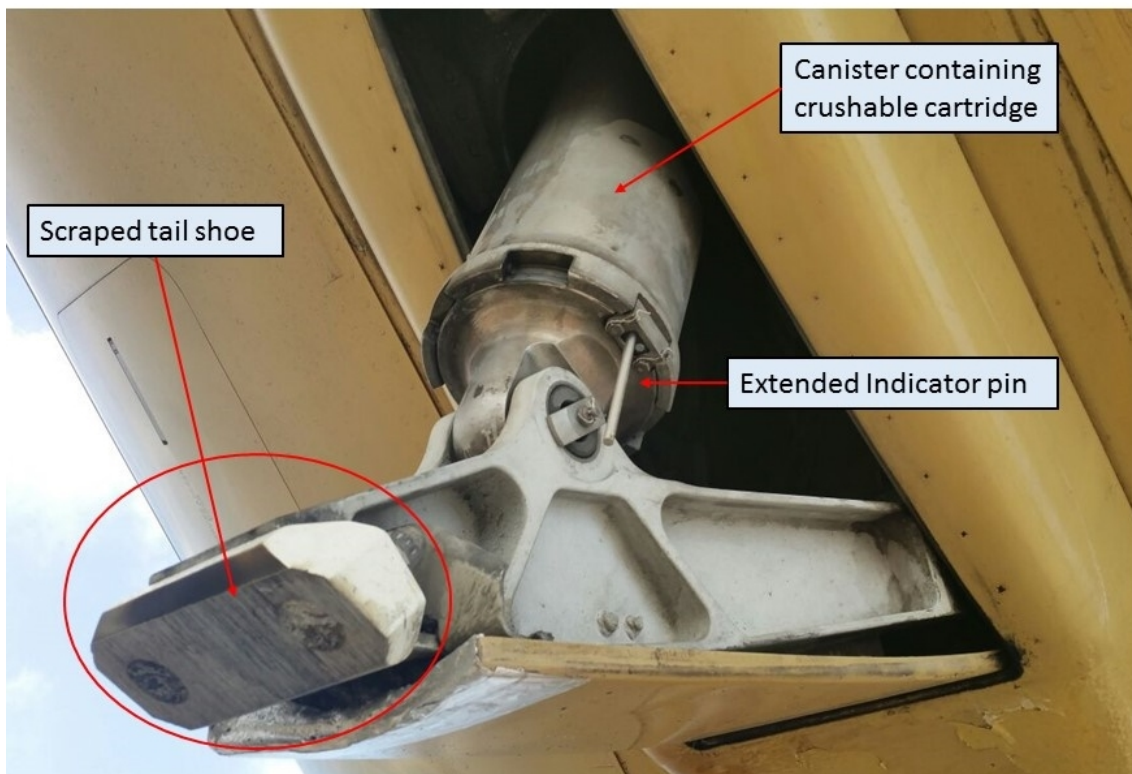
Figure 1: Damage to tail skid

Subsequently, an uneventful landing was carried out in Singapore. Engineers conducted a post-incident inspection of the aircraft and found no damage to the aircraft fuselage. Damage was evident to the tail skid system with indications of a scraped tail shoe, compression of the crushable cartridge and one indicator pin extended (Figure 1). This damage indicated that a moderate energy skid contact had occurred during take-off.

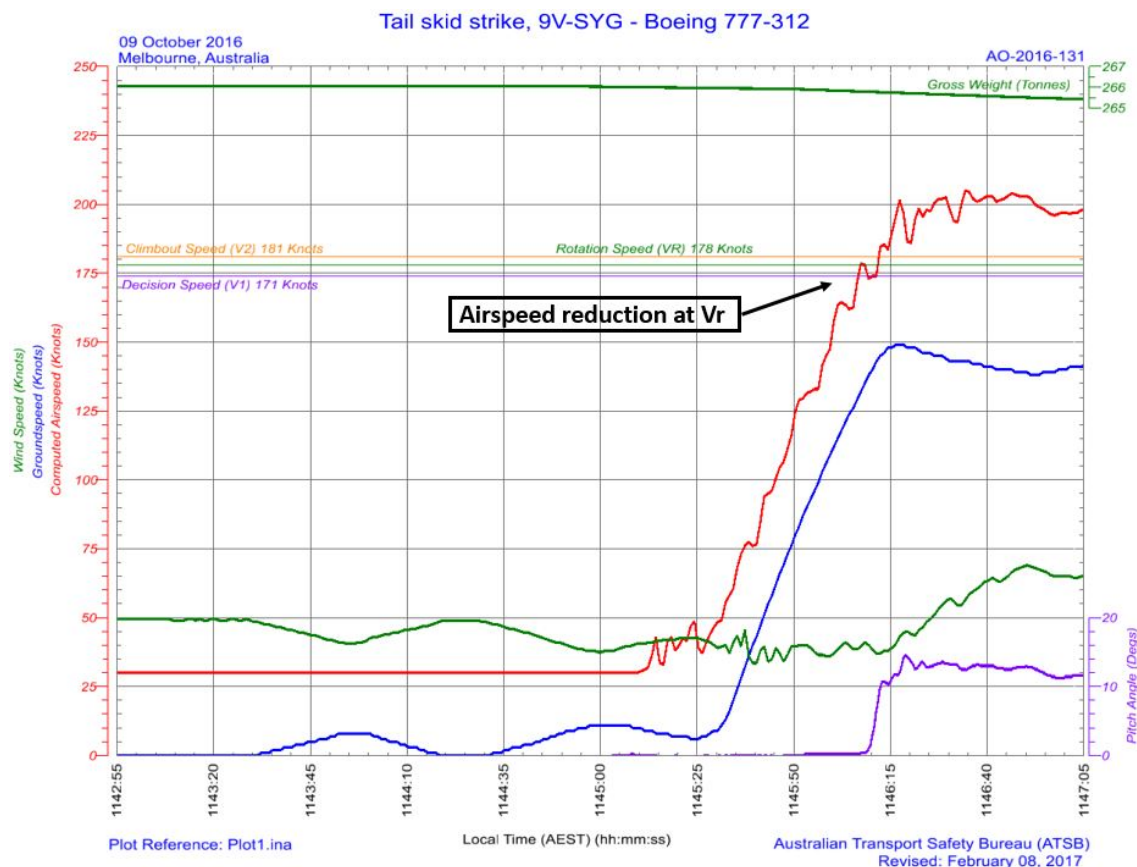
Figure 2: Flight data plot including computed airspeed, and rotation speed (Vr) and pitch attitude

before increasing to approximately 3 to 4 degrees per second. As rotation was initiated, the headwind component decreased 12 kt, the computed airspeed stagnated and reduced to 173 kt (Figure 2). Lift-off occurred at a pitch attitude of 10.7 degrees. The tail skid contact attitude is 8.9 degrees.

- The tail skid contact was a result of airspeed stagnation due to gusty atmospheric conditions which prolonged the time to lift-off, allowing the pitch attitude to exceed the tail skid contact attitude.
- The use of a higher take-off thrust setting would most likely have reduced the required runway length and minimised the aircraft exposure to gusty atmospheric conditions during rotation and lift-off.

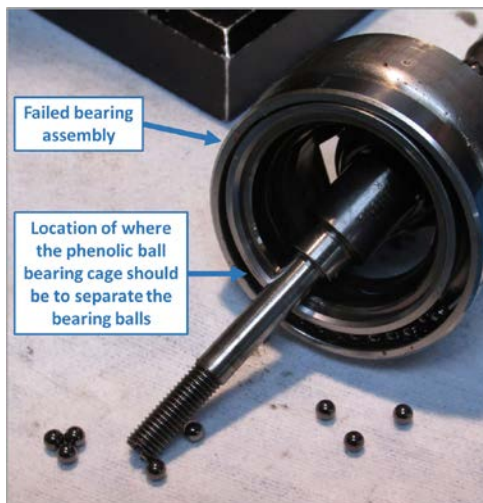
Figure 1: Failed bearing assembly

Aircraft maintenance personnel inspected the right engine after the flight and found that the engine's fuel control unit⁵ was at fault. An examination of the fuel control unit at a component overhaul facility found that the input drive shaft was not free to move. The fuel control unit was inspected and a bearing was found to have failed (Figure 1). The phenolic bearing cage⁶ that separates the bearings was found broken (Figure 2) with many small fragments found to be interfering with the operation of the fuel control unit in that area.

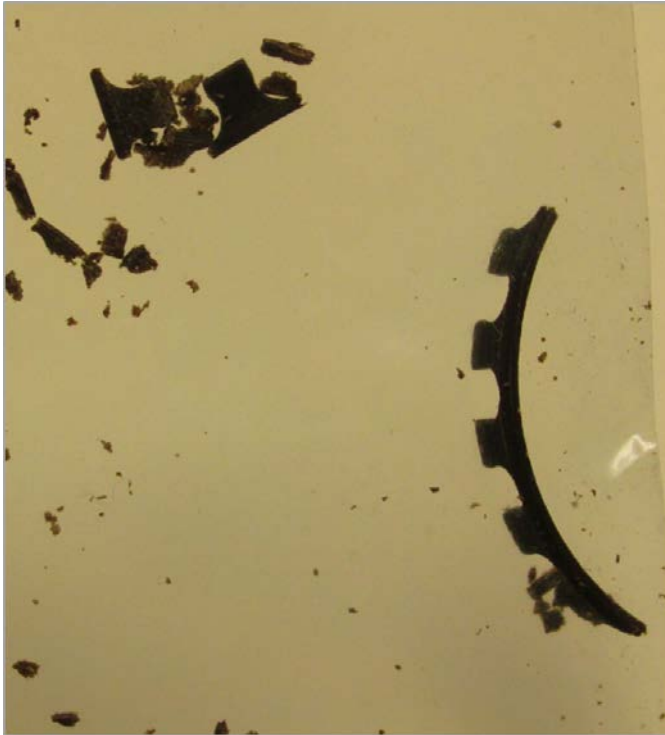
Figure 2: Pieces of the failed phenolic bearing cage

⁶ The phenolic bearing cage is manufactured from fibre-reinforced phenolic resin. The cage retains the ball bearings, to maintain a specific separation between all the bearing assembly parts.

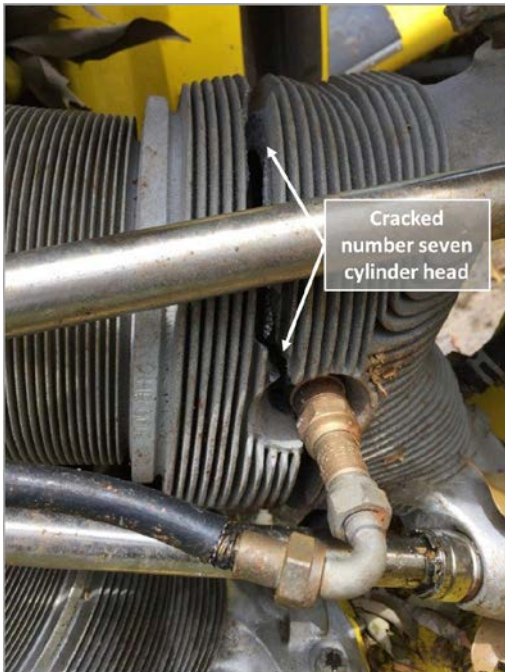
Figure 3: Engine cracked number seven cylinder

The aircraft was fitted with a Pratt and Whitney R-1340 radial engine that had 10,491 total hours and 478.1 hours since overhaul. The engine was inspected after the accident by a representative from an aircraft maintenance organisation and they determined that the number seven cylinder had failed (Figure 3). A crack was located around the circumference of the cylinder head, between the two spark plug holes. A recurring inspection of this area (CASA airworthiness directive *AD/PW-P/19*) was conducted about 91.9 hours prior to the accident at the periodic (100 hourly or 12-month) maintenance inspections.

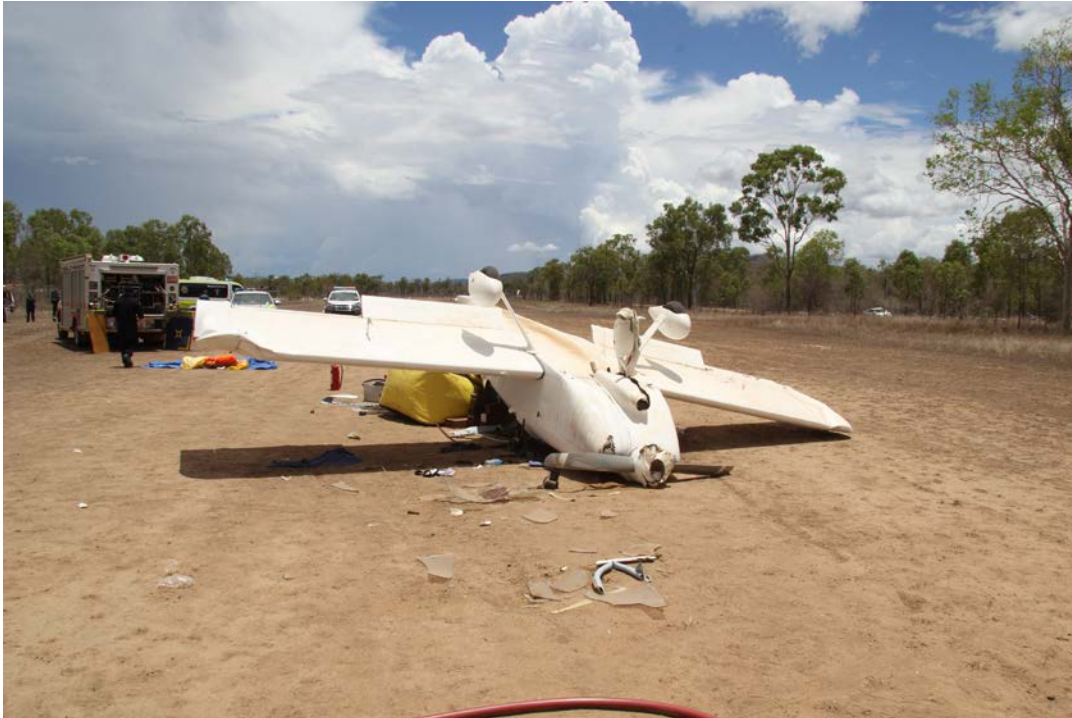
Figure 1: Accident site showing damage to VH-TJM

On 2 January 2017, the pilot of a Van's RV-6A aircraft, registered VH-TJM, conducted a private local flight from Starke Field aircraft landing area (ALA), Queensland. At about 1029 Eastern Standard Time (EST), after a flight of about 85 minutes, the aircraft approached to land at the ALA on runway 15. The aircraft landed heavily, bounced back into the air, and as it contacted the ground again, the nose landing gear collapsed. The propeller struck the runway and the aircraft nosed over and came to rest inverted. The pilot and passenger were seriously injured and the aircraft sustained substantial damage (Figure 1).

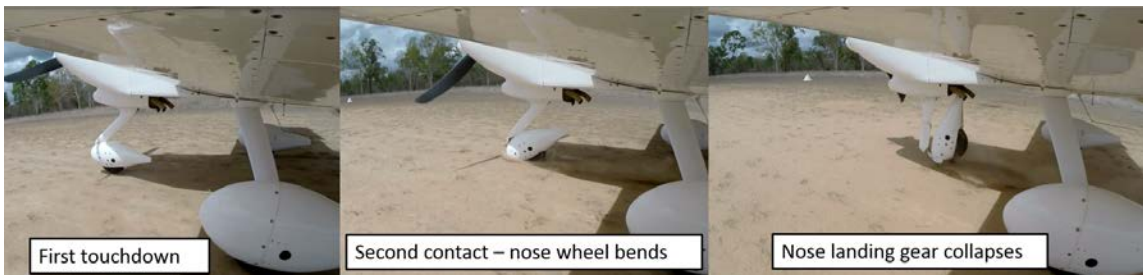
Figure 2: Landing sequence with collapse of nose landing gear

Footage from a video recording device, mounted on the underside of the aircraft's fuselage, showed that the aircraft landed heavily on the initial touchdown. The nose wheel touched very soon after the main wheels and started to vibrate (or shimmy). The aircraft then bounced back into the air and the nose landing gear was still vibrating fore and aft. The nose landing gear was aft of its neutral position when it contacted the ground the second time, just before the main wheels touched again. With that impact, the nose landing gear fork bent and the nose landing gear folded under itself. The aircraft then nosed over.

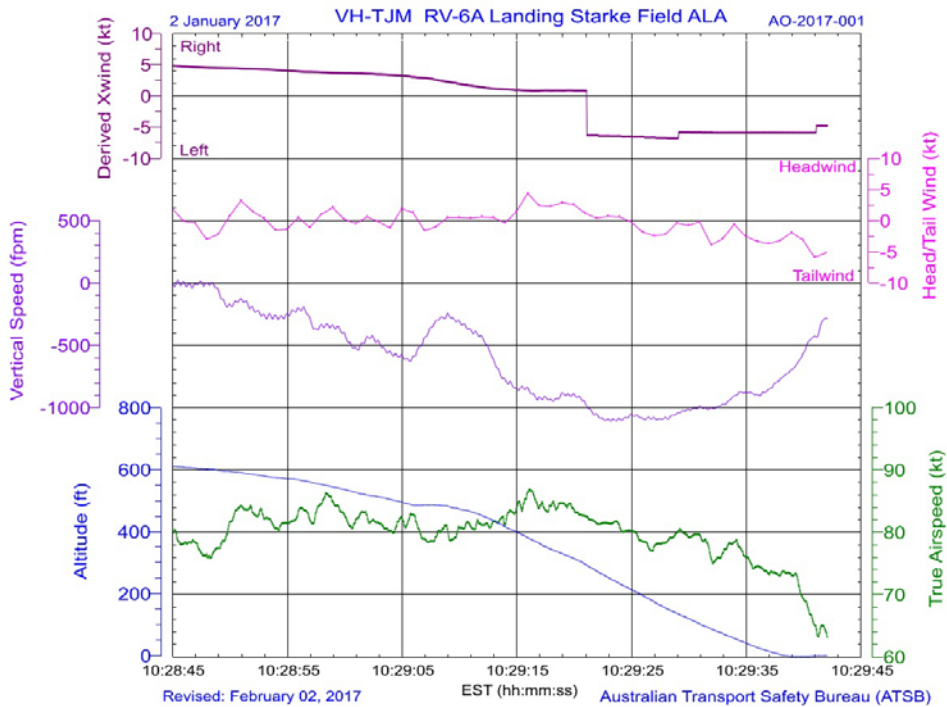
Figure 3: Flight data extract

At 1029:38, the aircraft first contacted the ground, at an airspeed of about 75 kt, with a tailwind of 2 kt and descending at about 700 ft per minute.

The aircraft had a stall speed¹ of 48 kt without flaps and 43 kt with 40 degrees of flap, therefore the aircraft landed at about 1.6 times the published stall speed. The normal approach speed for an aircraft is about 1.3 times the stall speed in the landing configuration. The high rate of descent and speed relative to the ground at landing probably contributed to the nose landing gear collapse.

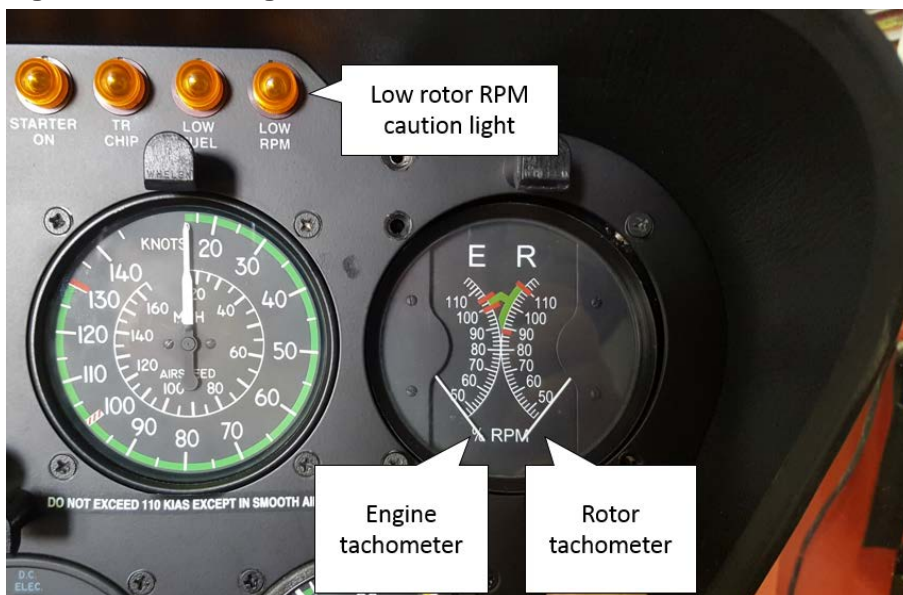
Figure 1: VH-SJK engine and rotor tachometers

The pilot checked the engine and rotor tachometer and noted that the engine RPM was in the normal flight range, but the rotor RPM had degraded to about 85 per cent (Figure 1).¹ They immediately turned right towards land (coastal cliffs) while considering the possibility that it was an instrument fault. However, during the turn and again when over land, the rotor RPM tachometer indicated a decay in RPM whenever the pilot raised the collective.² The rotor RPM response to the pilot’s collective movements indicated to the pilot that there was a genuine problem with the helicopter’s drive system (see *Rotor drive system*).

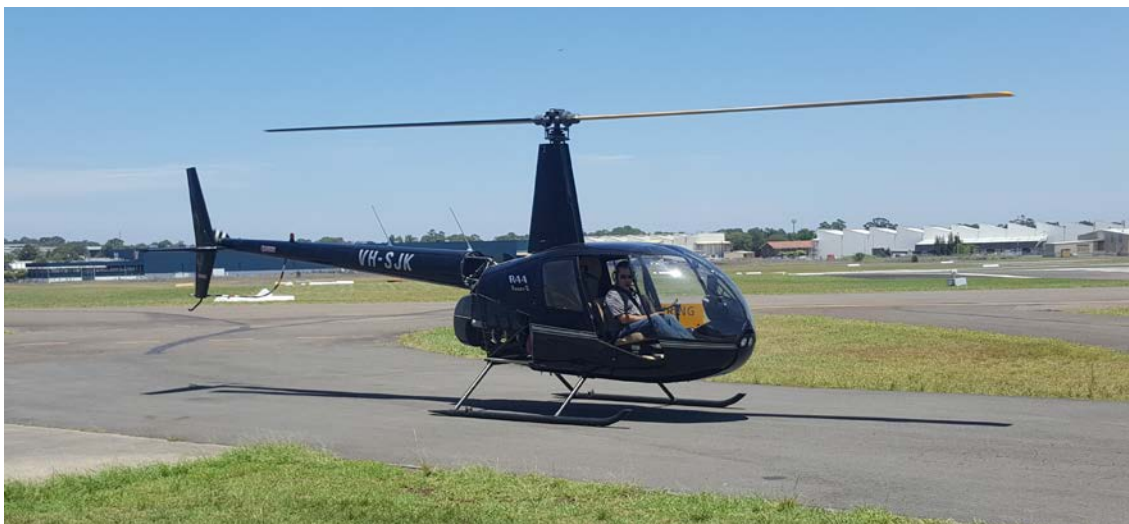
Figure 2: VH-SJK ground running post-recovery

A post-recovery maintenance inspection was conducted, which included a visual inspection and ground run of the helicopter (Figure 2). No fault was found with the engine, drive system or flight controls, but the visual inspection did find chaffing damage to a rotor tachometer wire, which was in intermittent contact with earth. Damage to the helicopter prevented a maintenance test flight.
