Flight control system event involving an Embraer 120, VH-YEI

Adelaide Airport, South Australia, 25 October 2016

ATSB Transport Safety Report
Aviation Occurrence Investigation
AO-2016-143
Final – 24 May 2017

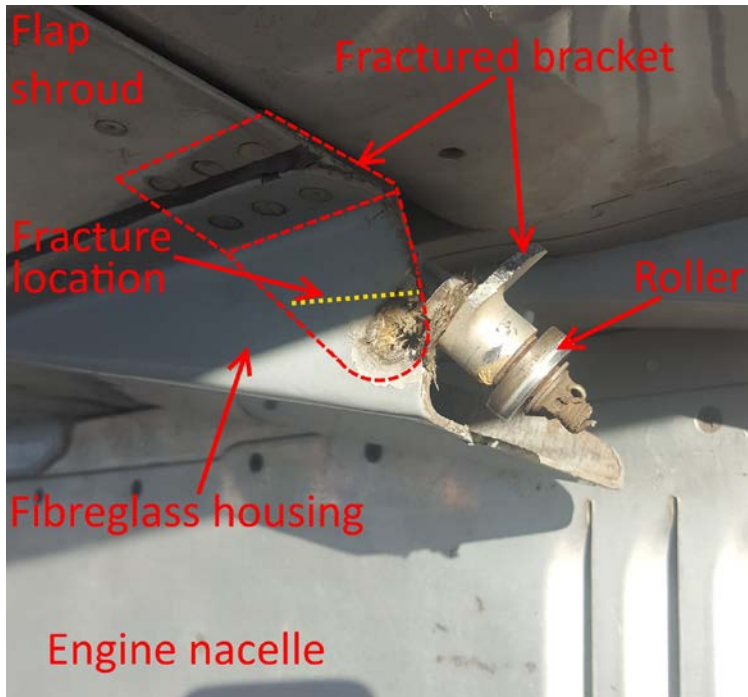
The failed bracket secured a roller to the underside of the wing. This roller supported the inboard side of the left hand outboard flap shroud, and was used to guide the flap shroud as it was deployed and retracted. Figure 1 shows failed the bracket, still fixed to the aircraft after it was identified by the flight crew.

The support of the roller pictured was not required for the flaps to actuate. This was apparent after landing, when the flaps were successfully retracted, despite the bracket fracture. It is likely that a portion of the bracket or its fibreglass housing obstructed the flap, preventing it from fully retracting during flight.

Figure 1: Bracket on the aircraft after it had failed. Most of the bracket is obscured by the fibreglass housing. Its outline is shown by the dotted red line.

Following the identification of the failed bracket, the operator inspected similar parts on YEI as well as the rest of their Embraer-120 fleet. No further damage or signs of cracking were identified.

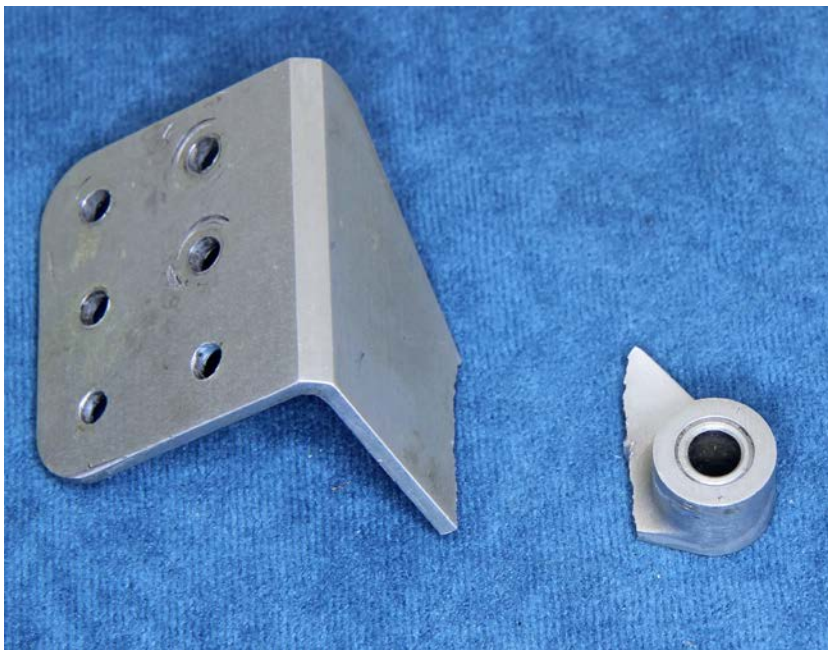
Figure 2 shows the failed component after it was removed from the aircraft. Figure 3 shows the fracture surface on the smaller of the two fragments. Two distinct regions were visible on the fracture surface. The upper region was tarnished and had likely been exposed to the atmosphere for a longer period of time. It was probable that this was the result of a pre-existing crack, and the stress in the remaining section resulted in failure of the component during normal operation.

Figure 2: The failed bracket after it had been removed from the aircraft.

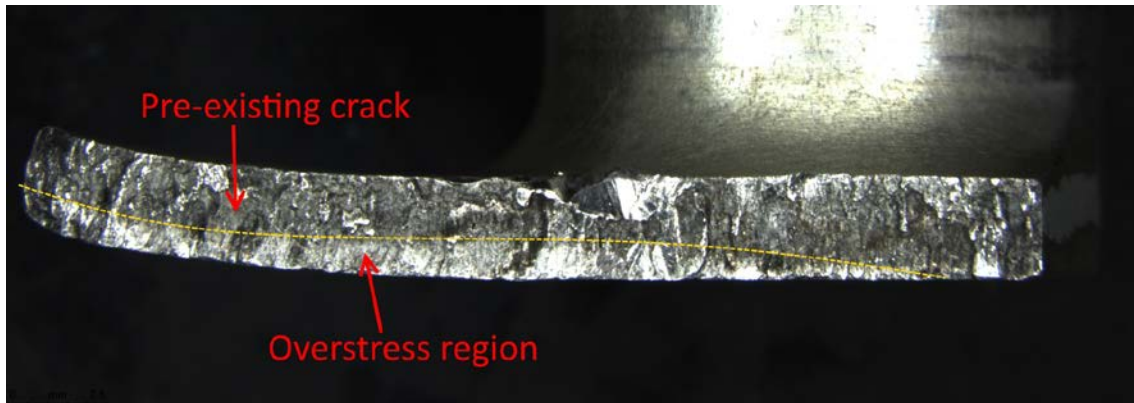
Figure 3: Fracture surface illustrating the pre-existing crack and the overstress region, which fractured when the bracket finally failed.

A pre-existing crack on a partially concealed bracket propagated to the point where it failed in overstress during normal operation. The origin and age of the crack could not be determined, so it is not known whether there was an opportunity for it to have been detected during a base check conducted in 2014.
