Main rotor anti-flap stop failure involving Sikorsky S-92, VH-ZUQ

Broome Airport, Western Australia, 10 November 2016

ATSB Transport Safety Report
Aviation Occurrence Investigation
AO-2016-152
Final – 24 May 2017

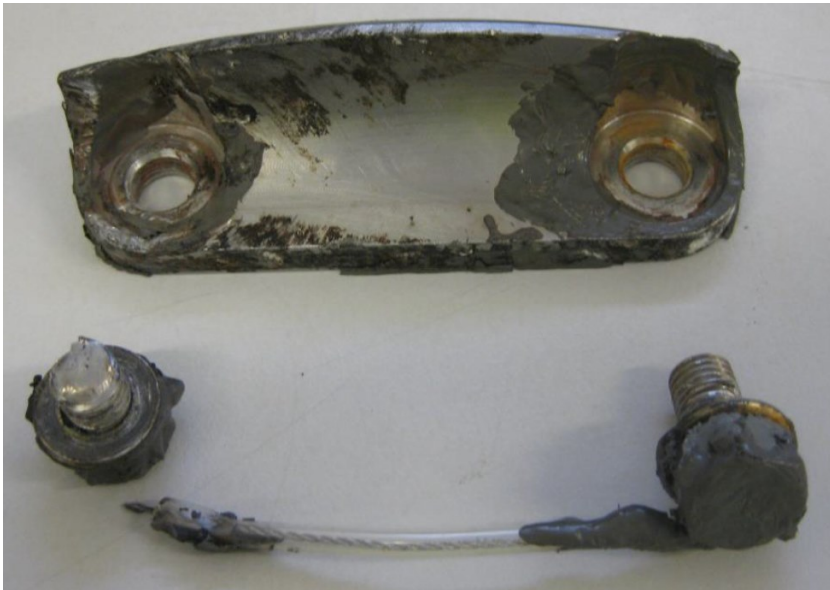
At approximately 1215 Western Standard Time (WST), a member of the ground crew showed the pilots an anti-flap stop that had broken off the main rotor head. Figure 1 shows the recovered anti-flap stop and securing hardware. Figure 2 shows the anti-flap stop attached to the main rotor hub. The helicopter was subsequently shut down. Further inspection revealed that two anti-flap stops had been sheared off the main rotor head during start-up. One of the stops landed next to the aircraft, while the other struck one of the main rotor blades and narrowly missed a member of the ground crew. It was recovered 45 metres from the aircraft.

Figure 1: Anti-flap stop and securing hardware.

The damage to the anti-flap stops was found to have been the result of the PM not lowering the collective control lever at the appropriate time during the engine start. The raised collective resulted in the blades lifting upward, placing abnormal stresses on the anti-flap stops (which are designed to limit upward movement of the blades). This behaviour resulted in the vibrations experienced by the crew.

- a review of S-92A start procedures, addressing as a minimum:
 - flight crew division of duties with specific regard for the collective control lever
 - standardised calls relating to the position of the collective control lever
 - the use of the rotor brake for the start procedure³
- changes to the engine start procedures, the section on lowering the collective is currently written in a 'Note', this will be changed to a 'Caution' to highlight its importance to flight crew
- a review of the policy and procedures used for shadow planning be undertaken, addressing as a minimum all hazards and risks associated with shadow planning inclusive of whether flight crew undergoing training should be exposed to the requirement.

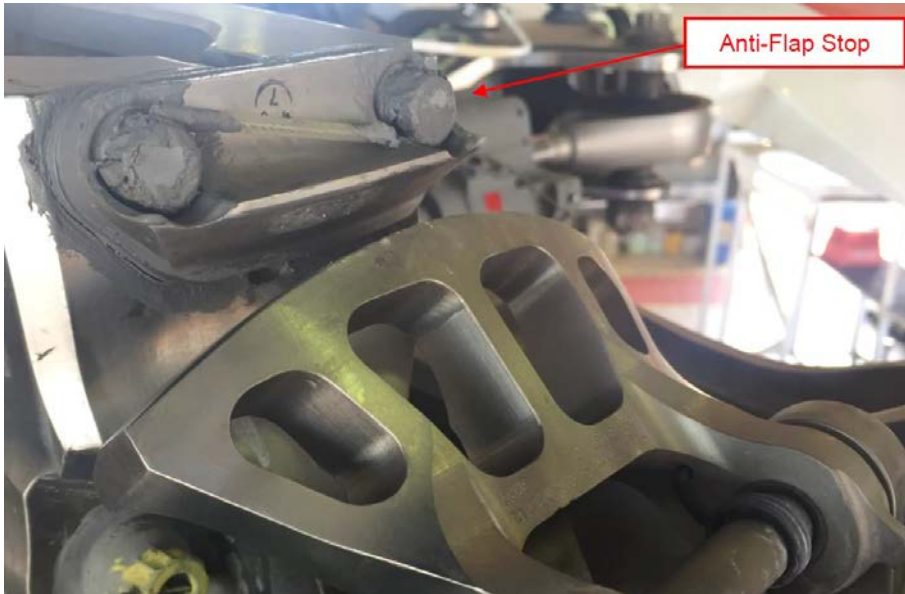
Figure 2: Anti-flap stop secured to the main rotor hub.
