# Pre-flight preparation event involving Airbus A320, VH-VNC

Cairns Airport, Queensland, 21 January 2017

**ATSB Transport Safety Report**  
Aviation Occurrence Investigation  
AO-2017-008  
Final – 24 May 2017

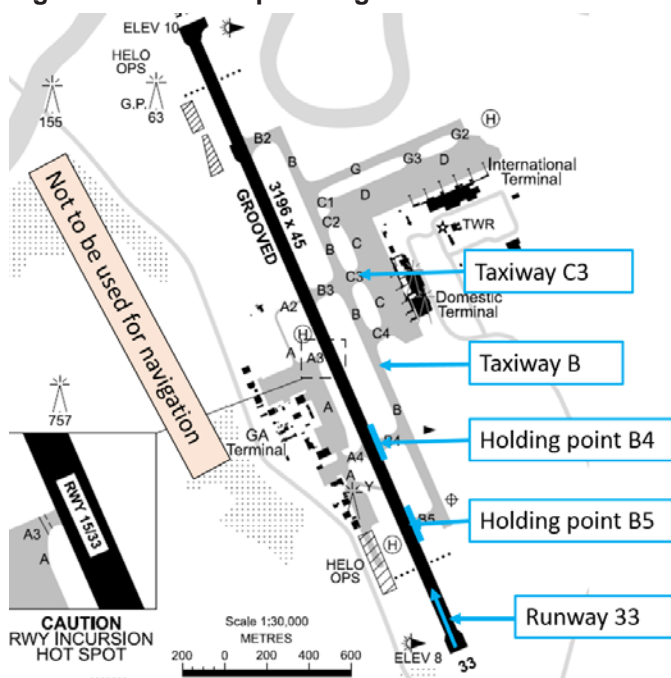
Figure 1: Cairns Airport diagram extract

The flight crew conducted a take-off and departure briefing based on the environmental conditions and runway in use, expecting to commence the take-off roll from the B5 taxiway intersection (Figure 1). They entered the take-off data into the iPad application and loaded the data into the flight management guidance computer.

VNC then taxied behind the DHC-8 along taxiway B. As the DHC-8 turned onto the runway at B4, the first officer of VNC inadvertently also taxied to holding point B4. After completing the 'above the line' pre-take-off checks (see *Pre-take-off checks*), at about 1515, the captain of VNC advised the aerodrome controller (ADC) that they were ready for take-off. The ADC cleared VNC to line up on the runway and, as the first officer taxied the aircraft onto the runway, the flight crew completed the 'below the line' pre-take-off checks.

About 1 minute later, the ADC cleared VNC for take-off. Immediately after the captain read back the take-off clearance, the ADC advised the crew that they were lined up at the B4 (not B5) intersection. The crew did not respond, so the ADC cancelled the take-off clearance and instructed them to hold position. The captain then confirmed that they needed to commence the take-off from B5. The ADC cleared them to turn around on the runway, exit using B4 and taxi to B5. The aircraft subsequently took off from the B5 intersection and the flight continued without incident.

There was a 403 m difference in available runway length, between the B4 and B5 taxiway intersections.
