# Aviation Short Investigations Bulletin

Issue 60

AB-2017-050

Final – 24 May 2017

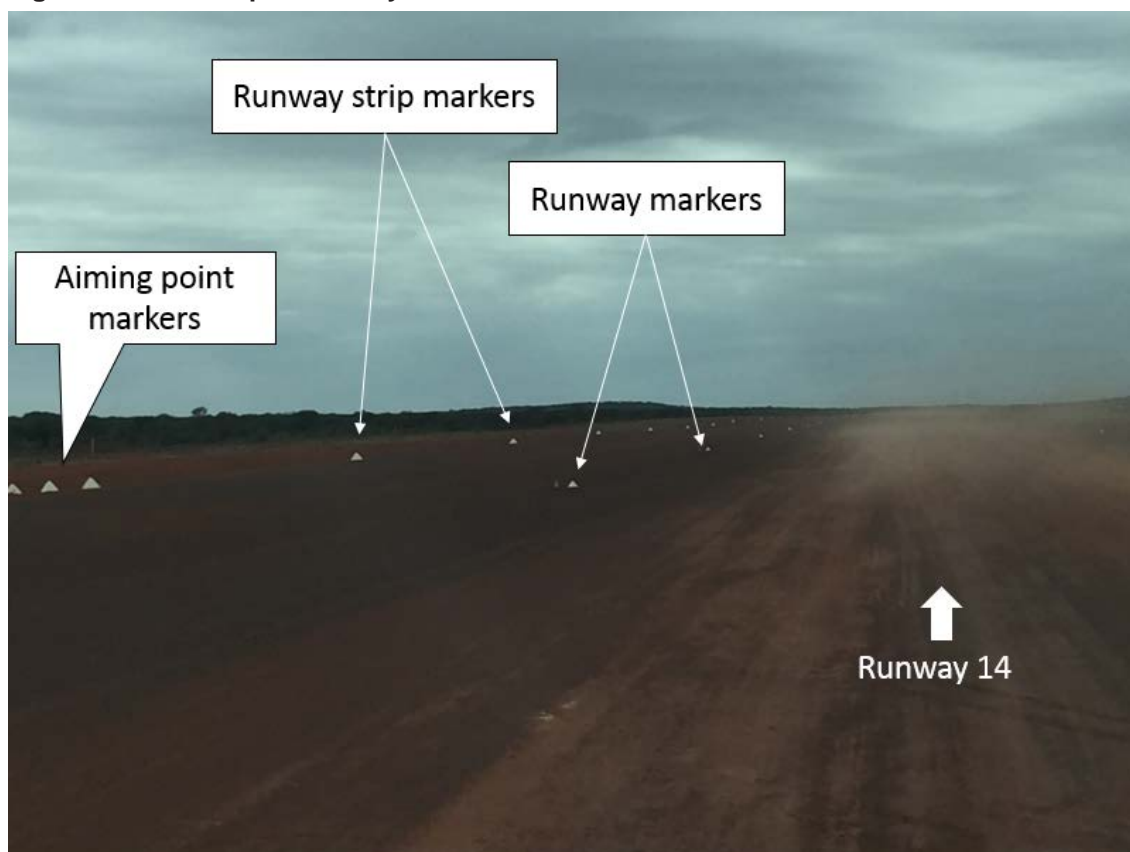
**Figure 1: Darlot Airport runway 14**

Source: Pilot, annotated by ATSB. Image depicts Darlot Airport runway 14 and left side of runway strip as viewed from the right seat of the aircraft with white frangible cones used as markers. Raised dust extends from the centre of the runway across the southern side of the runway strip.

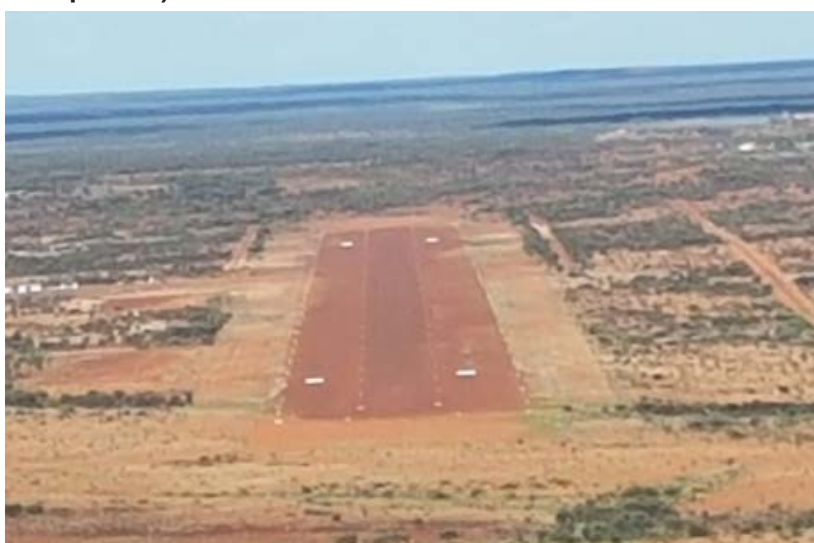
The aircraft operator provided services to three other airports with unsealed runways. Following this incident, the operator reviewed the other airports and found that at two airports the aiming point markers were located inside the runway strip (one used gable markers and the other cones), either side of the runway (Figure 2), and at the third airport the aiming point markers had been removed. Therefore, the aiming point markings were inconsistent between all four airports.

**Figure 2: Gable aiming point markers within the runway strip (different airport used by the operator)**

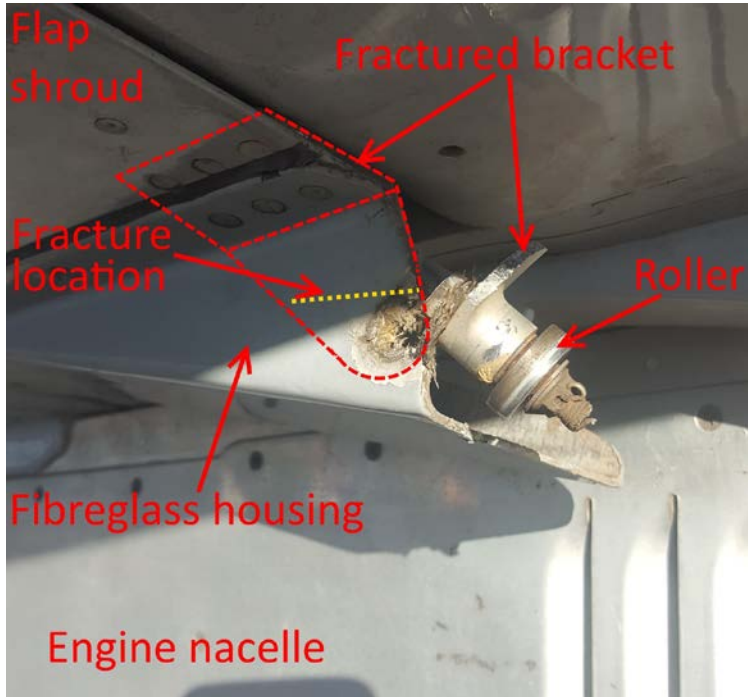
The failed bracket secured a roller to the underside of the wing. This roller supported the inboard side of the left hand outboard flap shroud, and was used to guide the flap shroud as it was deployed and retracted. Figure 1 shows failed the bracket, still fixed to the aircraft after it was identified by the flight crew.

The support of the roller pictured was not required for the flaps to actuate. This was apparent after landing, when the flaps were successfully retracted, despite the bracket fracture. It is likely that a portion of the bracket or its fibreglass housing obstructed the flap, preventing it from fully retracting during flight.

**Figure 1: Bracket on the aircraft after it had failed. Most of the bracket is obscured by the fibreglass housing. Its outline is shown by the dotted red line.**

Following the identification of the failed bracket, the operator inspected similar parts on YEI as well as the rest of their Embraer-120 fleet. No further damage or signs of cracking were identified.

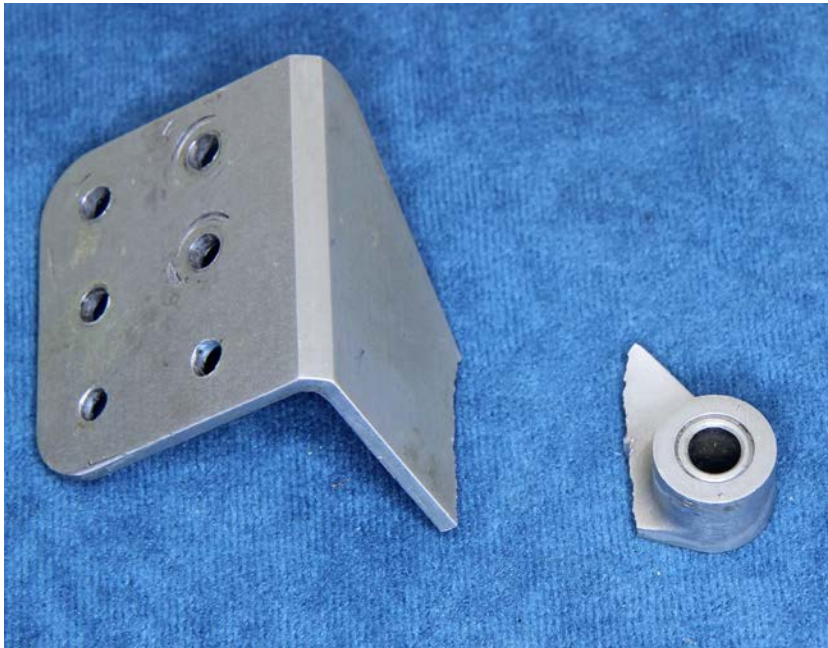
Figure 2 shows the failed component after it was removed from the aircraft. Figure 3 shows the fracture surface on the smaller of the two fragments. Two distinct regions were visible on the fracture surface. The upper region was tarnished and had likely been exposed to the atmosphere for a longer period of time. It was probable that this was the result of a pre-existing crack, and the stress in the remaining section resulted in failure of the component during normal operation.

**Figure 2: The failed bracket after it had been removed from the aircraft.**

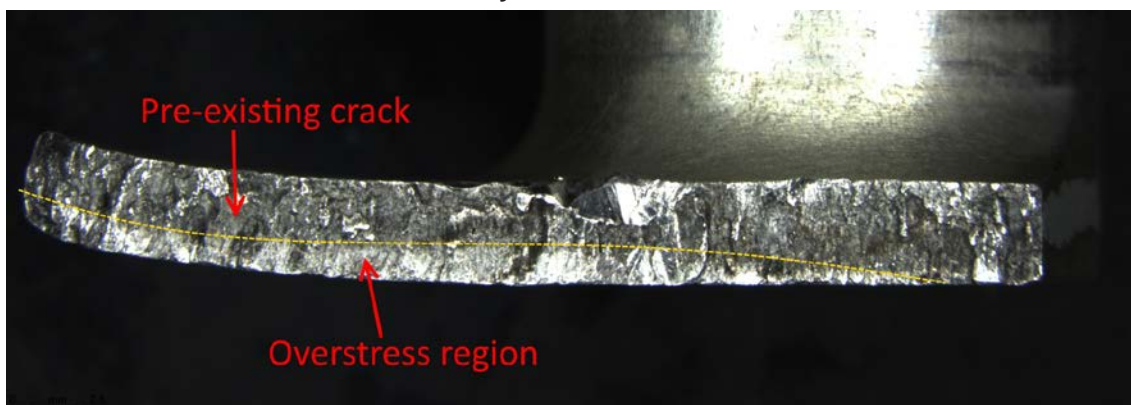
**Figure 3: Fracture surface illustrating the pre-existing crack and the overstress region, which fractured when the bracket finally failed.**

A pre-existing crack on a partially concealed bracket propagated to the point where it failed in overstress during normal operation. The origin and age of the crack could not be determined, so it is not known whether there was an opportunity for it to have been detected during a base check conducted in 2014.

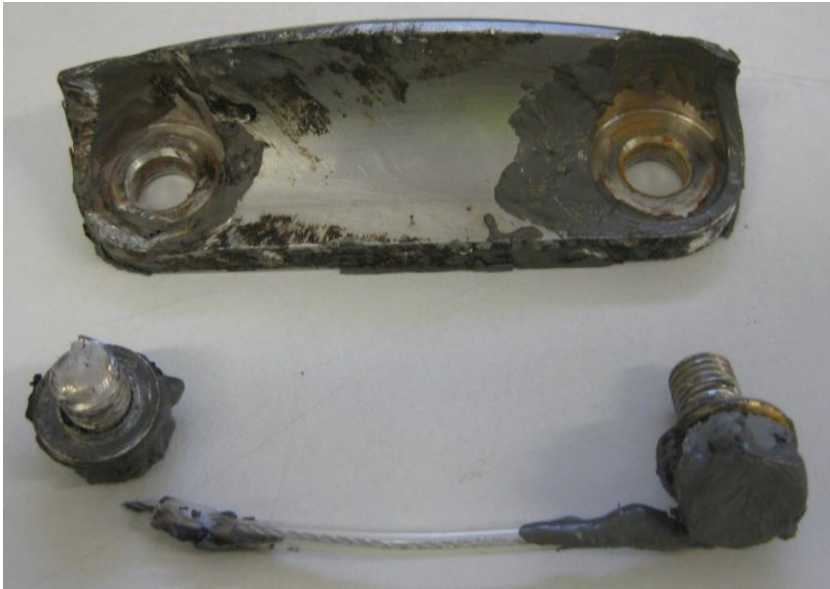
At approximately 1215 Western Standard Time (WST), a member of the ground crew showed the pilots an anti-flap stop that had broken off the main rotor head. Figure 1 shows the recovered anti-flap stop and securing hardware. Figure 2 shows the anti-flap stop attached to the main rotor hub. The helicopter was subsequently shut down. Further inspection revealed that two anti-flap stops had been sheared off the main rotor head during start-up. One of the stops landed next to the aircraft, while the other struck one of the main rotor blades and narrowly missed a member of the ground crew. It was recovered 45 metres from the aircraft.

**Figure 1: Anti-flap stop and securing hardware.**

The damage to the anti-flap stops was found to have been the result of the PM not lowering the collective control lever at the appropriate time during the engine start. The raised collective resulted in the blades lifting upward, placing abnormal stresses on the anti-flap stops (which are designed to limit upward movement of the blades). This behaviour resulted in the vibrations experienced by the crew.

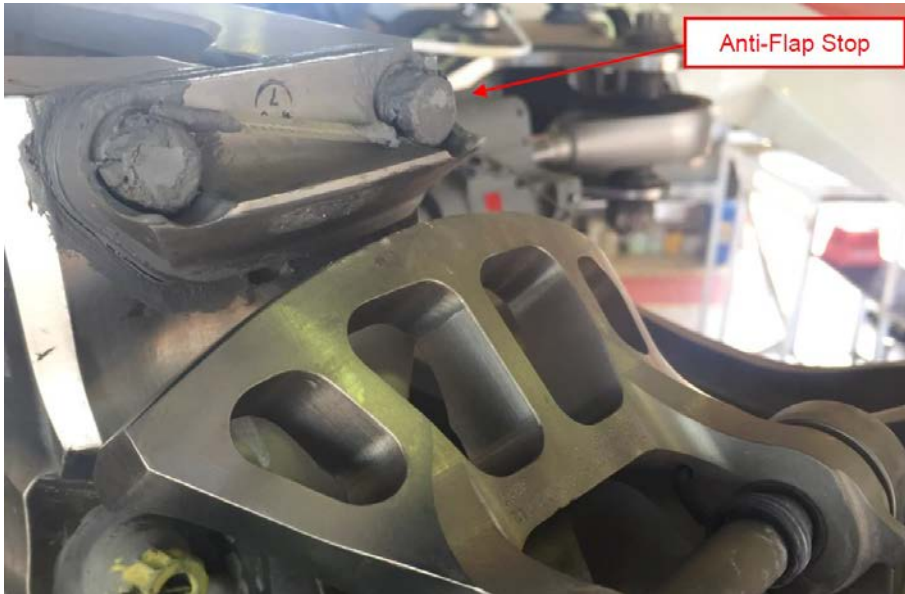
**Figure 2: Anti-flap stop secured to the main rotor hub.**

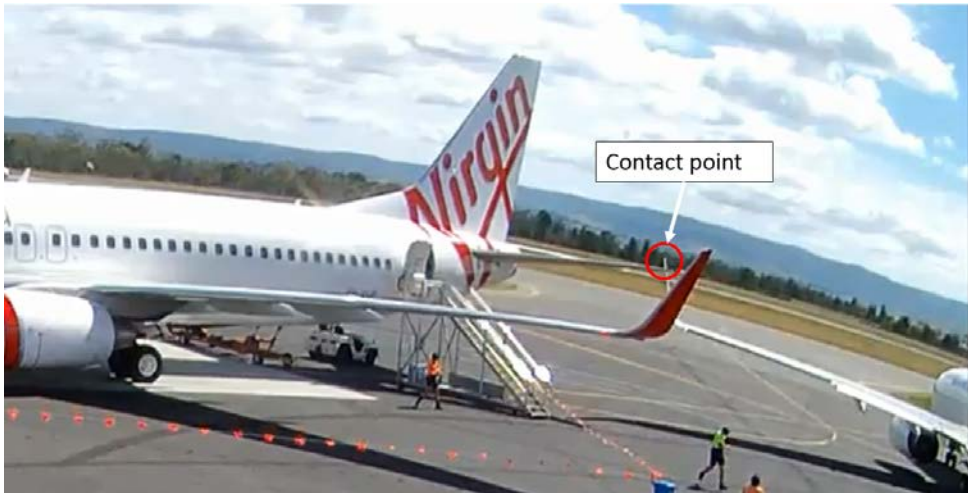
About 30 seconds after recommencing the taxi, as YFT continued to turn, the left wingtip collided with the horizontal stabiliser (tailplane) of VUP (Figure 7).

**Figure 7: Contact between YFT left winglet and VUP left horizontal stabiliser**

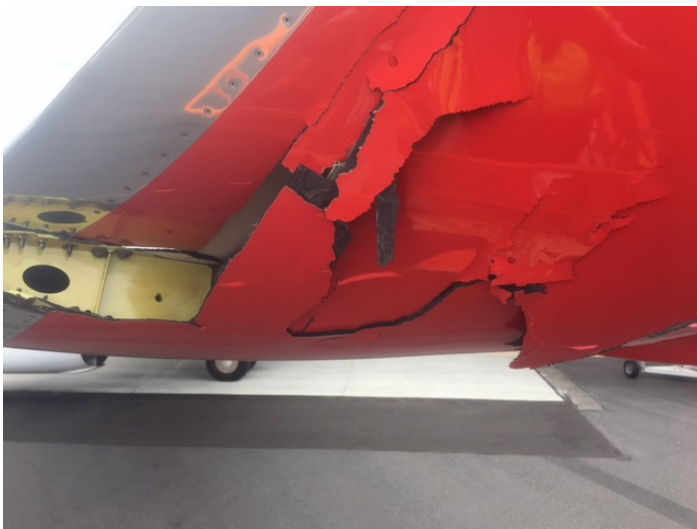
The winglet of YFT was damaged (Figure 8) as was the horizontal stabiliser of VUP (Figure 9). No one was injured.

**Figure 8: Damage to YFT left winglet**

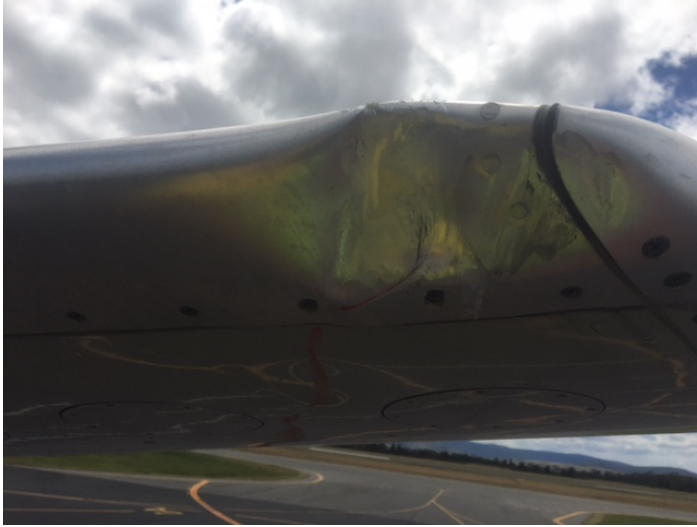
**Figure 9: Damage to VUP left horizontal stabiliser**
