Wirestrike and collision with terrain involving Bell 206B helicopter, VH-WHU

near Carmila, Queensland | 25 March 2016

ATSB Transport Safety Report
Aviation Occurrence Investigation
AO-2016-027
Final – 26 June 2017

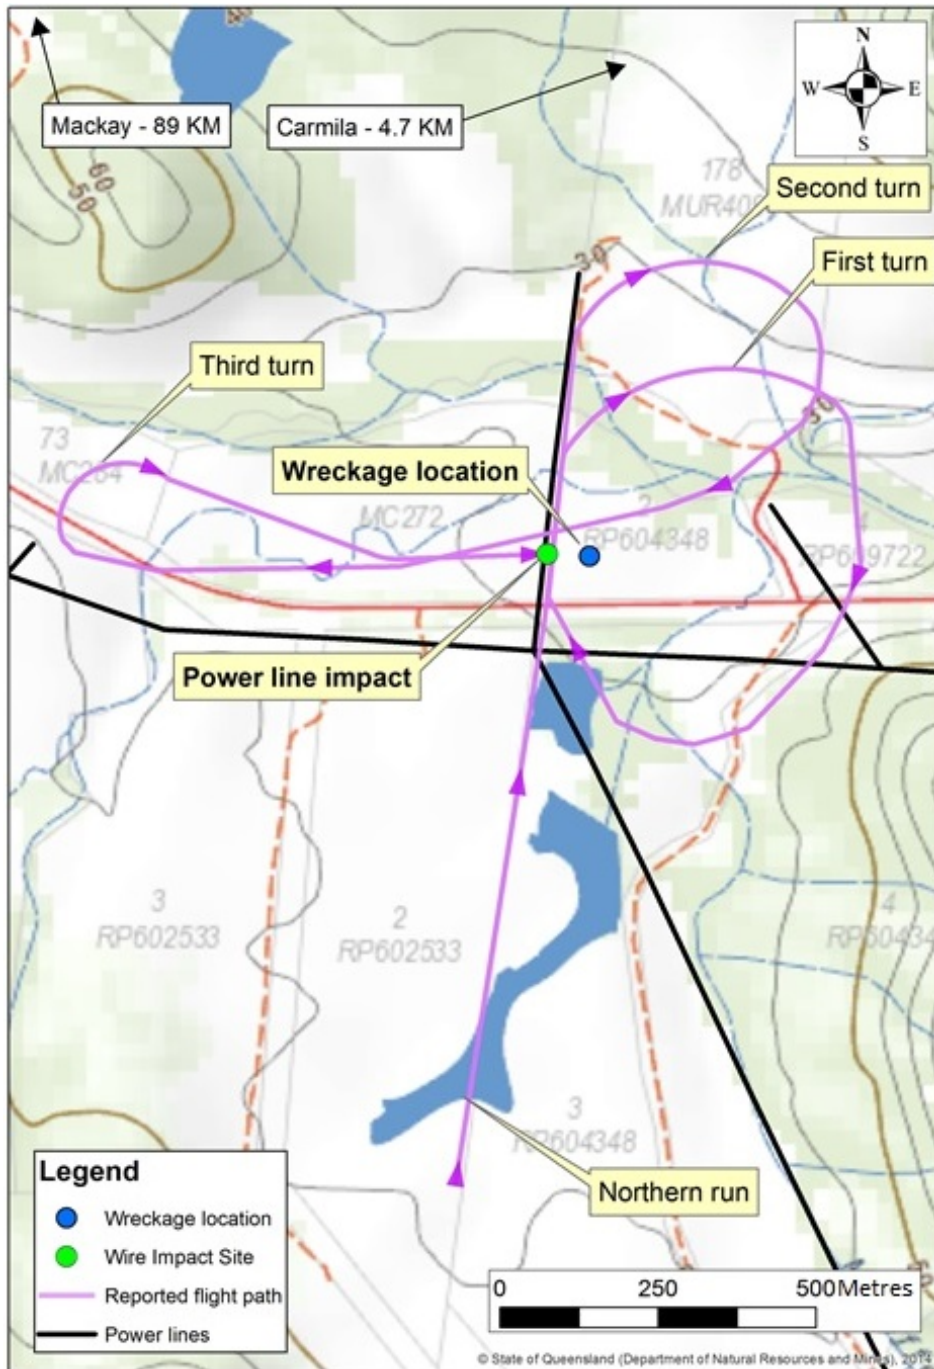
Figure 1: WHU's flight path, as reported by witnesses

The pilot took off and was observed flying at various locations around the property. The property owner and loader presumed the pilot was conducting 'clean-up runs'. Shortly prior to the wirestrike, the helicopter was observed flying in a north-north-easterly direction, to the east of and adjacent to the north-south powerline (Figure 1). This line was strung low between three wooden power poles that were located between two sugar cane fields, about 8 m above the ground.

Concerned about the proximity of the helicopter to the powerlines, the loader radioed the pilot and reminded him of their location. The pilot replied 'powerlines sighted and marked'. The loader continued with the job at hand and the property owner observed the helicopter complete two clockwise circles before tracking to the west, over the north-south powerline. The pilot continued the application to the north and west of the powerlines before turning back towards the east.

At about 1028, the helicopter collided with the north-south powerline (Figure 1).

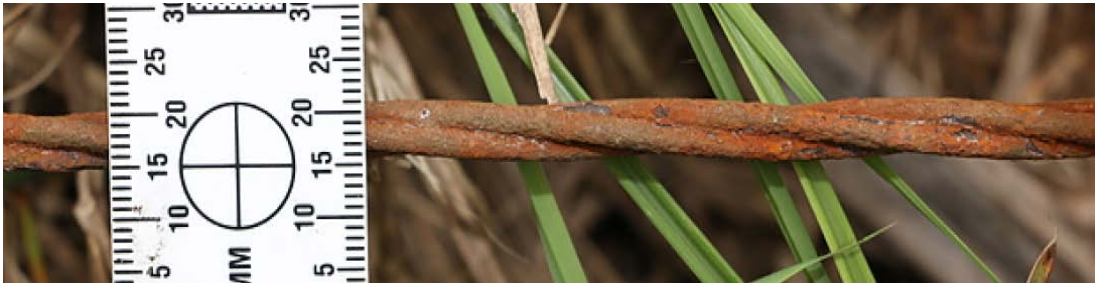
Figure 2: Power cable consisting of three steel wires twisted together (note the rust-like discolouration)

The area being sprayed was divided by powerlines that consisted of three cables, each made from three steel wires twisted together (Figure 2). The powerline that was struck by WHU was

strung north-to-south, rusted and supported by three power poles over a distance of about 386 m (Figure 1). The poles to the north and south were located between tall trees (Figure 3). The centre of these poles was estimated to be about 3–4 m higher than the surrounding cane fields and was situated in a north–south clear area that was used as an access road.

- outer supporting power poles were obscured by trees as the pilot approached them, negating one of the visual cues often used by pilots to locate powerlines
- luminance of the power cables was reduced by their rust-like discolouration, reducing the likelihood of their detection by the pilot
- powerlines were not marked, and were not required to be marked, with visibility devices
- contrast in texture between the background and the powerline was decreased, including by a sugarcane field, rising terrain and a tree-lined creek. In combination, these features resulted in a camouflaging effect.

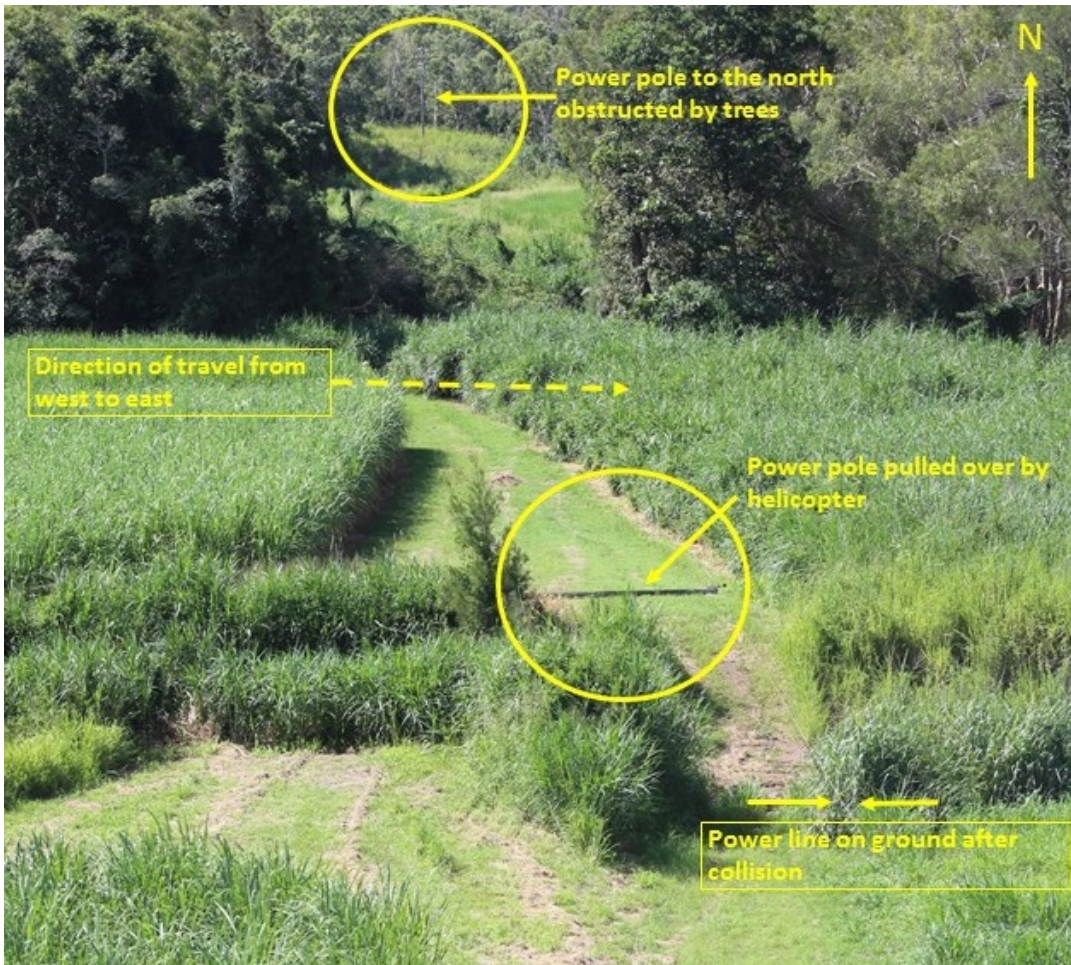
Given the approximate 8 m height of the centre pole, and the normal spraying height of the helicopter, there was the potential for the pole to have been masked by the trees and rising terrain to the east of the powerline. The powerlines were not marked with visibility devices, nor were they required to be by regulation.

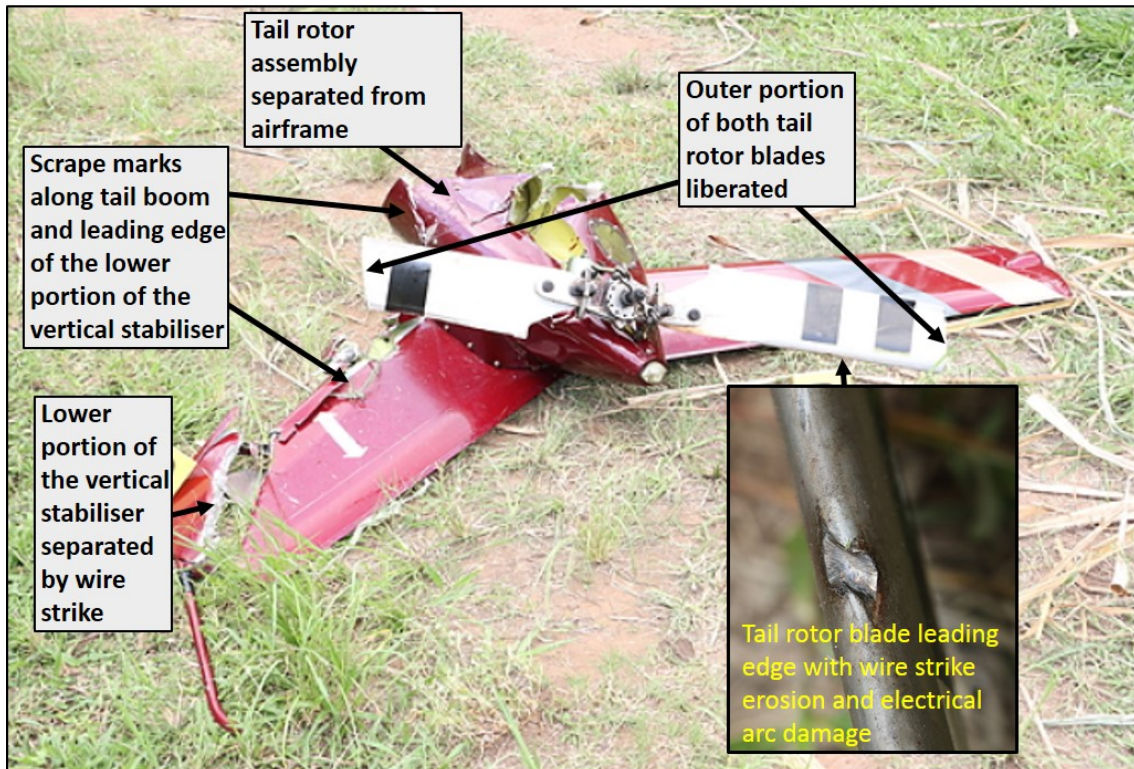
Figure 4: Separated tail rotor assembly, showing the liberation of the outer portion of both tail rotor blades, electrical arcing to the leading edge of one tail rotor blade (at inset) and the separated lower portion of the vertical stabilizer

The vertical stabiliser and tail rotor assembly fractured from the boom during the accident sequence and were found about 30 m from the main helicopter wreckage. Scrape marks and gouging identified along and around the tail rotor section was consistent with colliding with a wire.

The lower portion of the vertical stabiliser displayed uneven, high-energy impact damage. The composite structure was abraded, roughened and had separated from the vertical stabiliser assembly. This was consistent with one of the powerline cables ‘pulling through’ the stabiliser during the impact sequence. The outer portions of both tail rotor blades were fractured and gouged, also consistent with colliding with one of the power line cables before separating from the tail rotor assembly (Figure 4). The liberated outer portions of the tail rotor blades were not recovered.

Evidence of scraping along the tail boom, the damage to the lower vertical stabiliser and the separation of the outer portion of the tail rotor blades indicated that WHU struck the powerline in a nose-up attitude. This would be consistent with the pilot taking action to avoid a wirestrike, but likely contributed to the wire passing underneath the lower component of the helicopter's wirestrike protection system and striking the tail rotor and stabiliser assembly. The tail rotor and stabiliser assembly separated from the helicopter's tail boom, resulting in a loss of directional
