Flight below lowest safe altitude involving Boeing 747, N416MC

15 km NNW Sydney Airport, New South Wales, 12 February 2017

ATSB Transport Safety Report
Aviation Occurrence Investigation
AO-2017-023
Final – 27 July 2017

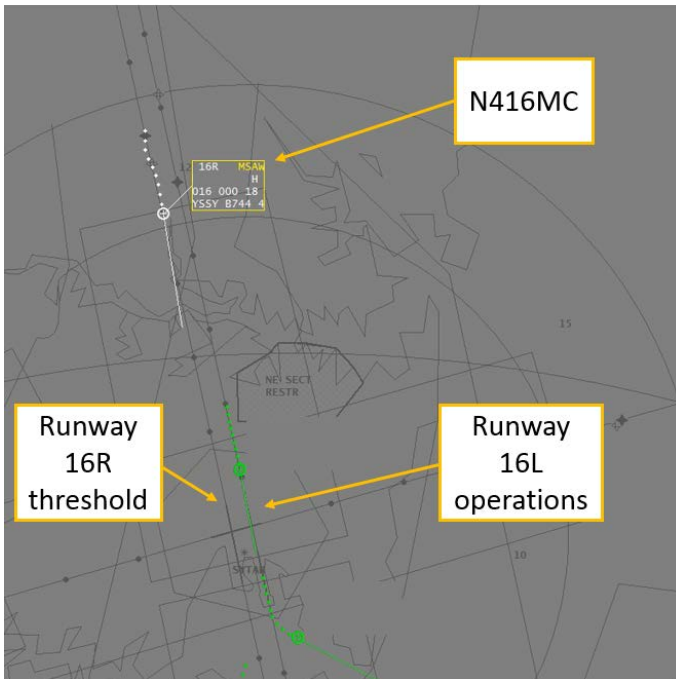
Figure 1: Minimum safe altitude warning for N416MC

The lowest point on the approach was 1,559 ft from flight data (1,600 ft on radar) at about 8.0 NM (14.8 km) from runway 16R (Figure 1). This resulted in the aircraft descending about 1,000 ft below the nominal 3° glideslope at the time of the incident. The aircraft was flown on the second approach with auto-pilot engaged. The localiser and glideslope captured and tracked the ILS with no anomalies detected.

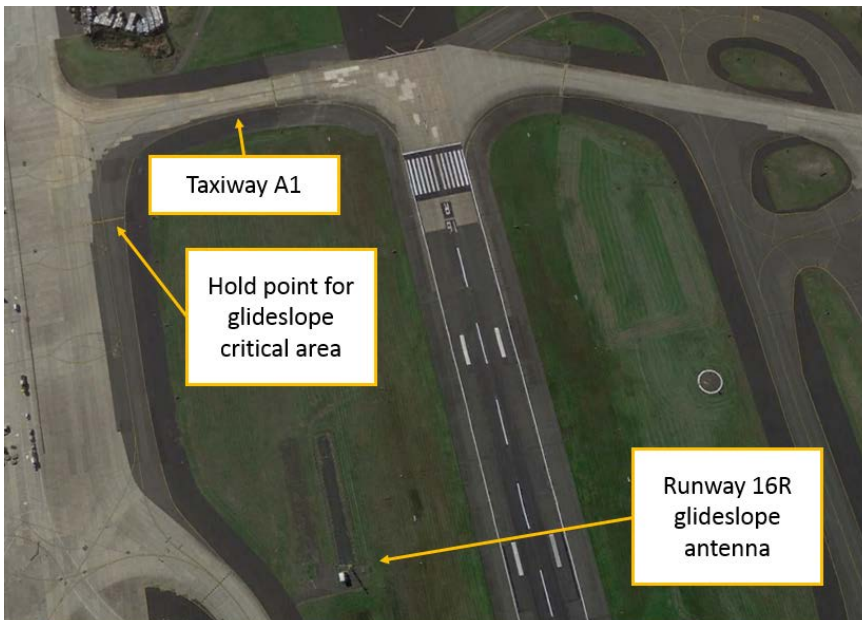
Figure 2: Runway 16R glideslope antenna and critical area hold point

Disturbances to ILS localiser and glideslope courses are caused by fixed structures, such as buildings (static distortion), and moving vehicles or aircraft (dynamic distortion). The total ILS course distortion is determined by the root square summation of static and dynamic distortion and this is used to define critical areas⁷ near each localiser and glideslope antenna (Figure 2).

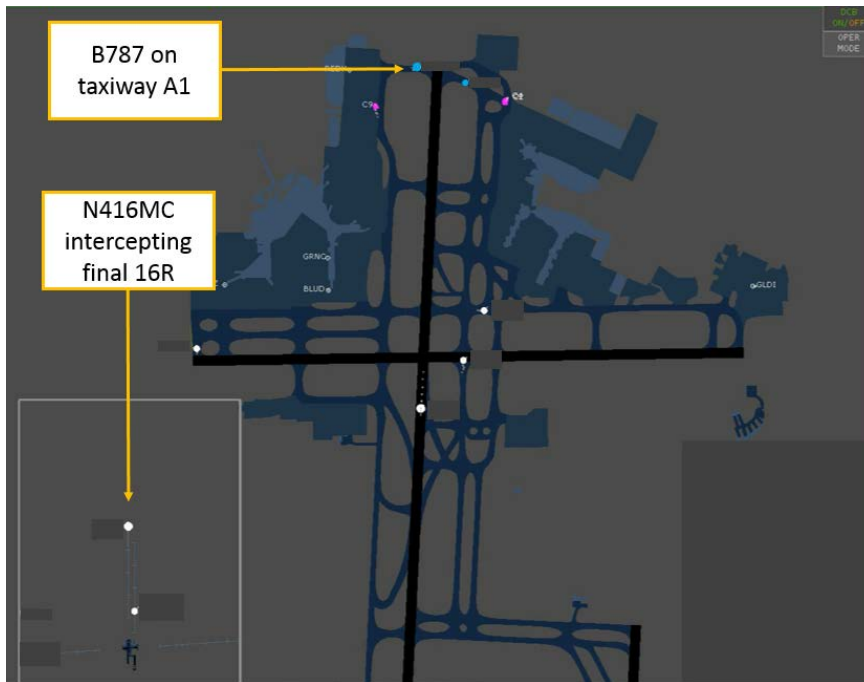
Figure 3: Infringement of the 16R glideslope critical area

At the time N416MC intercepted the runway 16R localiser, a Boeing 787 was holding on taxiway A1, within the runway 16R glideslope critical area (Figure 3). However, the weather conditions did not require air traffic control to activate the ILS critical area, and N416MC was instructed to go-around before reaching the outer marker.⁸

N416MC intercepted the final approach and the auto-pilot captured the ILS localiser and glideslope at the same time as a Boeing 787 (B787) was holding on taxiway A1, which lies within the critical area for the runway 16R glideslope. The presence of the 787 in the critical area likely resulted in N416MC receiving either a distorted glideslope beam or a beam of varying signal strength. This required flight crew intervention following a glideslope failure indication, which was detected by the captain crosschecking the two primary flight displays. At the time of the incident,

- The descent below the nominal 3° approach glideslope was probably the result of the aircraft auto-pilot capturing a distorted glideslope beam.
- The glideslope beam was probably distorted due to the presence of a Boeing 787 in the glideslope critical area, which was not required to be protected in the weather conditions which prevailed at the time of the incident.
