# Descent below lowest safe altitude involving Boeing 777, 9V-SRP

40 km SSW of Canberra Airport, Australian Capital Territory, 22 February 2017

**ATSB Transport Safety Report**  
Aviation Occurrence Investigation  
AO-2017-026  
Final – 27 July 2017

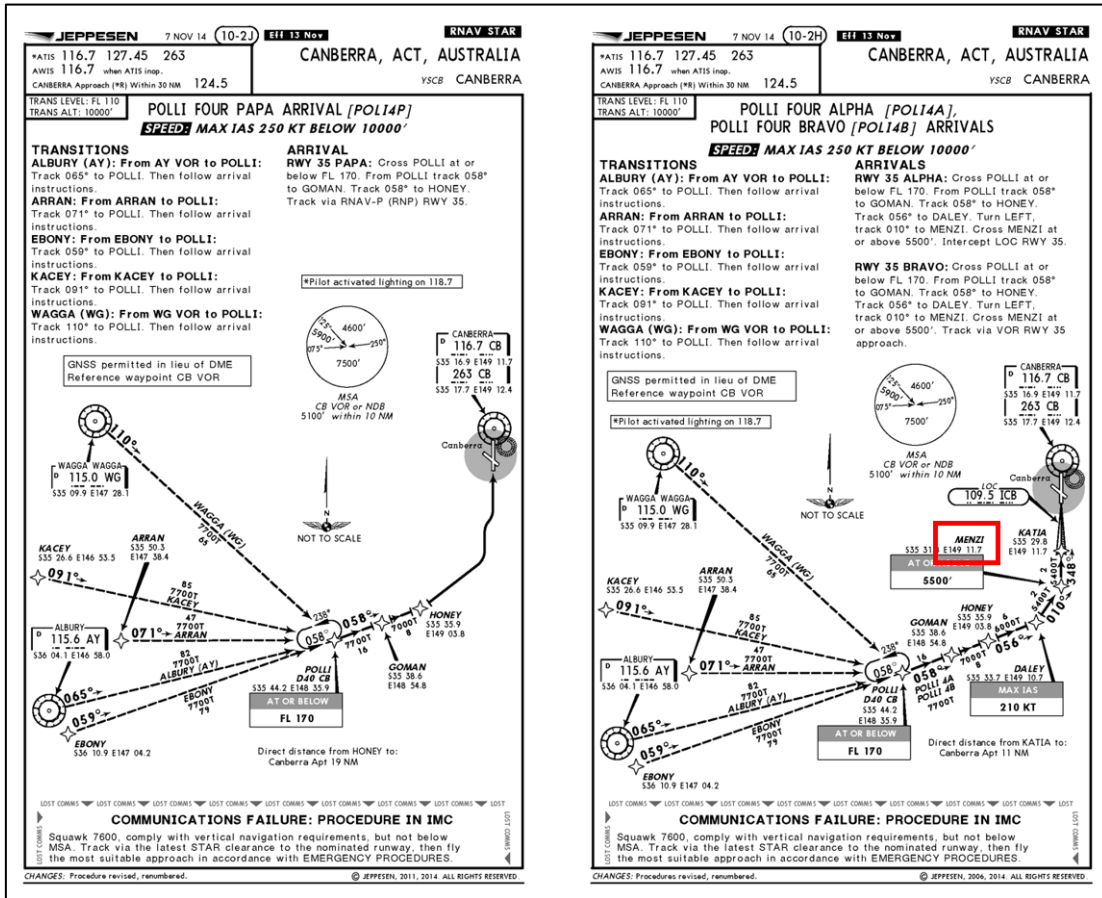
Figure 1: POLLI FOUR PAPA (left) and POLLI FOUR BRAVO (right) arrivals

As the aircraft descended, air traffic control (ATC) instructed the flight crew to conduct the POLLI FOUR BRAVO arrival (Figure 1 right).

The flight crew had not briefed for this arrival and the first officer, who was pilot flying, identified that the POLLI FOUR BRAVO arrival led to the runway 35 VOR approach.<sup>6</sup> As the POLLI FOUR PAPA and POLLI FOUR BRAVO arrivals were very similar, the flight crew elected to reprogram the POLLI FOUR BRAVO arrival into the FMC while keeping the RNAV-Z approach. The flight crew intended to request the RNAV-Z approach from ATC upon first contact with the Approach controller. As the POLLI FOUR BRAVO arrival did not lead to the RNAV-Z approach, this created a discontinuity<sup>7</sup> in the programmed FMC flight path between the completion of the arrival at waypoint MENZI and the commencement of the approach. To correct this discontinuity, the first officer asked the captain to connect waypoint MENZI to the approach at waypoint SCBSI. In doing so, the waypoint SCBSG was erased from the programmed FMC approach.

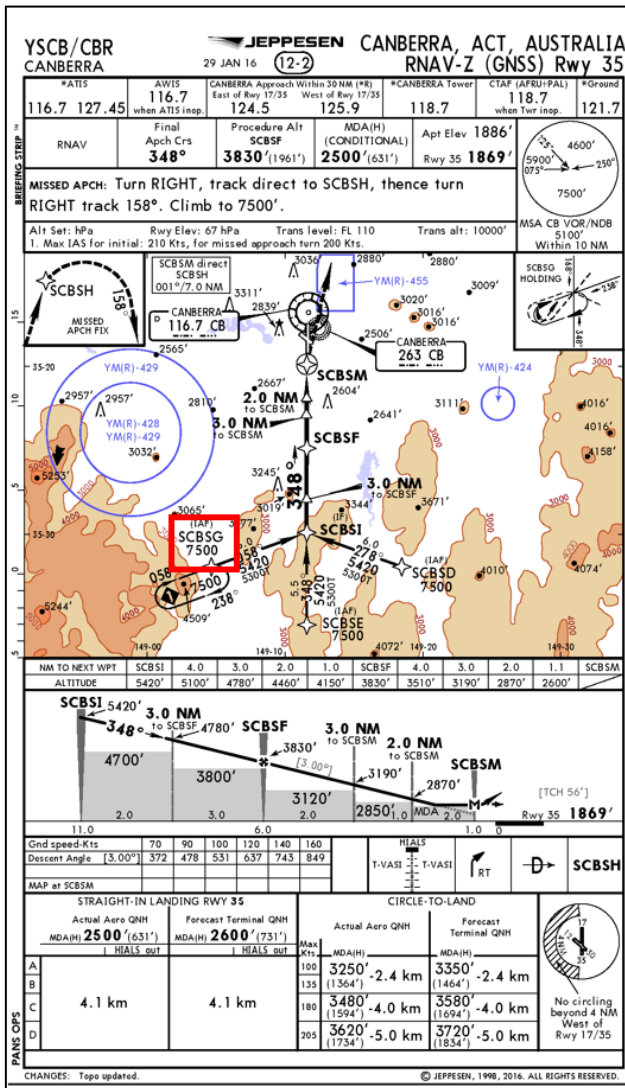
Figure 2: RNAV-Z Approach

After the flight crew were advised to expect the VOR approach, they immediately requested the RNAV-Z approach. ATC instructed the flight crew to track to the commencement of the RNAV-Z approach at SCBSG and to expect the RNAV-Z approach. Due to high terrain to the south and southwest of Canberra, the RNAV-Z approach via SCBSG must be commenced from an altitude at or above the minimum sector altitude (MSA) of 7,500 ft. This altitude constraint is included in the FMC programmed flight path when selecting an approach using the arrivals/departures page in the FMC.<sup>9</sup>

After the controller advised the flight crew to expect the RNAV-Z approach, the captain manually re-entered SCBSG into the FMC without detecting that the 7,500 ft MSA constraint was now missing. The captain then manually connected SCBSG to SCBSI for the continuation of the approach.

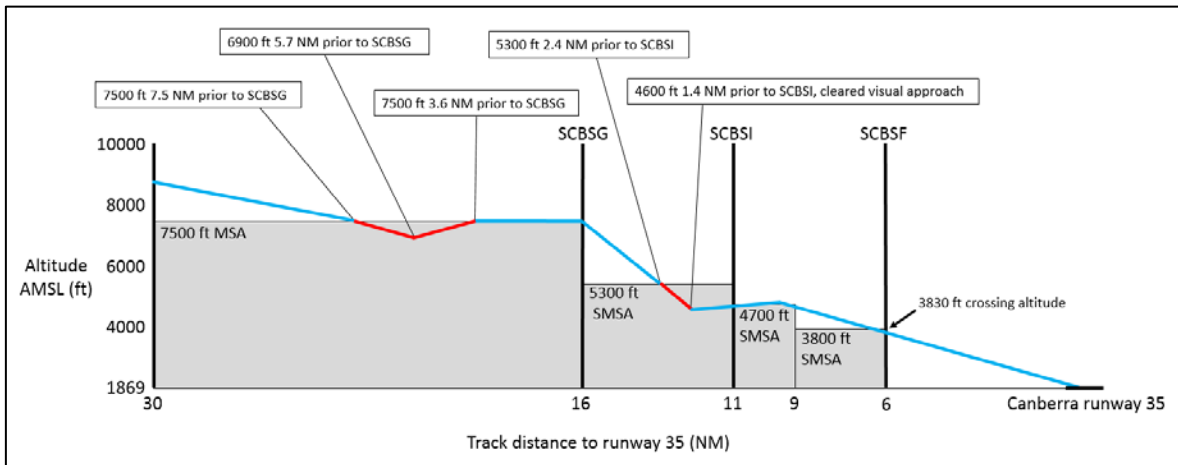
**Figure 3: Arrival and approach profile**

At 0909.16 in visual conditions, the aircraft tracked towards SCBSG. About 7.5 NM (13.9 km) prior to SCBSG, the aircraft descended below 7,500 ft (Figure 3). At 0909.37, as the aircraft descended to about 7,000 ft, the controller contacted the flight crew and advised that they were required to maintain 7,500 ft until SCBSG. The flight crew immediately disconnected the autopilot and

At 0912:37, about 2.1 NM (3.9 km) prior to passing SCBSI on the segment between SCBSG and SCBSI, the aircraft descended below 5,300 ft. As the aircraft descended to about 4,600 ft the captain commented that the aircraft approach profile was becoming low. At the same time, the controller contacted the flight crew and advised them that the aircraft was below the SMSA and that they were required to maintain 5,300 ft until passing SCBSI. The first officer immediately levelled the aircraft at about 4,600 ft. The flight crew advised the controller that they had the runway and terrain in sight. The controller then cleared the flight to conduct a visual approach. After being cleared for a visual approach, the first officer commenced a climb to about 5,000 ft and re-established the aircraft on the desired approach profile.

The flight crew entered the altitude of 3,900 ft into the autopilot altitude selector prior to commencing the approach. With the autopilot engaged, the aircraft descended through 7,500 ft prior to commencing the approach at SCBSG. The flight crew did not detect that the aircraft had descended through the 7,500 ft MSA. The approach controller identified the error and alerted the flight crew.

Once established visual with the runway, the flight crew elected to conduct a manually flown visual approach without advising ATC, and did not receive a clearance to discontinue the RNAV-Z and conduct a visual approach. The aircraft then descended below the standard profile which led to the aircraft descending below the 5,300 ft SMSA prior to passing SCBSI.
