In-flight engine shutdown involving Bombardier DHC-8, VH-XKI

Meekatharra Airport, Western Australia, 18 April 2017

ATSB Transport Safety Report
Aviation Occurrence Investigation
AO-2017-045
Final – 27 July 2017

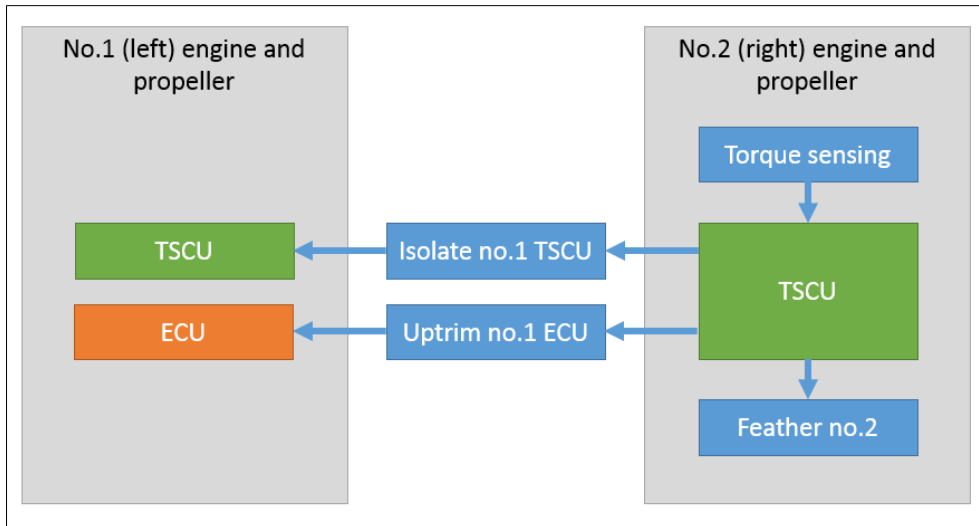
Figure 1: Autofeather overview for no.2 (right) engine failure

In the event of an engine failure on take-off (less than 29 per cent torque sensed), the failed engine torque signal conditioning unit (TSCU) initiates autofeathering by switching its logic from 'arm' to 'arm and fail.' A relay signals the engine control unit (ECU) of the other engine to increase power (uptrim) to compensate for the failed engine (Figure 1). After 3 seconds, the TSCU logic transitions from 'arm and fail' to 'fail and feather'. This isolates the second engine's TSCU to disable its autofeather system to ensure both propellers cannot be feathered at the same time, and energises the failed engine feathering solenoid to feather the propeller of the failed engine.
