Australian Government
Australian Transport Safety Bureau

Aviation Short Investigations Bulletin

Issue 61

ATSB Transport Safety Report
Aviation Short Investigations
AB-2017-068
Final – 27 July 2017

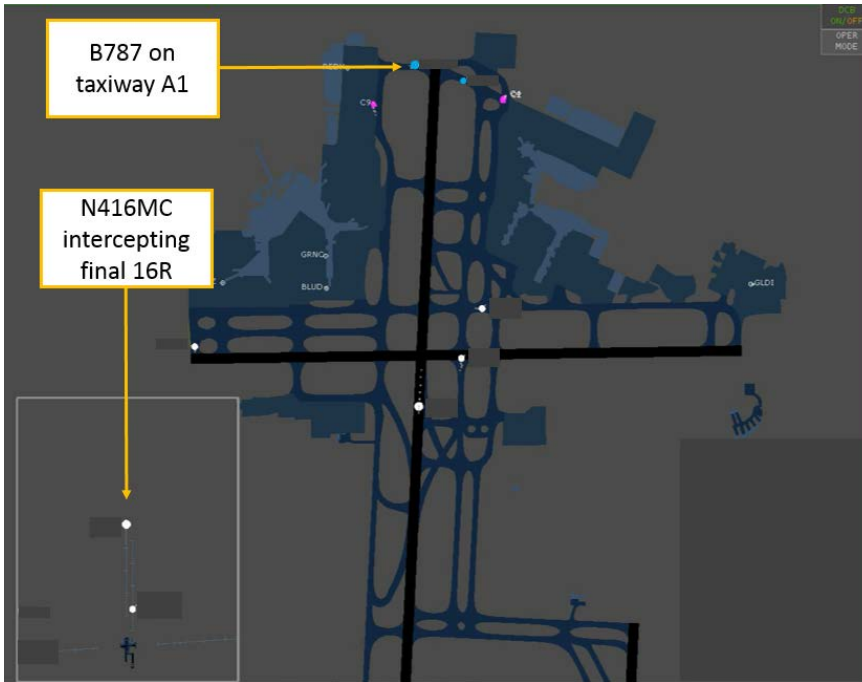
At the time N416MC intercepted the runway 16R localiser, a Boeing 787 was holding on taxiway A1, within the runway 16R glideslope critical area (Figure 3). However, the weather conditions did not require air traffic control to activate the ILS critical area, and N416MC was instructed to go-around before reaching the outer marker.⁸

Figure 3: Infringement of the 16R glideslope critical area

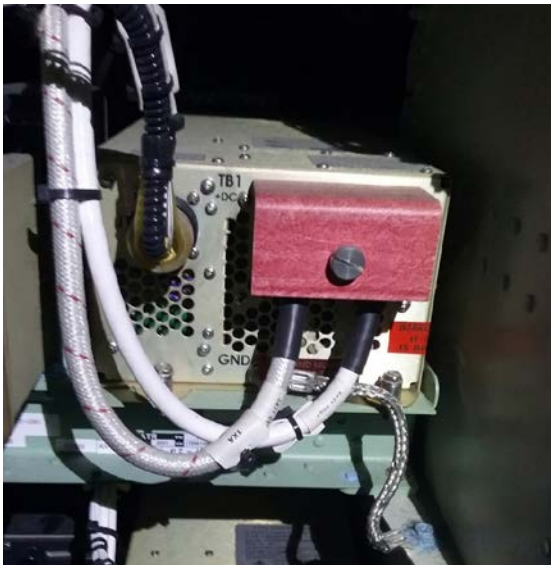
Figure 3: Number one static inverter

The manufacturer of the static inverter conducted an engineering investigation of the failed static inverter. The investigation found that the failure of the number one static inverter and associated smoke and odour was caused by a failure of the C603 capacitor within the number one static inverter.

A C603 capacitor within the number one static inverter failed in a manner consistent with other C60x series capacitor failures. Failure of the capacitor resulted in failure of the static inverter and smoke being emitted into the cockpit.

- Replacement of C311 capacitor resulting in service units being modified to Amendment E standard. New production units have been modified and the retrofit process is on-going.
- Change in the manufacturing process with 'burn in' test on C60x capacitors resulting in units being modified to 'Amendment F' standard. New production units have been modified. The retrofit process is being prepared.

- A design change is under development including the replacement of the C60x capacitors. The redesigned unit will be identified with a new part number. The design change certification expected to be complete before the end of quarter 2, 2017.

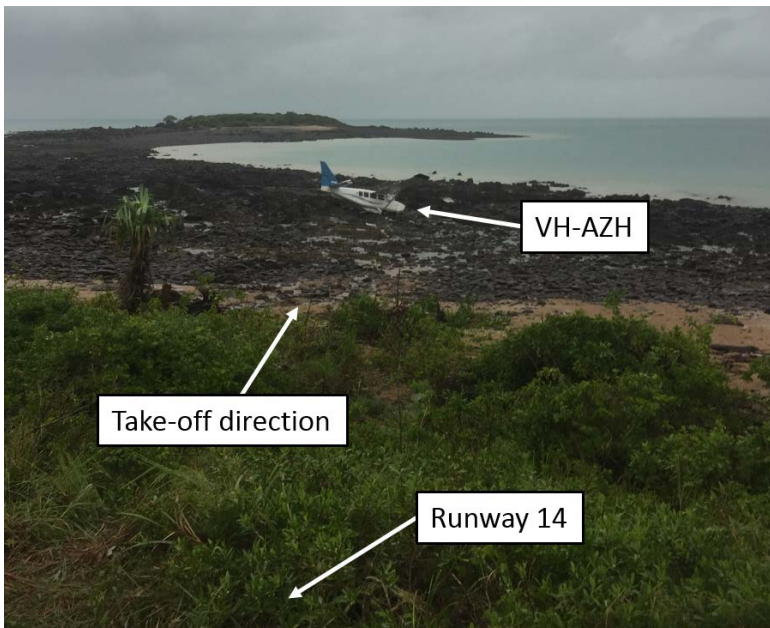
Figure 6: Accident site

The aircraft did not take-off before overrunning the runway and became airborne as it passed over the vertical drop at a speed of about 50 kt. While manoeuvring to avoid large rocks and obstacles (Figure 2), the pilot maintained a nose high attitude to minimise the effect of any impact. The aircraft was unable to maintain height and descended over about a further 100 m until the landing gear and underside of the rear fuselage impacted rocks. As the aircraft decelerated, the impact through the rudder pedals forced the pilot's ankle against the control column.

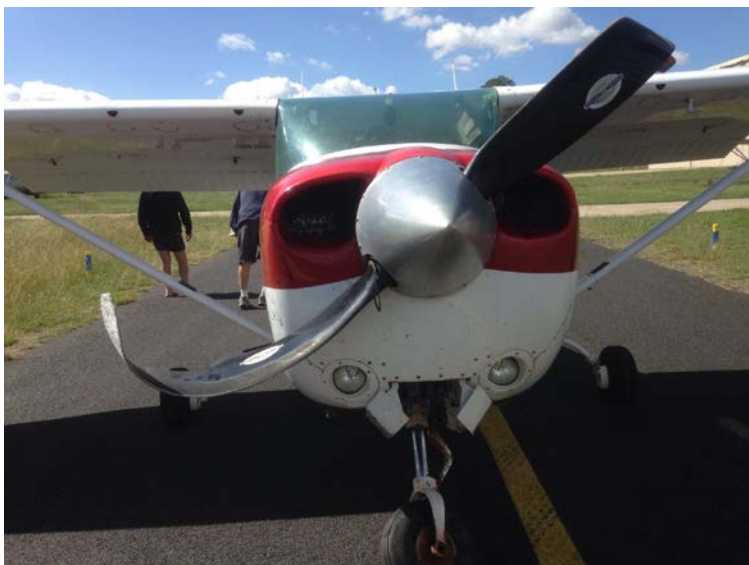
The aircraft sustained substantial damage and the pilot and passenger were uninjured (Figure 1).

Figure 7: VH-JXX showing damage to the propeller and nose landing gear

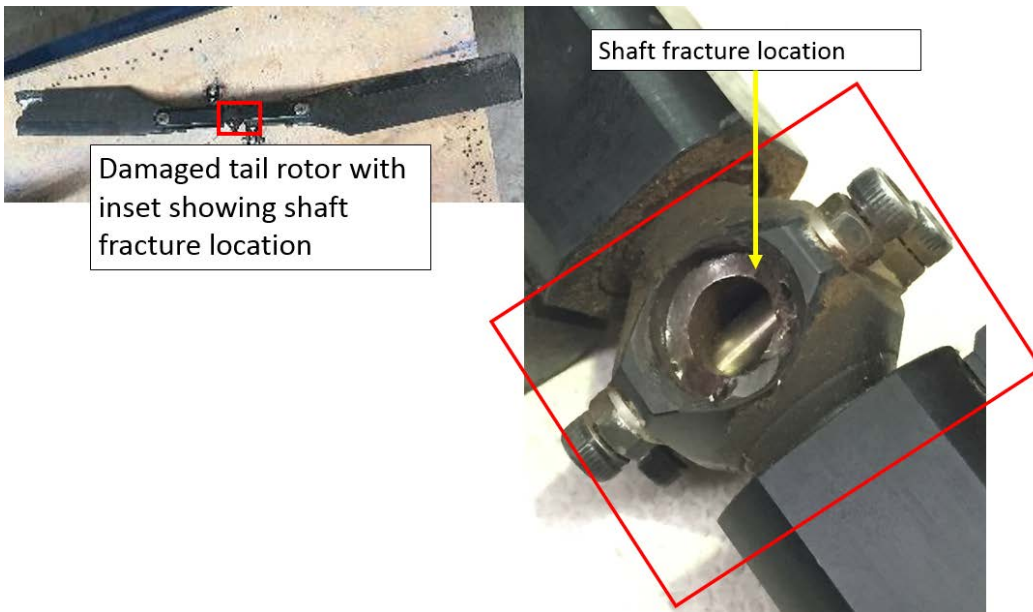
The manufacturer found that the tail rotor shaft had fractured, resulting in the tail rotor detaching from the aircraft (Figure 3).

Figure 3: Tail rotor showing fracture location

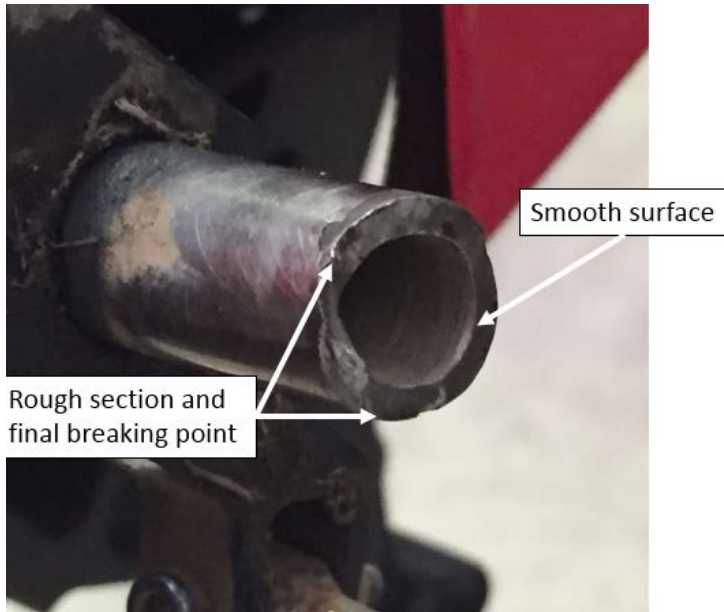
The manufacturer assessed that the fracture had probably existed for some time, as one section of the fracture site was smooth, indicating a pre-existing fracture. Another section of the fracture was rough indicating the failure occurred during the accident flight (Figure 4). The tail rotor blade (Figure 3) probably struck the tail cover after the shaft failed, as this allowed excessive movement in the tail rotor head.

Figure 4: Fractured tail rotor shaft
