# In-flight smoke in the cockpit involving GIE Avions de Transport Regional ATR72, VH-VPJ

near Williamtown Airport, New South Wales, 22 February 2017

**ATSB Transport Safety Report**  
Aviation Occurrence Investigation  
AO-2016-025  
Final – 27 July 2017

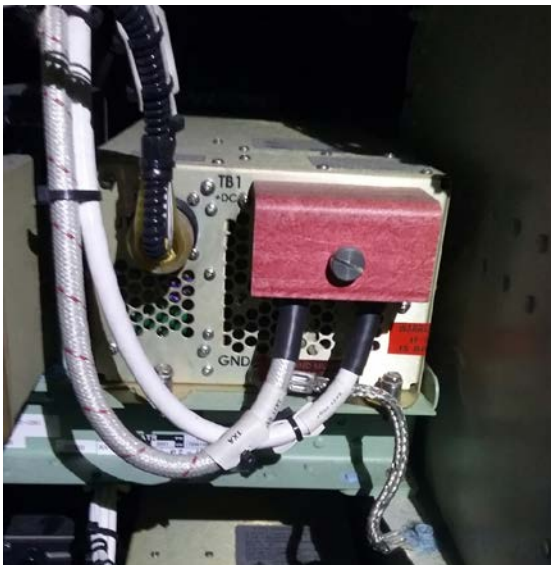
**Figure 1: Number one static inverter**

At 1453:35, during cruise at Flight Level (FL) 180,<sup>1</sup> the Centralized Crew Alerting System (CCAS) alerted the flight crew to a failure of the number one static inverter (Figure 1).<sup>2</sup> The CCAS then displayed multiple messages indicating a loss of power to systems associated with the number one static inverter. The aircraft electrical system power transfer function automatically transferred these systems to the number two static inverter and the CCAS warnings extinguished.

The manufacturer of the static inverter conducted an engineering investigation of the failed static inverter. The investigation found that the failure of the number one static inverter and associated smoke and odour was caused by a failure of the C603 capacitor within the number one static inverter.

The C603 capacitor within the number one static inverter failed in a manner consistent with other C60x series capacitor failures. Failure of the capacitor resulted in failure of the static inverter and smoke being emitted into the cockpit.

- Verifying the integrity of the Power Transfer function across the ATR fleet. The operator advised that after completing this campaign no adverse findings were reported.
- The operator has initiated a retrofit campaign to route all in-service static inverters to the vendor to have the modification to both the C311A and the C60x capacitors completed ('Amendment E' and 'Amendment F' (see *Aircraft manufacturer*) standard).
- The operator has initiated a fleet wide inspection and operational test of the oxygen mask integrated microphone.
- The operator has undertaken a risk assessment for single and dual static inverter failure.

- Replacement of C311 capacitor resulting in service units being modified to Amendment E standard. New production units have been modified and the retrofit process is on-going.
- Change in the manufacturing process with 'burn in' test on C60x capacitors resulting in units being modified to 'Amendment F' standard. New production units have been modified. The retrofit process is being prepared.

- A design change is under development including the replacement of the C60x capacitors. The redesigned unit will be identified with a new part number. The design change certification expected to be complete before the end of quarter 2, 2017.
