Ground handling occurrence involving Airbus A330, 9M-MTB

Melbourne Airport, Victoria | 31 March 2016

ATSB Transport Safety Report
Aviation Occurrence Investigation
AO-2016-028
Final – 13 September 2016

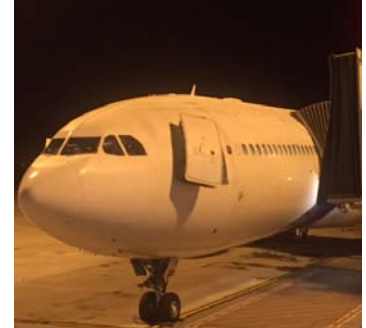
On 31 March 2016, an Airbus A330-323, registered 9M-MTB and operated by Malaysia Airlines Berhad (Malaysia Airlines), was being prepared and boarded for a flight from Melbourne Airport, Victoria, to Kuala Lumpur, Malaysia. The captain engaged the aircraft's park brake before carrying out an external inspection of the aircraft. The resulting lit park brake indicator light on the nose landing gear led the aircraft maintenance engineer to assume that the park brake would remain on. Thinking that the aircraft would remain secure, the maintenance engineer removed the main landing gear chocks out of sequence with the relevant procedure and without informing the others in the ground crew. The ground crews did not check the main gear chocks before removing the nose gear chocks to attach the tow tractor to the nose gear. Unaware that no chocks were in place, and out of sequence with the relevant procedure, the captain released the park brake on return to the flight deck. The aircraft rolled back about 3 m and struck the aerobridge. The aircraft's forward-left door and hinges, and the aerobridge were damaged. There were no injuries.

Damaged door of 9M-MTB
