Runway operations with hookcable raised involving Cessna 310, VH-COQ

Tindal Airport, Northern Territory, 28 April 2017

ATSB Transport Safety Report
Aviation Occurrence Investigation
AO-2017-049
Final – 5 September 2017

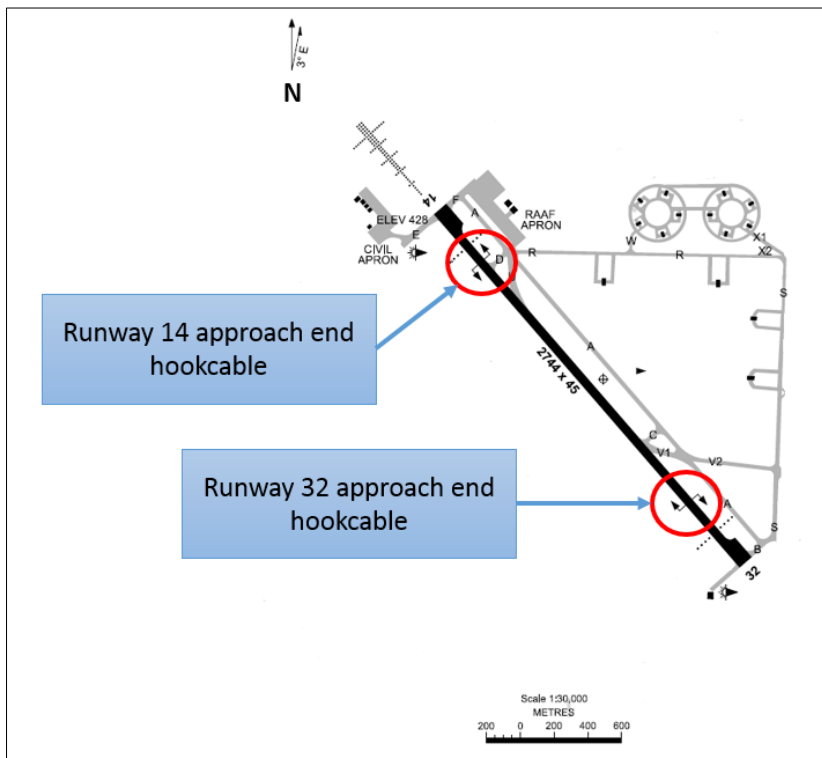
Figure 1: Tindal airport runway hookcables

Tindal Airport has bi-directional hookcables, used to stop military jets in an emergency, positioned at both ends of the runway (Figure 1). The air traffic control tower had opened for a scheduled military jet departure and was therefore active when COQ made its approach to land. During the tower opening checklist procedure, the tower controller annotated the 'cables' check was completed. About 21 minutes after the tower opened, COQ requested a clearance to land from the base leg position for runway 14. The tower controller scanned the control console, noted that both hookcable pushbutton lights were green, and cleared COQ to land on runway 14.

When COQ was on short final approach to land on runway 14, the pilot noticed the approach end hookcable was raised.¹ They² adjusted their aim point beyond the hookcable and landed without incident. The pilot of COQ reported the position of the hookcable to the tower controller, who then rectified the situation.

The Tindal Airport aircraft arrestor system (AAS) is used to stop military jets that have a malfunction, which may otherwise result in a runway excursion. The jet will lower a hook at the rear of the aircraft to catch the cable. The AAS includes two cables, one positioned at either end of the runway and displaced from the respective threshold as displayed in Figure 1.

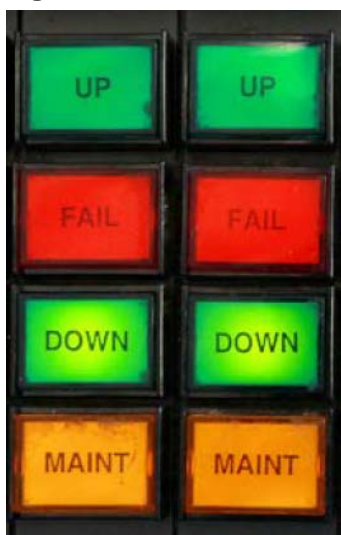
Figure 2: Tower control console hookcable pushbuttons

The AAS may be controlled by air traffic control from the air traffic control tower using the cable control console pushbutton selection/indicator lights (Figure 2). There are four pushbutton selection/indicator lights for each hookcable. Two separate green UP and green DOWN pushbuttons are used to select, and then indicate, the desired position for each hookcable.

The distractions during the opening procedure resulted in the tower controller inadvertently leaving both hookcables in the UP position after they tested the operation of the system. When they received the request to land from COQ, the tower controller subsequently checked the status of the hookcable but they misidentified the two green UP status lights as DOWN indicators, which are also green.

This incident highlights the risks of expectation bias. The tower controller observed two green lights on the control console, but did not recognise they were the UP indicators. However, the design of the indicators, where green lights can have two different meanings, removes the usefulness of the colour of the lights in determining whether the hookcable is up or down.

The possibility of changing the colour of the UP lights will be investigated through an engineering process to better differentiate between the UP and DOWN positions (this will be for all our sites that have arrestor systems). Furthermore, due to the relative low number of civilian aircraft operating at Tindal Airport, Tindal air traffic control will be advising the position of the cable with every landing and take-off clearance given to civilian aircraft. This will help force the controller to verify the position of the cable in addition to the conduct of the instrument scan.
