# Tail strike on takeoff involving Airbus A320, VH-VGF

Melbourne, Victoria | 11 May 2016

**ATSB Transport Safety Report**  
Aviation Occurrence Investigation  
AO-2016-046  
Final – 4 September 2017

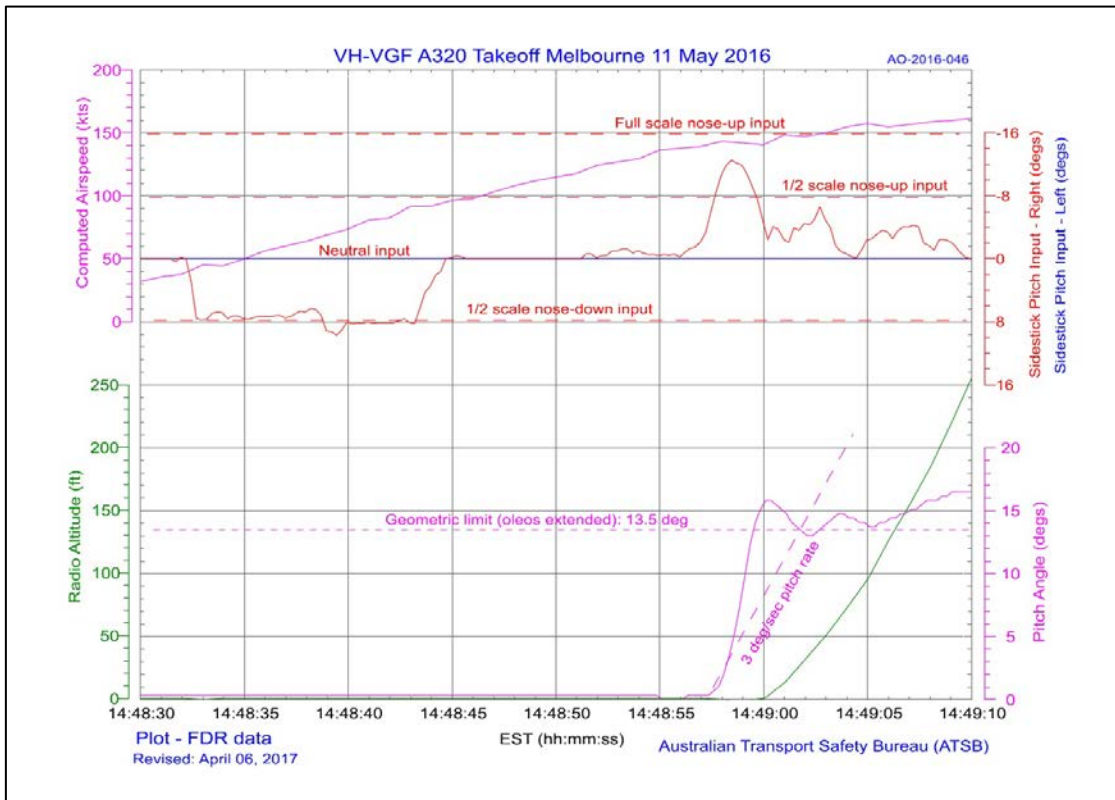
Figure 1: FDR plot of key parameters

Key parameters from the FDR were analysed and are shown in Figure 1.

The aircraft taxied onto runway 27 and the takeoff commenced at 1448. The sidestick data shows that the pilot in the right seat (cadet) was the PF. At approximately 40 kt, a nose-down sidestick input was made and this input remained until the aircraft had accelerated to 100 kt. The sidestick pitch input was then neutral until approximately 140 kt when a nose-up input commenced. The nose-up input reached a maximum value of 12.5° or 78 per cent of a full-scale input. The aircraft rotated with a pitch rate of about 9 deg/sec reaching a maximum pitch attitude of 16°. The sidestick input was then reduced and the aircraft's pitch attitude correspondingly reduced.

During rotation, the cadet pilot applied a larger than normal pitch input (3/4 backstick versus the recommended 1/2 to 2/3 of backstick travel) resulting in an excessive pitch rate during rotation (9 deg/sec versus a target of 3 deg/sec).

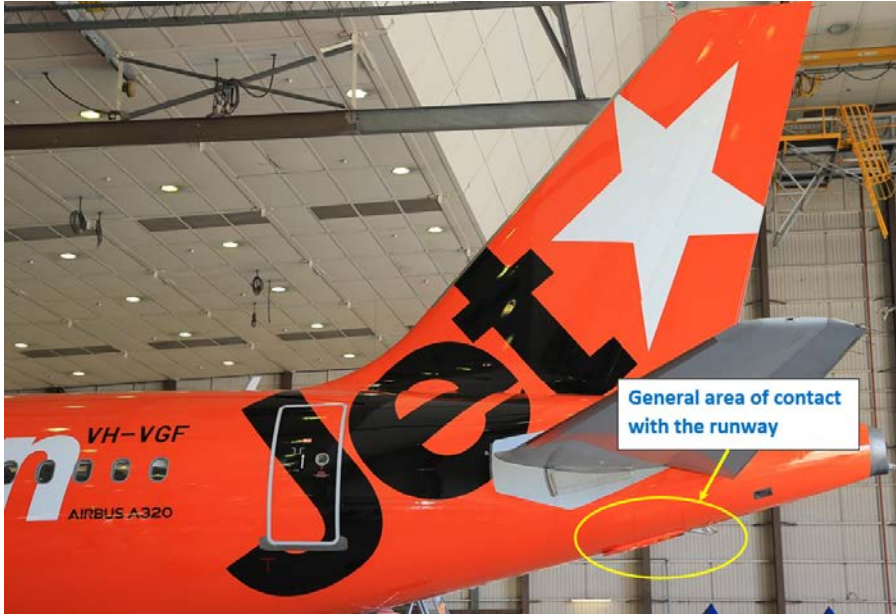
**Figure 2: General location of damage**

After landing, engineers inspected the tail of the aircraft (Figure 2). Damage to the APU diverter (air inlet) and APU drain mast was evident (Figure 3). This damage was consistent with the aircraft tail contacting the runway surface.

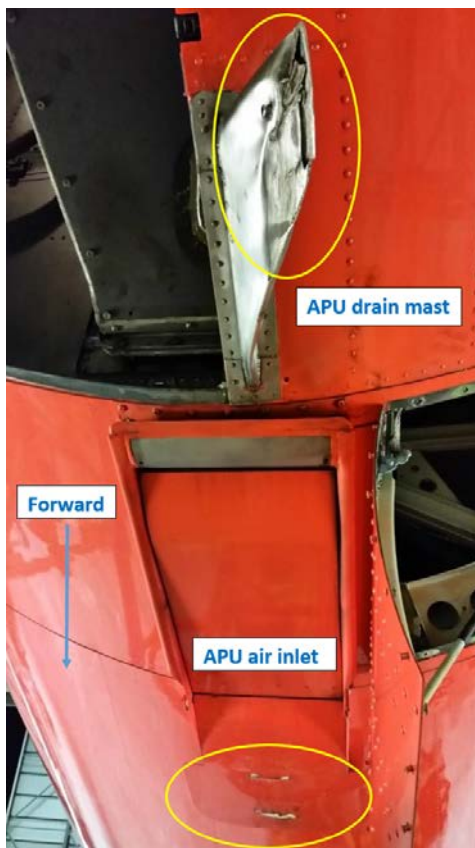
**Figure 3: Damage to aircraft tail section (circled). Note: access doors are open for inspection**

After landing, engineers inspected the aircraft. Damage to the auxiliary power unit (APU) diverter (air inlet) and APU drain mast was evident. This damage was consistent with the aircraft tail contacting the runway surface during rotation.

- The cadet pilot applied a larger than normal sidestick pitch input to initiate rotation. This resulted in a high rotation rate during the take-off and the aircraft's tail contacted the runway.

Following the incident, the cadet pilot undertook additional training and assessment before returning to flight duties.
