Collision between track worker and passenger train at Petrie, Queensland

on the 29 May 2017

ATSB Transport Safety Report
Rail Occurrence Investigation
RO-2017-003
Preliminary – 22 August 2017

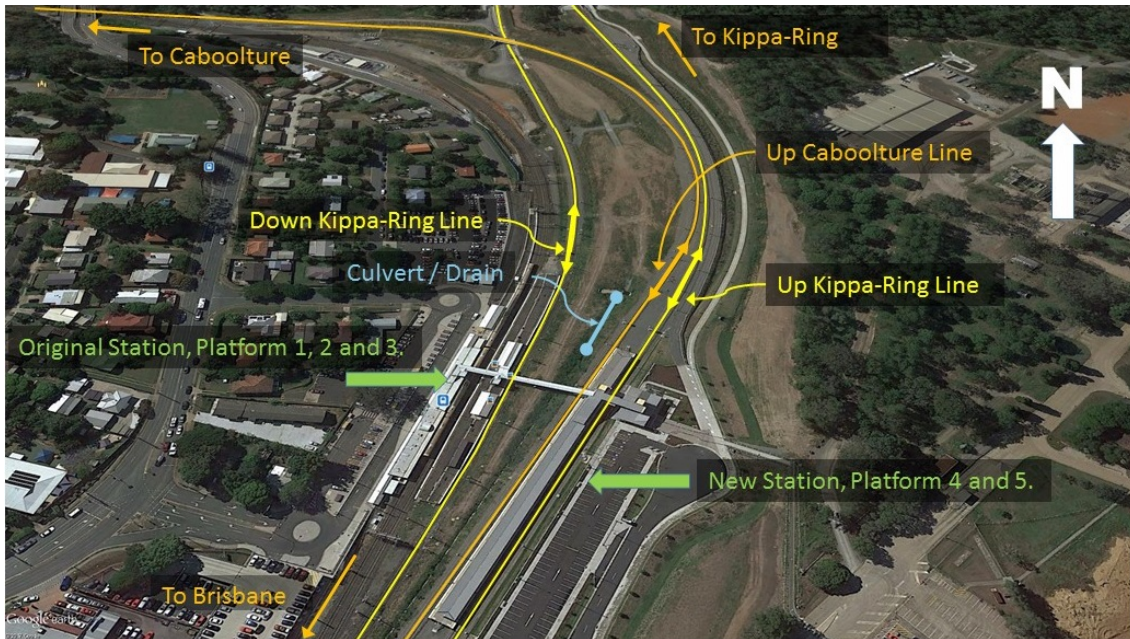
Figure 2: Layout of the Petrie Railway Station showing platform numbers (depicted in green), location of the Culvert/Drain (depicted in blue), Up³ Caboolture line feeding platform 4 (depicted in orange) and Up Kippa-Ring line feeding platform 5 (depicted in yellow).⁴

Another protection officer proceeded to erect a stop sign on the Down Kippa-Ring line adjacent to signal PE67 (Figure 3). This was to block the Down Kippa-Ring line. As a culvert and small drain (Figure 2) blocked a direct route from the protection officers' vehicle to signal PE67, the protection officer chose to walk 20 metres in a northerly direction along the middle of the Up Caboolture line (which was open for rail traffic) until there was clear access to walk across to signal PE67.

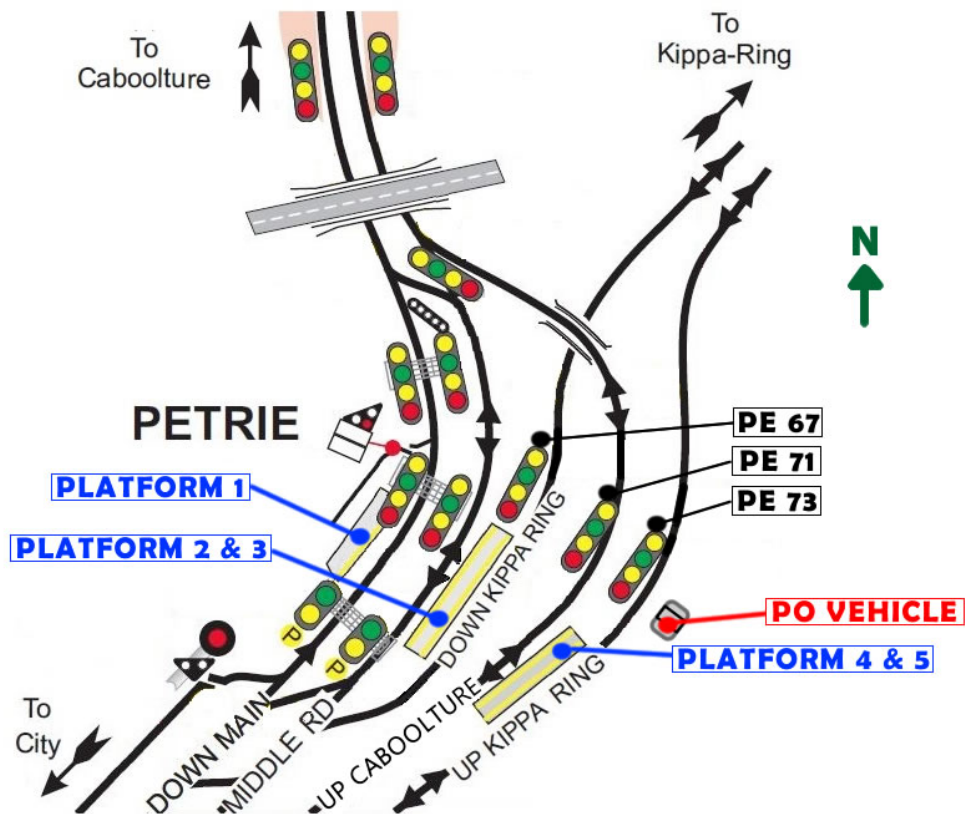
Figure 3: Signal layout information for Petrie Railway Station

On hearing that blocking facilities had been applied, two protection officers proceeded into the rail corridor to erect permanent way stop signs.⁵ One of the protection officers proceeded to erect a stop sign adjacent to signal PE73 (Figure 3), which was located near to the protection officers' vehicle and at the northern end of No.5 platform (Figure 3). This was to block the Up Kippa-Ring line for down rail movements.

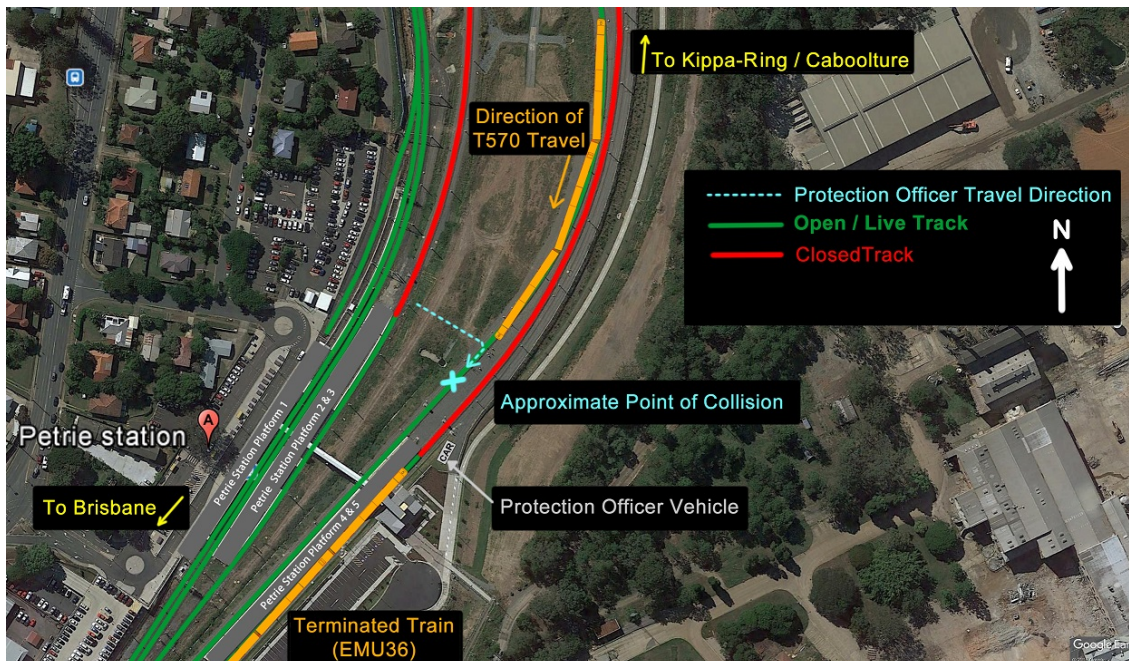
The protection officer proceeded to walk in the middle of the Up Caboolture line in a southerly direction (Figure 4). The protection officer was walking the same section of track that he had previously used to avoid the culvert and drain. At about this time, suburban train, designation T570, approached Petrie station on the Up Caboolture main line from the north. The ATSB determined that the distance separating the train and the protection officer when the protection officer reached the Up Caboolture line was approximately 400 metres.

At about 2225, video footage showed the protection officer stopped in the middle of the rail lines. He remained in a stationary position, for approximately four seconds, with his back to the approaching train. As the train then exited the sweeping curve, the headlights shone directly on the protection officer. Upon sighting the protection officer, the train driver applied an emergency brake and sounded the train horn. The protection officer attempted to vacate the track, however, there was insufficient time and the train collided with the protection officer (Figure 4).

Figure 4: Layout of Petrie accident site, showing details of open (depicted in green) and closed (depicted in red) tracks, protection officer direction of travel (depicted in blue), train details (depicted in orange), and point of collision.
