Aviation Short Investigations Bulletin

Issue 62

ATSB Transport Safety Report
Aviation Short Investigations
AB-2017-082
Final – 5 September 2017

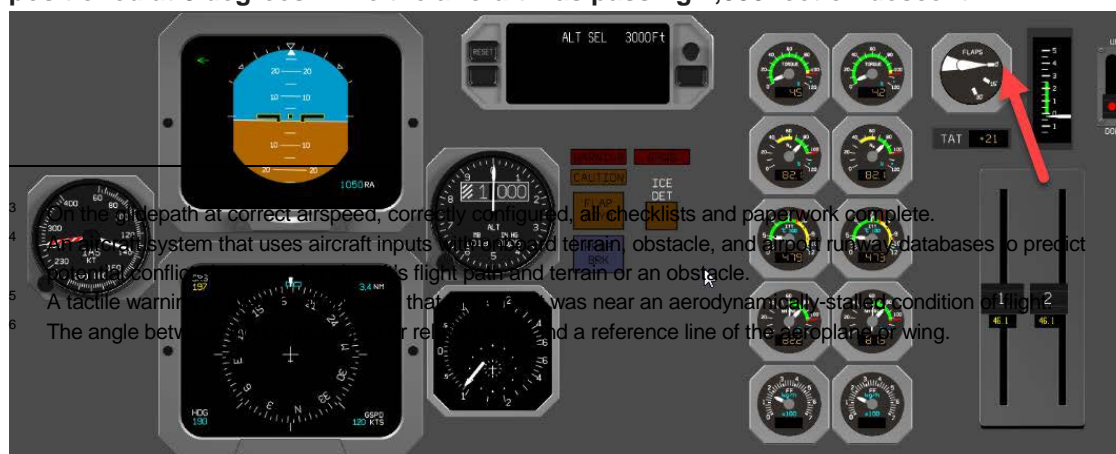
Figure 2: A screen capture from the operator’s flight data showing the flap indicator positioned at 0 degrees while the aircraft was passing 1,000 feet on descent

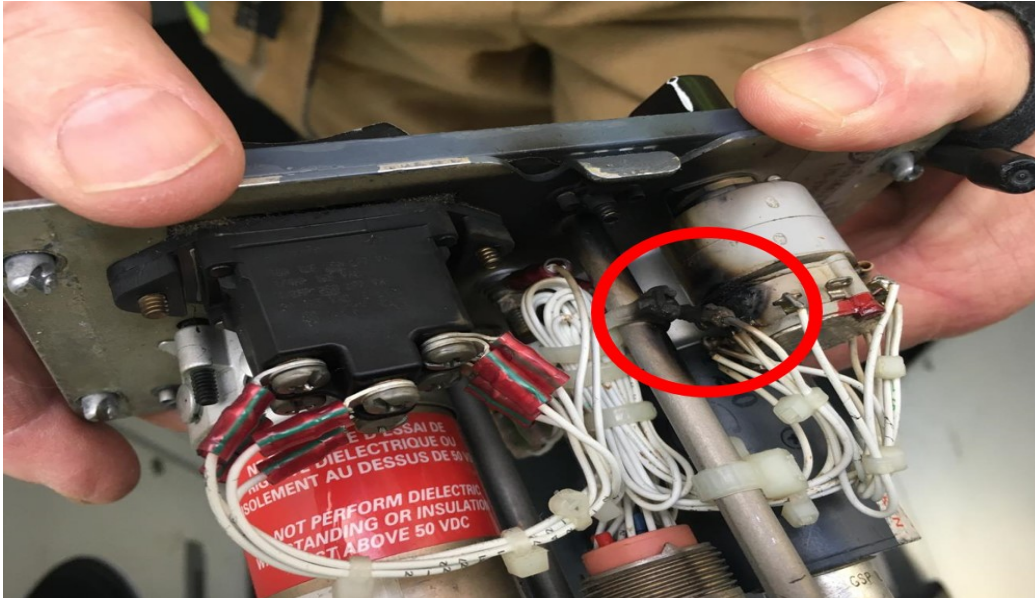
Following the incident, engineers removed the aileron/rudder trim control panel for inspection. That inspection identified visible damage underneath the rudder trim switch. Specifically, the rudder trim potentiometer⁴ was blackened and burnt (Figure 1). The trim control panel was subsequently replaced.

Figure 1: Burnt potentiometer in the aileron/rudder trim control panel (circled in red)

- The rudder trim potentiometer burnt in-flight, resulting in fumes and smoke in the cockpit during a critical phase of flight.
- Shortly after landing, the crew conducted a precautionary disembarkation on the taxiway, which reduced the risk of fumes exposure to the aircraft's occupants.

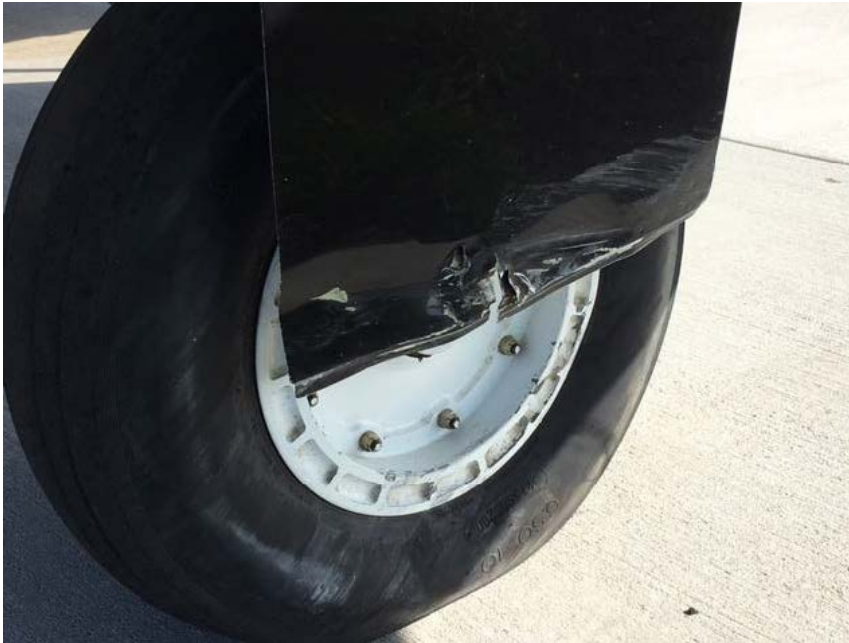
The pilot applied full power to conduct a go-around.² As full power was applied, the aircraft passed over Barwon Heads Road and the left main landing gear impacted the truck. The pilot observed the truck continue on Barwon Heads Road without stopping and the pilot continued with the go-around. The pilot elected to leave the landing gear extended in case it had sustained damage.

The pilot subsequently landed the aircraft without incident. The pilot was uninjured and the aircraft sustained minor damage (Figure 3).

Figure 3: Damage to left main landing gear of VH-JQS.

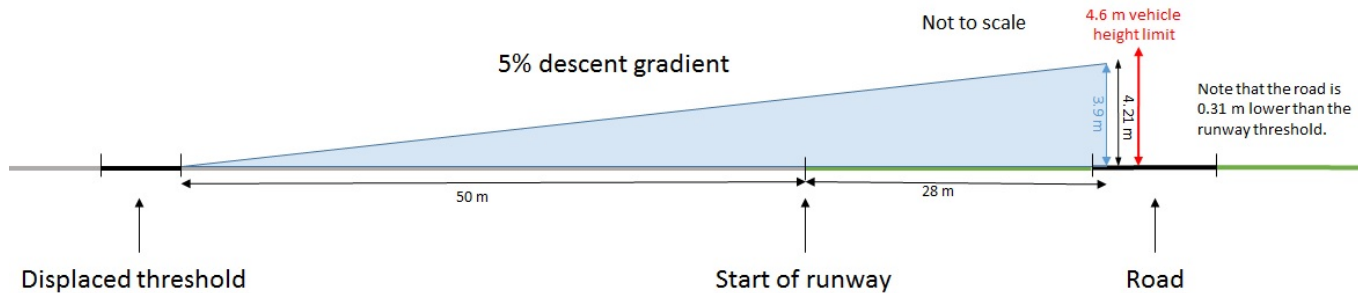
Figure 5: Diagram showing a 5 per cent (3 degree) approach profile for Barwon Heads runway 36 and the proximity of Barwon Heads Road. A 5 per cent descent gradient aiming at the threshold results in aircraft passing over Barwon Heads Road at 4.21m which is lower than the VicRoads vehicle height limit of 4.6m.

The threshold of runway 36 was 78 m from Barwon Heads Road (Figure 2). Using the 5 per cent approach recommended by CAAP 92-1, a distance of 78 m results height of 3.9 m above the runway elevation. Combining this with the 0.31 m elevation difference, results in a clearance of 4.21 m which is less than the 4.6 m road vehicle height permitted in Victoria. Therefore, a normal approach aiming for the threshold of runway 36 at Barwon Heads can intersect with road vehicles on Barwon Heads Road.

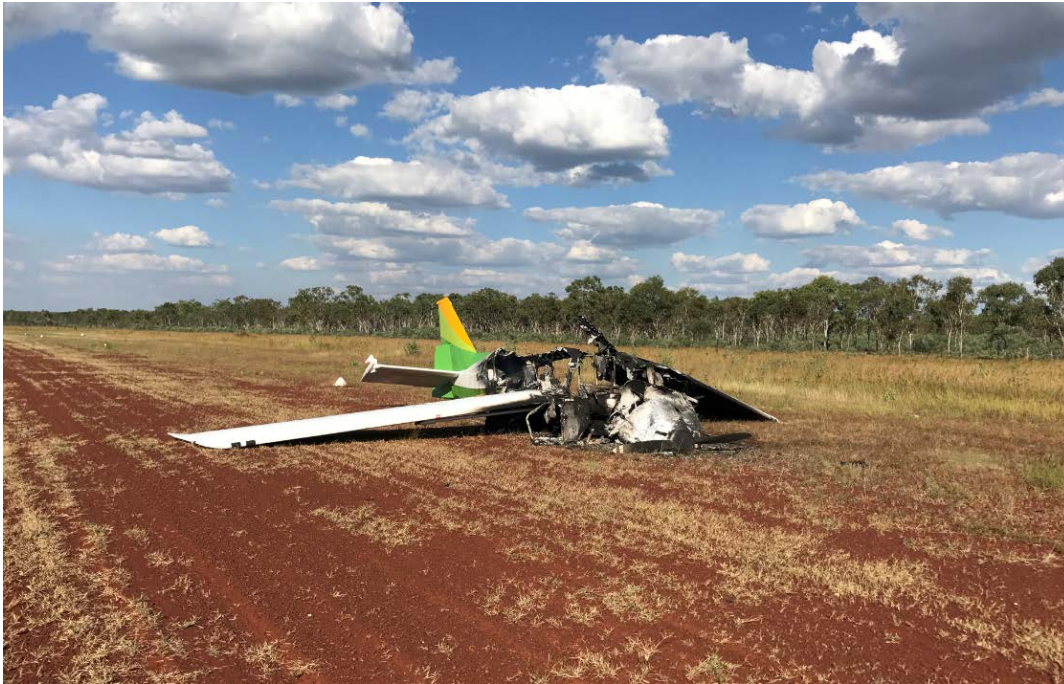
Figure 1: VH-AJZ wreckage

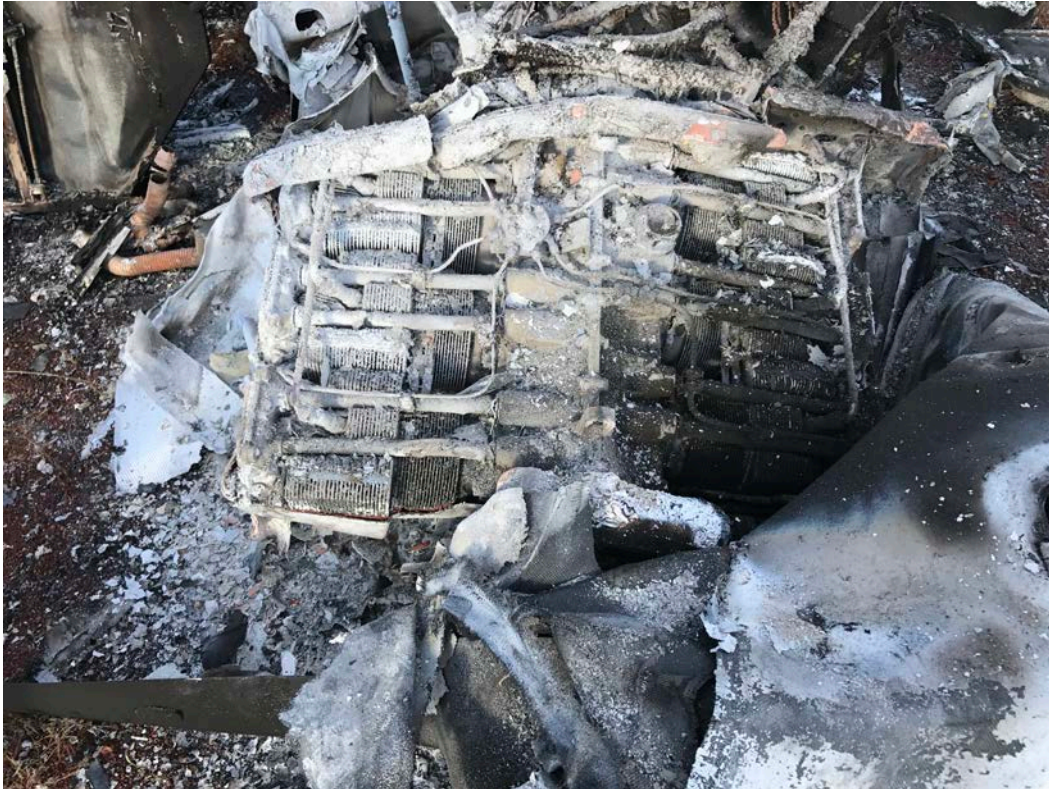
- Due to the significant fire and heat damage, the cause of the fire could not be determined (Figure 2).
- When taxiing in high ambient temperatures and at low power settings, fuel may vaporise within the mechanical engine fuel pump, and this can lead to the engine failing. When operated in these conditions, the aircraft should be taxied with the electric fuel pump on to prevent fuel vaporisation.

Figure 2: Fire damage to engine

The extent of damage to the engine and aircraft prevented the reasons for the engine failure being determined.

The presence of fire on the nose wheel below the engine indicates that the fire was probably fed by a fluid. However, the extent of damage to the engine prevented the reason of the fire being determined.

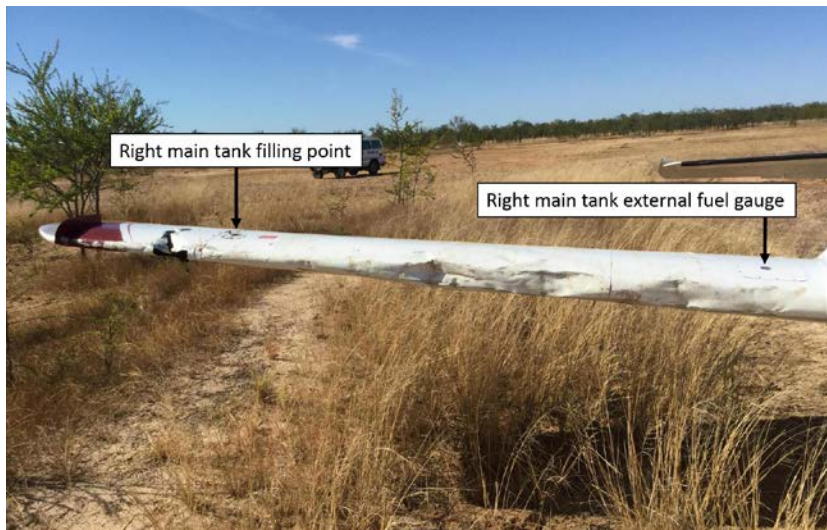
The pilot was not injured during the incident, however, the aircraft sustained substantial damage (Figure 2).

Figure 2: Damage to right wing

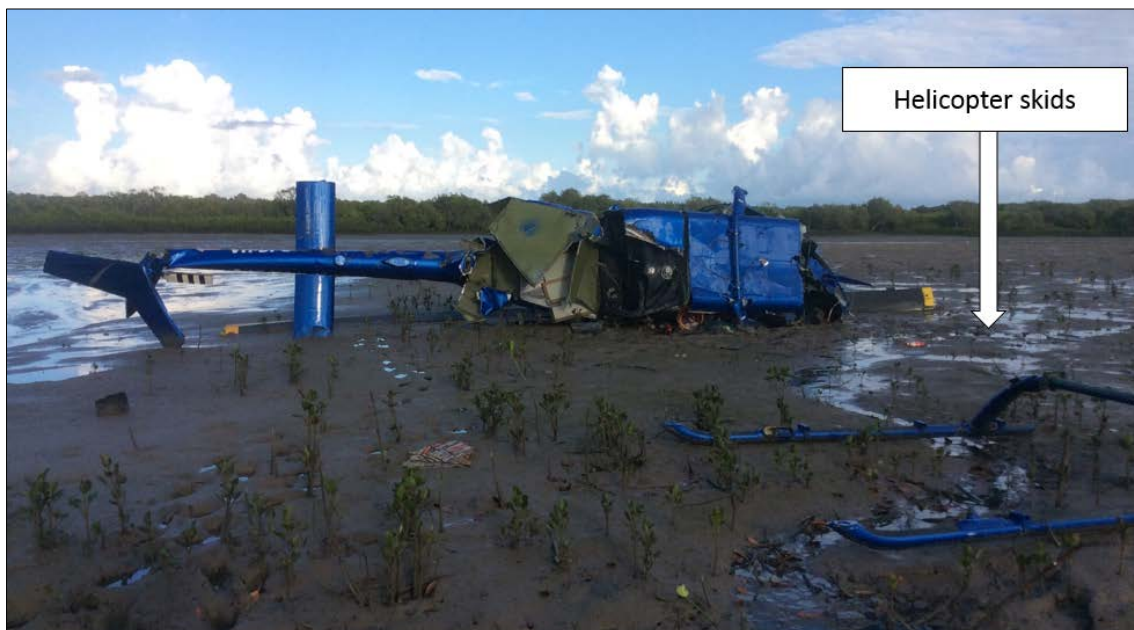
The helicopter initially impacted upright in the water before the airframe separated from the helicopter skids, turned through 180° and rolled onto its left side (Figure 2). This placed the passenger, in the left seat, under water. As soon as movement ceased, the pilot tried to pull the passenger’s head above the water, but the passenger was initially trapped in their harness. The passenger subsequently struggled free from their harness without unfastening it. The pilot and passenger exited the helicopter, at which stage the pilot reported to the passenger that they felt paralysed below the waist.

Figure 2: VH-DPU accident site at low tide

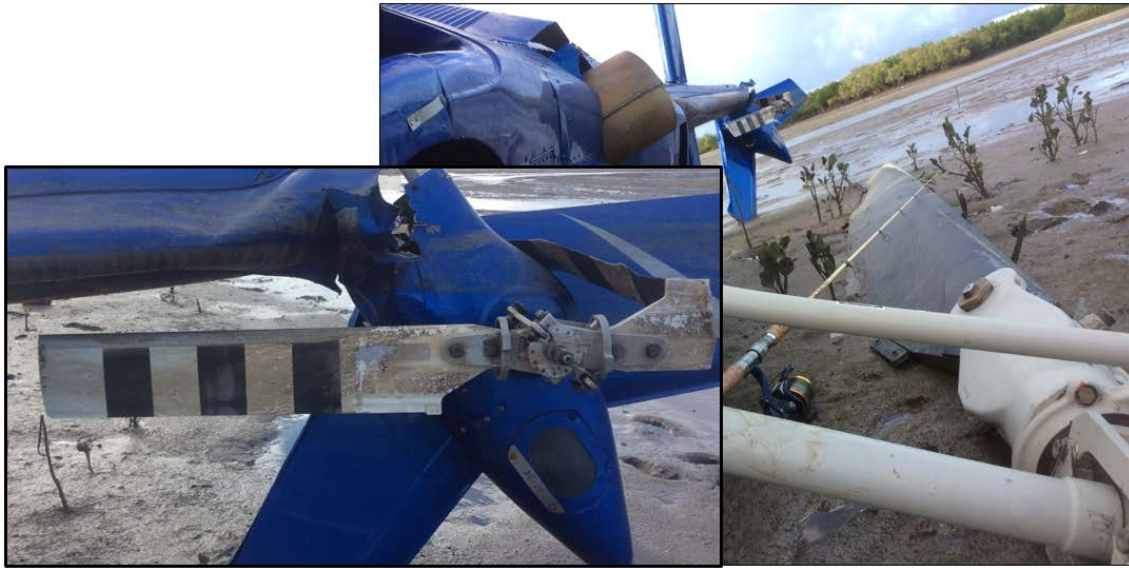
Testing the warning and caution lights, and checking the overhead circuit breakers, are items in the flight manual checklists for before and after engine start. The pilot reported that these checks were performed before departure from Caboolture. They made radio transmissions during the flight and communicated with the passenger using headsets, which indicates that the audio circuit breaker was in prior to the accident. The ATSB noted that the condition of the main and tail rotor blades indicated there was little rotational energy in the blades at the time of impact (Figure 3).

Figure 3: VH-DPU main and tail rotor blades

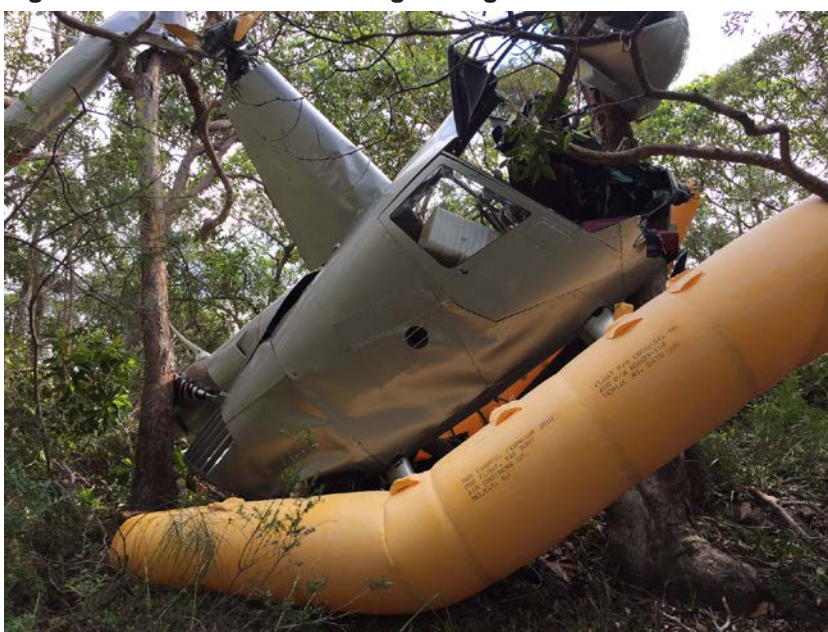
As the helicopter neared treetop height, the pilot deployed the emergency floats. As the floats contacted the trees, the pilot raised the collective to cushion the impact. The pilot and passenger sustained minor injuries and the helicopter was substantially damaged (Figure 1).

Figure 1: Accident site showing damage to VH-MNU

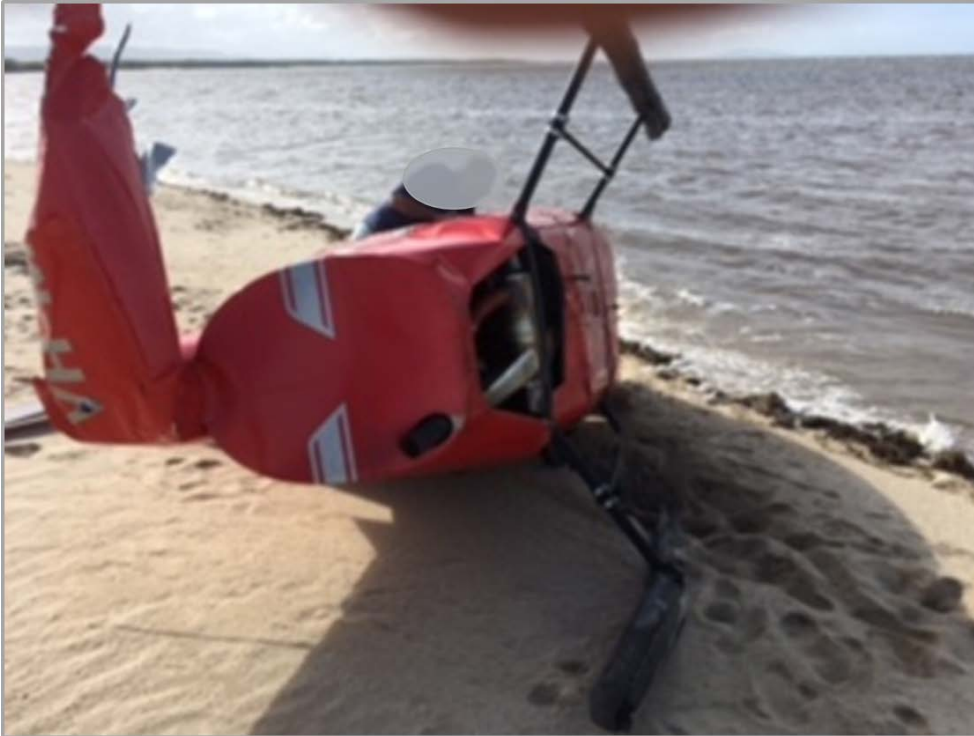
Figure 1: VH-MQE accident site

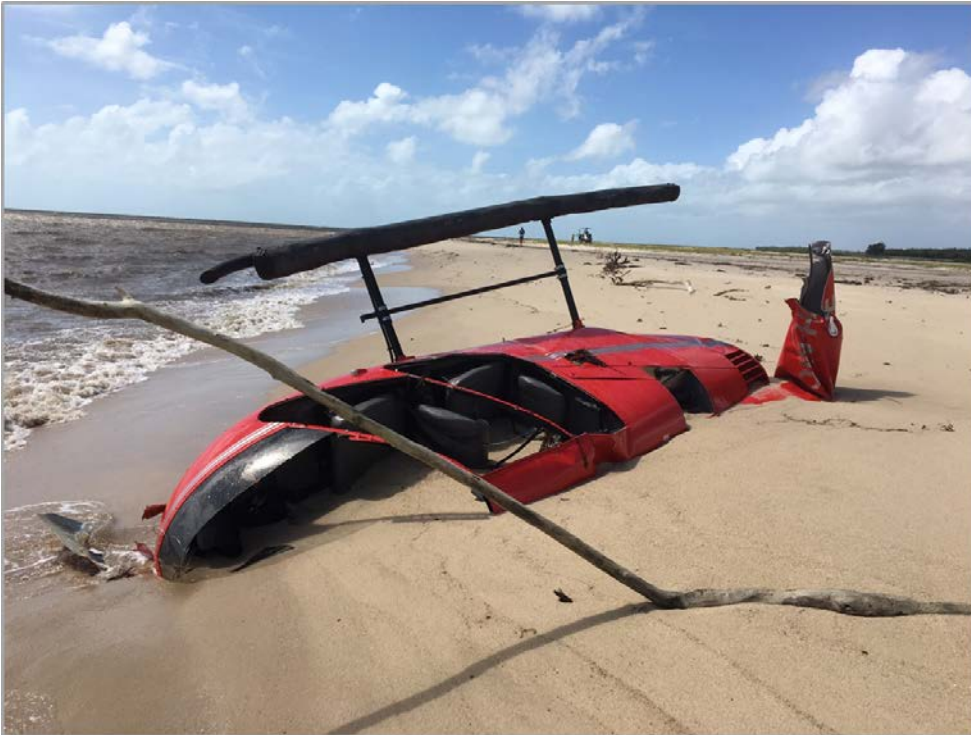
The operator reported that subsequent to the accident, the helicopter sustained substantial damage due to ocean tides (Figure 2) before it was recovered.

Figure 2: Subsequent damage due to the ocean tides
