Proximity event involving Bell 407, VH-VHU and Piper PA-31, VH-FDQ

near Cairns Airport, Queensland, 5 February 2017

ATSB Transport Safety Report
Aviation Occurrence Investigation
AO-2017-021
Final – 5 September 2017

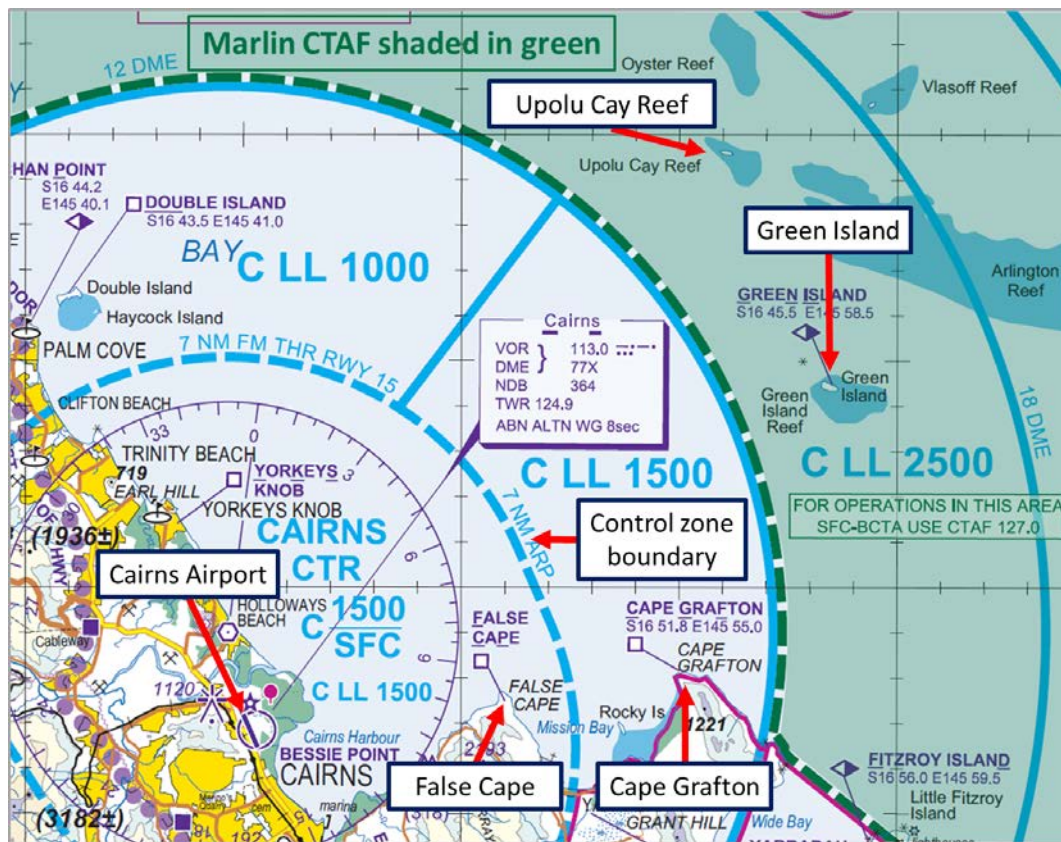
Figure 1: Extract of Cairns visual terminal chart showing the Marlin CTAF shaded in green, Green Island and Cape Grafton

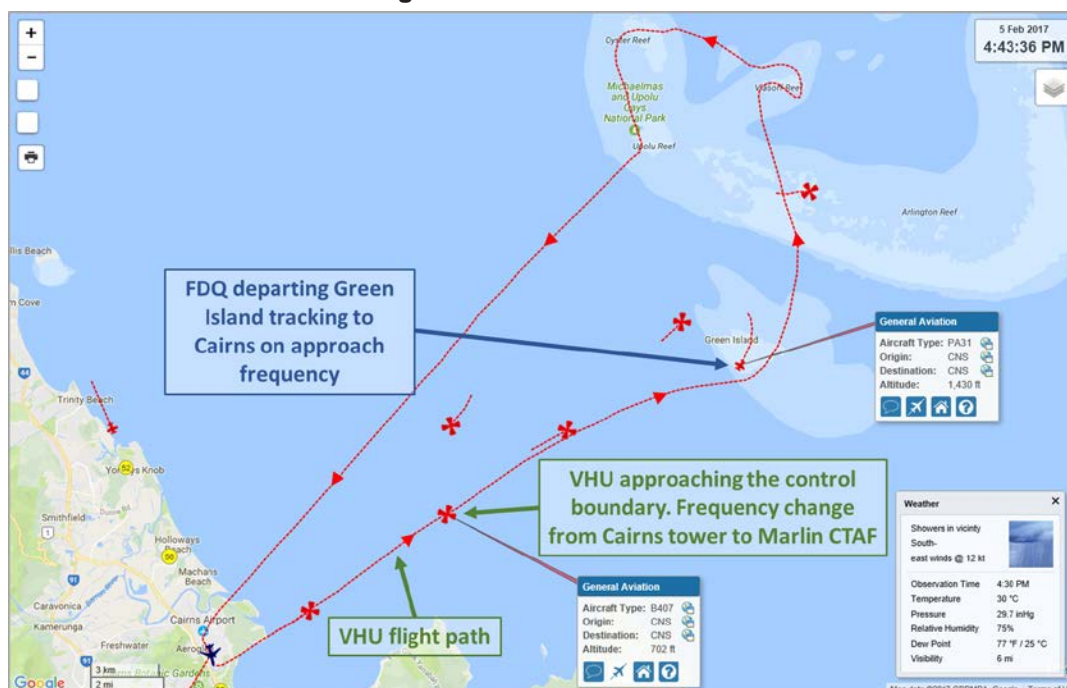
About 30 seconds later, the approach controller cleared the pilot of FDQ (then orbiting at Green Island) to track to Cairns via a left base circuit leg for runway 15 at 1,500 ft (Figure 2).

Figure 2: Location of VHU when changed to the Marlin CTAF and approximate location of FDQ when commenced tracking direct to Cairns

As VHU approached 900 ft on climb, the pilot indicated that their attention was inside the cockpit to ensure they did not climb above 1,000 ft and to set up the helicopter in the cruise. When the pilot subsequently scanned outside, they sighted an aircraft rapidly approaching³ in the opposite direction (FDQ). The pilot of VHU conducted a rapid descent to increase the separation with FDQ and estimated that the vertical separation between the two aircraft was between 100 to 150 ft.⁴ Radar data indicated that the minimum separation between the two aircraft was 400 ft vertically and 500 m horizontally.

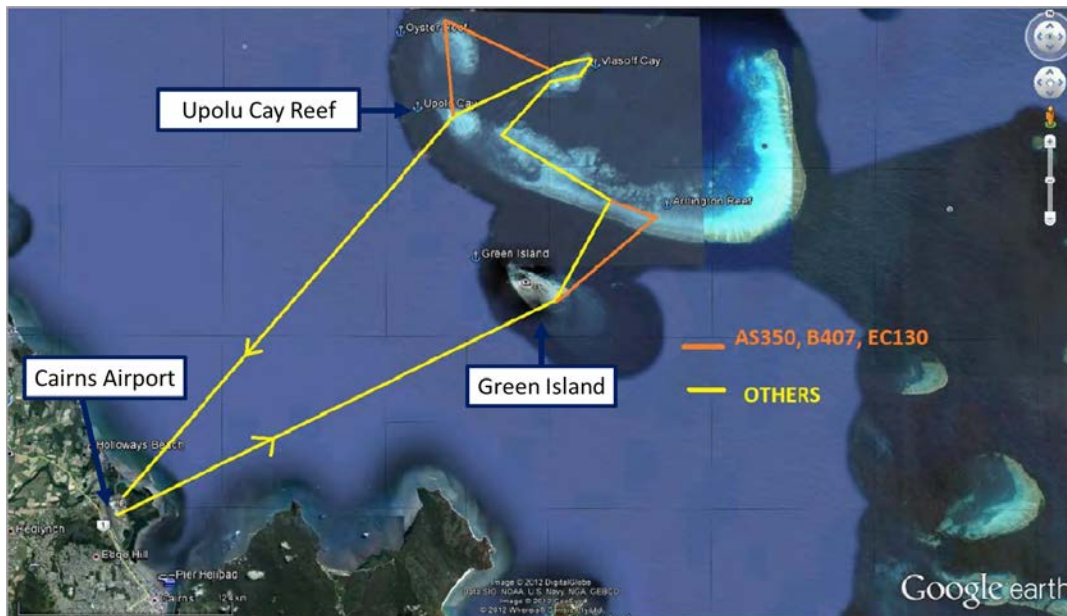
In the interim, on 10 January 2017, the operator of VHU sent an email to the chief pilots of other scenic flight operators with a suggested route for scenic flights (Figure 3). They reported that all helicopter operators agreed to fly in a counter clockwise direction and that this had decreased the incidence of near collisions between helicopters.

Figure 3: Suggested route for scenic flights
