# Engine failure and forced landing involving Jabiru J430, VH-OFR

17 km S of Bundaberg, Queensland, 18 June 2017

**ATSB Transport Safety Report**  
Aviation Occurrence Investigation  
AO-2017-063  
Final – 7 September 2017

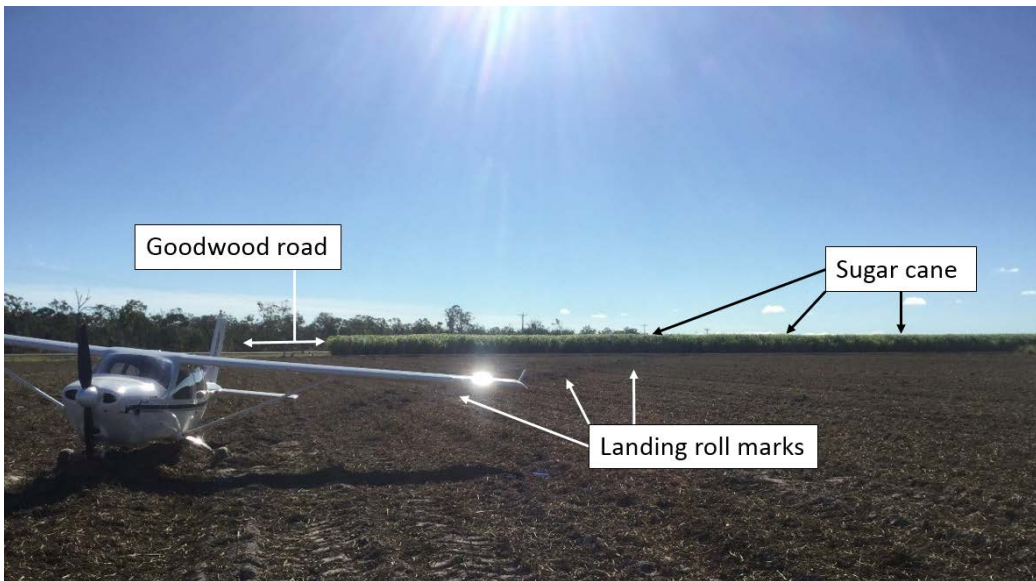
on the road prevented a safe landing. The pilot then identified a field to the east of Goodwood Road as suitable for a forced landing, and conducted a left circuit into the field. During the late stages of the approach, the pilot made a steep left turn to line up with furrows in the field. During this turn, the left wingtip clipped sugar cane in an adjacent field. The pilot continued the turn, and as the aircraft touched down in the field, the left wingtip and left main landing gear touched the ground simultaneously. The pilot levelled the aircraft for the landing. During the landing roll, the left main landing gear partially collapsed (Figure 2).

The pilot and passenger were not injured, the aircraft sustained minor damage.

**Figure 2: OFR after landing showing the sugar cane, Goodwood road, the landing roll marks and furrows.**

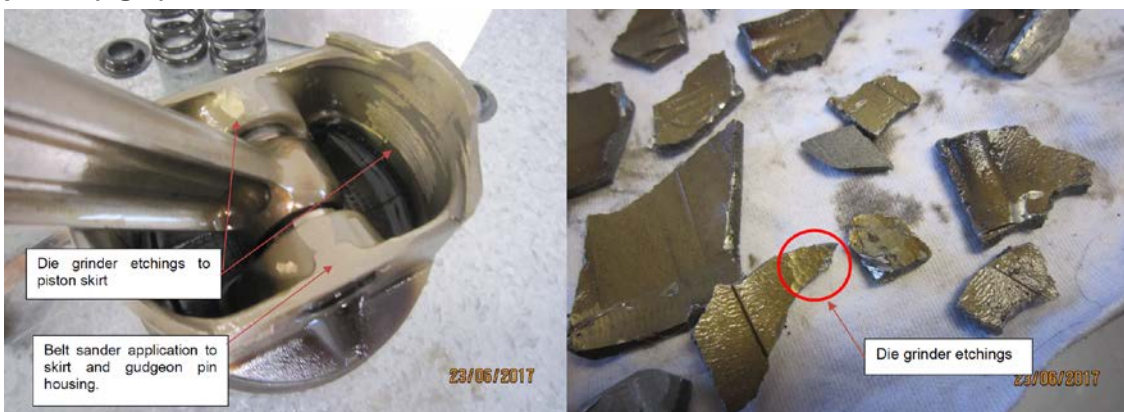
The original engine, a Jabiru 3300A, was manufactured in February 2010. After 403.7 hours of operation, the pilot overhauled the engine with the assistance of a friend familiar with the engine type. During the overhaul, the engine was heavily modified using parts sourced mostly from another engine manufacturer. The pistons were balanced using a belt sander and die grinder (Figure 3).

**Figure 3: Belt sanding and die grinding of a piston (left) and fragments of the number five piston (right).**

- Balancing of the pistons using a die grinder or belt sander is not a recommended procedure.
- Cylinder five had severe damage to the combustion chamber face and a bent exhaust valve (Figure 4). The piston was completely fragmented.
- All cylinders showed scoring. Cylinder two also had corrosion pitting on the cylinder wall (Figure 5).

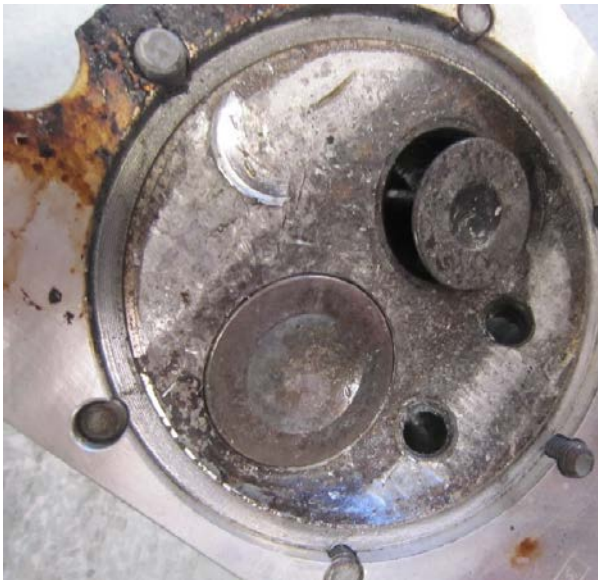
**Figure 4: Cylinder five combustion chamber face showing damage and the bent exhaust valve.**

The engine in the aircraft was heavily modified, and the impact of these modifications on the reliability of the engine was unknown. As the aircraft climbed, the engine experienced a failure in cylinder five which destroyed the piston and led to a complete power loss.

The damage caused to the engine after the failure within cylinder five prevented the cause of the failure from being determined.

- The engine experienced a failure within cylinder five, leading to a complete engine power loss. The cause of the failure could not be determined.

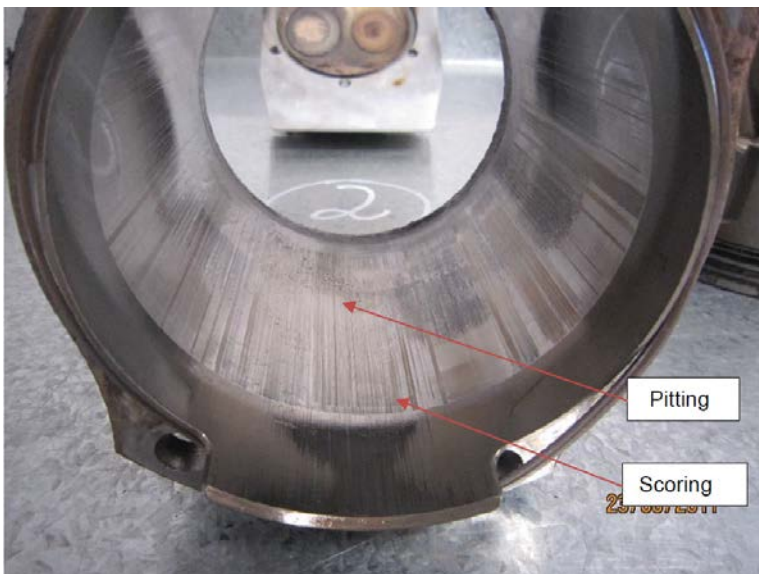
**Figure 5: Corrosion pitting and scoring within cylinder two.**
