Engine malfunction and forced landing involving Bell 206, VH-ONE

39 km NNE Sydney Airport, New South Wales, 11 June 2017

ATSB Transport Safety Report
Aviation Occurrence Investigation
AO-2017-060
Final – 19 September 2017

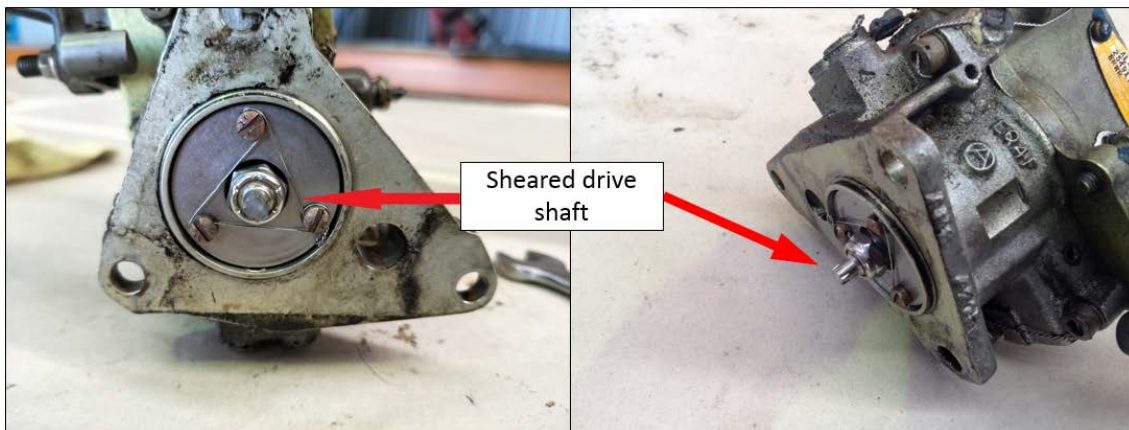
Figure 2: Sheared power turbine governor drive shaft

Following retrieval of the helicopter, it was inspected by the operator’s maintenance organisation. They found that the power turbine governor drive shaft had sheared and that the drive shaft did not have freedom of rotation (Figure 2). The governor had a maintenance program life of 2,000 hours (time between overhaul) and at the time of the failure it had completed 794.7 hours. The next inspection due was in 96.5 hours at the next 300 hour engine inspection. The 300 hour inspection was as follows:

The post-incident inspection of the helicopter revealed the power turbine governor drive shaft had sheared. Further examination revealed that the governor spool bearing had failed and sheared the spool bearing guide post. This resulted in consequential damage to other parts within the governor and the failure of the drive shaft.

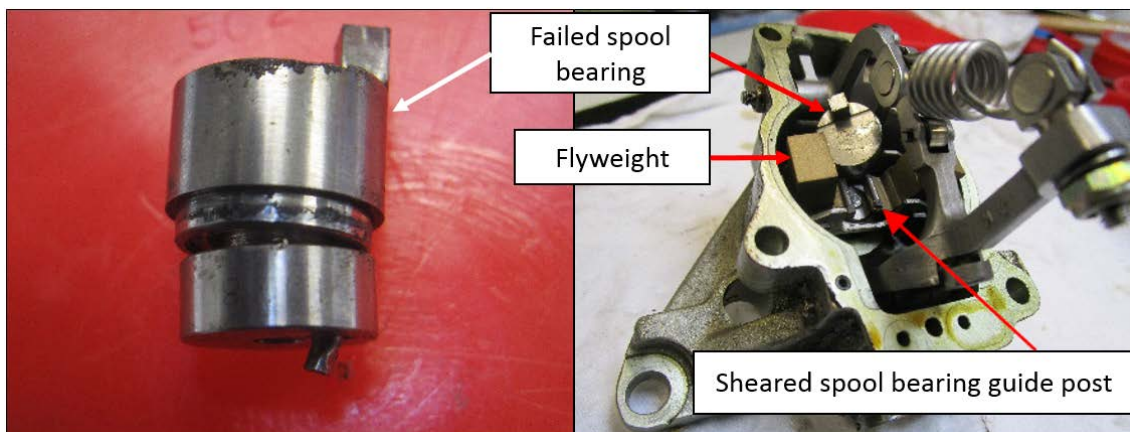
Figure 3: Spool bearing (left) and power turbine governor (right)

Following the removal and external inspection of the incident power turbine governor, the unit was sent to an authorised Rolls-Royce maintenance, repair and overhaul centre. A teardown (disassembly) of the unit was conducted on 21 July 2017. Disassembly of the governor revealed a sheared spool bearing guide post, failed spool bearing and consequential damage to other parts inside the governor (Figure 3).

- The power turbine governor spool bearing was found to have failed and sheared the spool bearing guide post. This likely resulted in the failure of the governor drive shaft and engine malfunction.

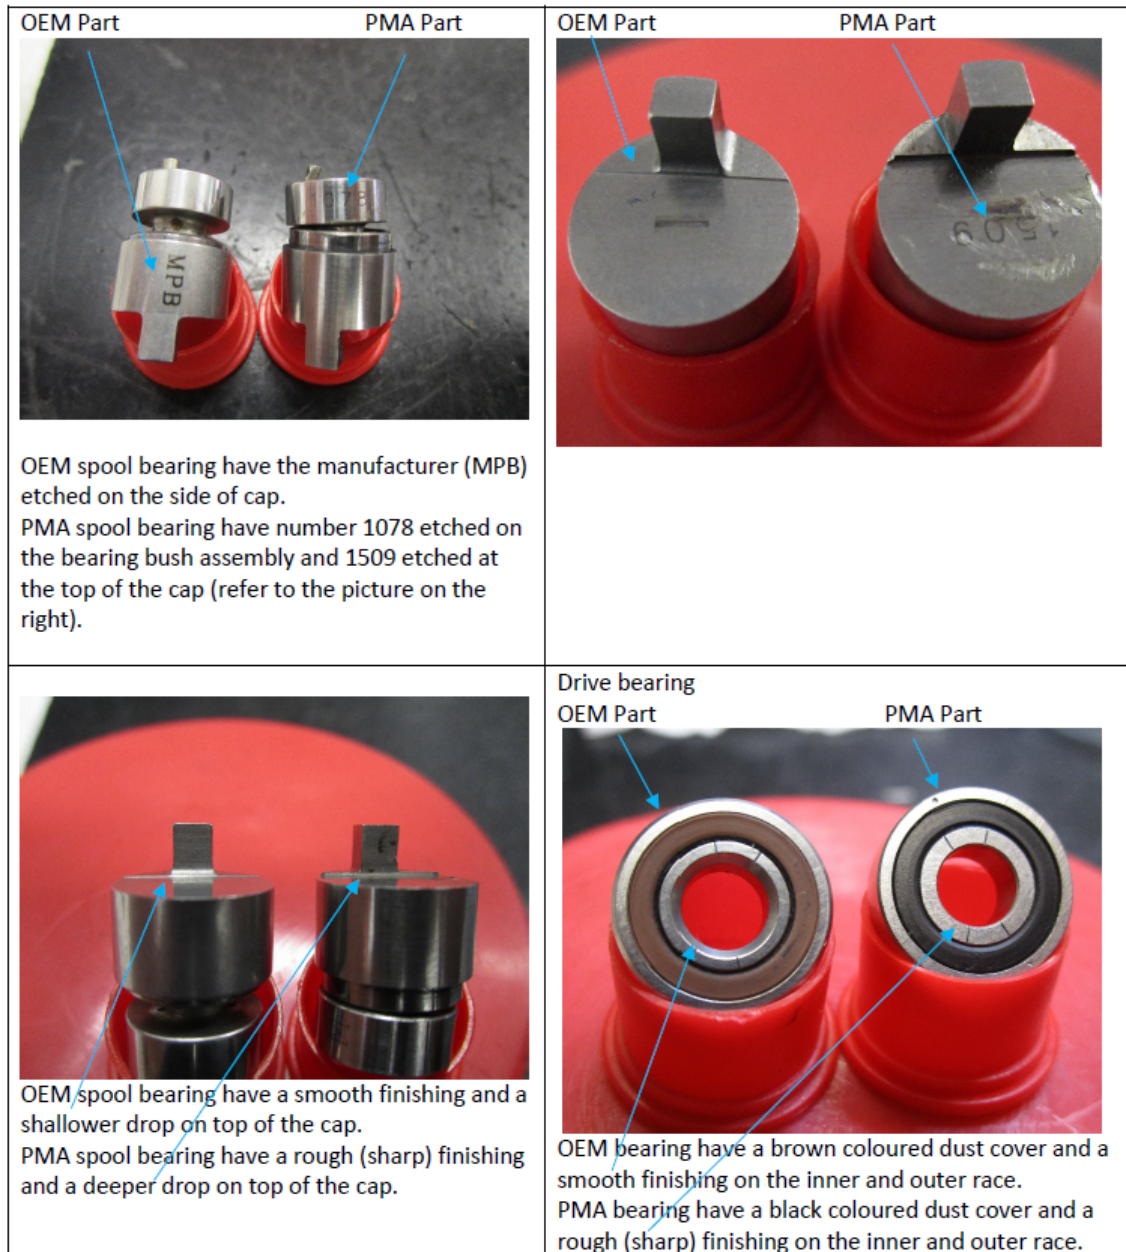
Figure 4: Comparison of OEM and PMA bearings

On inspection, the spool bearing and drive shaft bearing were found to be parts manufacturer approval (PMA) parts, rather than Honeywell original equipment manufacturer (OEM) parts.¹¹ The manufacture of PMA parts is based on the manufacturer demonstrating to the authority (United States Federal Aviation Administration) that it has developed specifications that will produce a part equal to the original. However, when the overhaul centre compared the PMA spool and drive bearings installed in the governor with OEM equivalent parts, they found discrepancies between the products (Figure 4). Figure 4 depicts the spool bearings top left, right and bottom left, and the drive shaft bearings bottom right.

The spool bearing was found to be a PMA part, which was installed in place of an OEM part by a third party repair station when the governor was last overhauled in 2015. While a comparison between the PMA spool bearing and OEM spool bearing revealed discrepancies, it was not determined if these discrepancies contributed to the failure of the spool bearing.
