Hard landing involving Gippsland Aeronautics GA-8, VH-MQI

Djamardi (Jimarda) ALA, Northern Territory, 2 August 2017

ATSB Transport Safety Report
Aviation Occurrence Investigation
AO-2017-079
Final – 17 November 2017

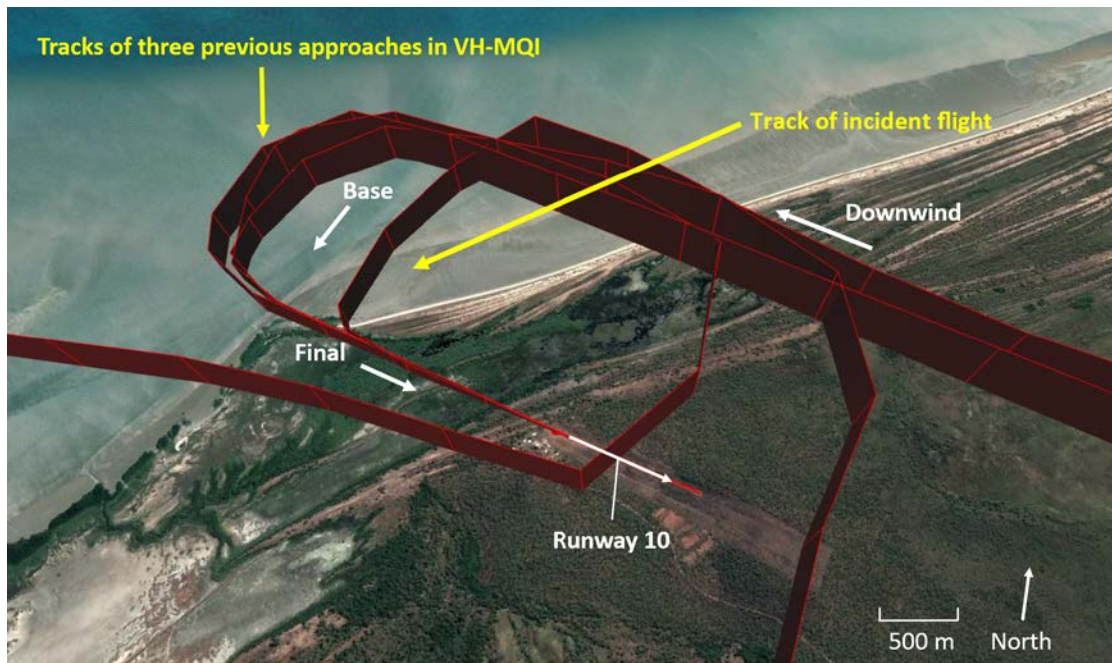
Recorded data captured the incident approach, along with three previous approaches, conducted by VH-MQI to runway 10 during earlier flights to Djamardi. The data shows that on the incident approach, the aircraft turned onto the base leg of the circuit earlier than these three previous approaches (Figure 1).

Figure 1: Representation of recorded data showing the tracks of four approaches, including the incident approach, made by VH-MQI to runway 10 at Djamardi ALA. The downwind, base and final legs of the circuit for runway 10 are also shown.

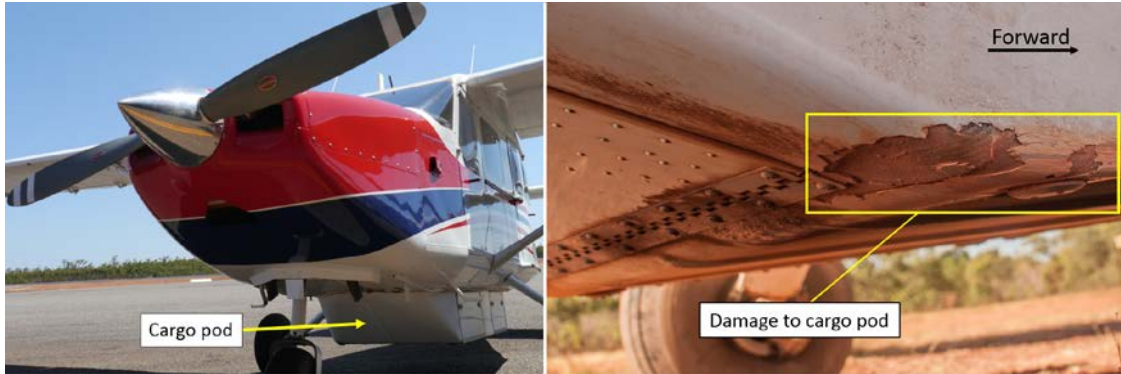
positively than normal, however he was unable to arrest the rate of descent. The aircraft touched down hard on the main landing gear. The cargo pod (Figure 2) struck the runway.

Figure 2: VH-MQI showing the cargo pod fitted to the aircraft (left) and damage sustained during the incident (right).

The hard landing damaged the cargo pod, the main undercarriage legs and fairings.

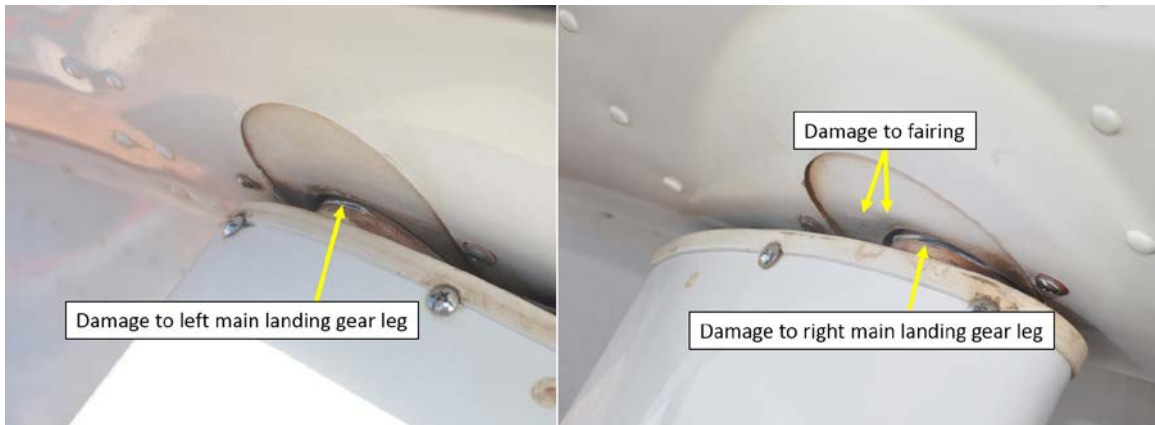
- The early base turn led to a steeper approach descent profile.
- A change in wind direction from a north-easterly, to a northerly as the aircraft approached the runway, combined with mechanical turbulence caused by trees, increased the aircraft descent rate.
- After the pilot detected the reducing approach speed, the technique used to accelerate the aircraft was incorrect. Engine power should have been immediately increased.
- The cargo pod, both main landing gear legs and the fairings where the landing gear legs enter the fuselage were damaged (Figure 3). The right main landing gear leg was also cracked.

Figure 3: Damage to left main landing gear leg (left), and damage to the right main landing gear leg and fairing (right).
