Fuel planning event, weather-related event and ditching involving Israel Aircraft Industries Westwind 1124A, VH-NGA

6.4 km WSW of Norfolk Island Airport | 18 November 2009

ATSB Transport Safety Report
Aviation Occurrence Investigation
AO-2009-072 (reopened)
Final – 23 November 2017

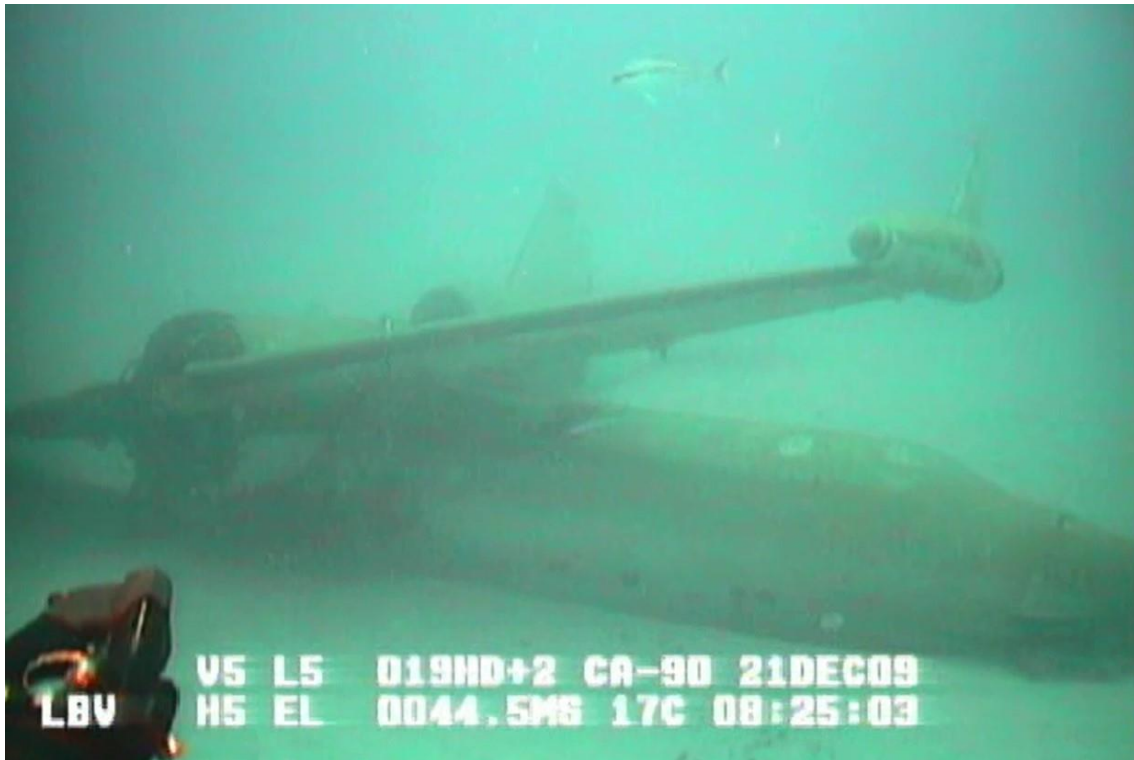
Figure 14: Disposition of the aircraft wreckage on the seabed

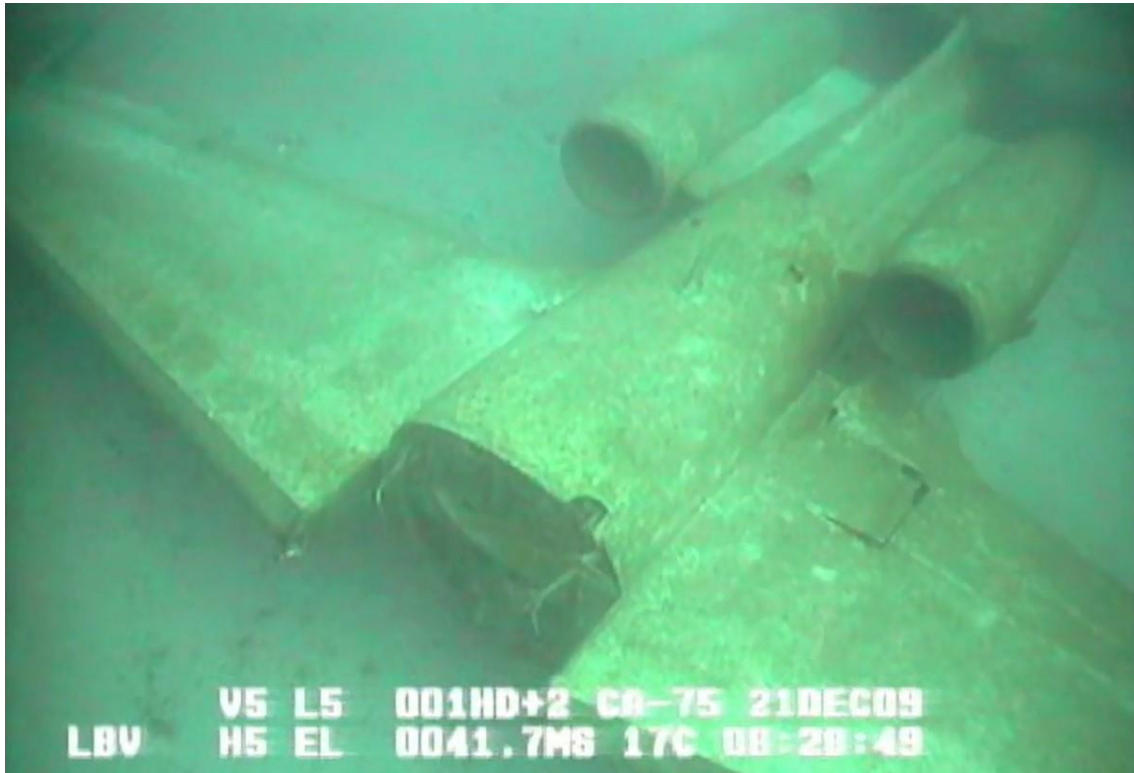
Figure 15: Overhead view of wreckage on the seabed, showing location of separation from forward fuselage ahead of the main wing spar

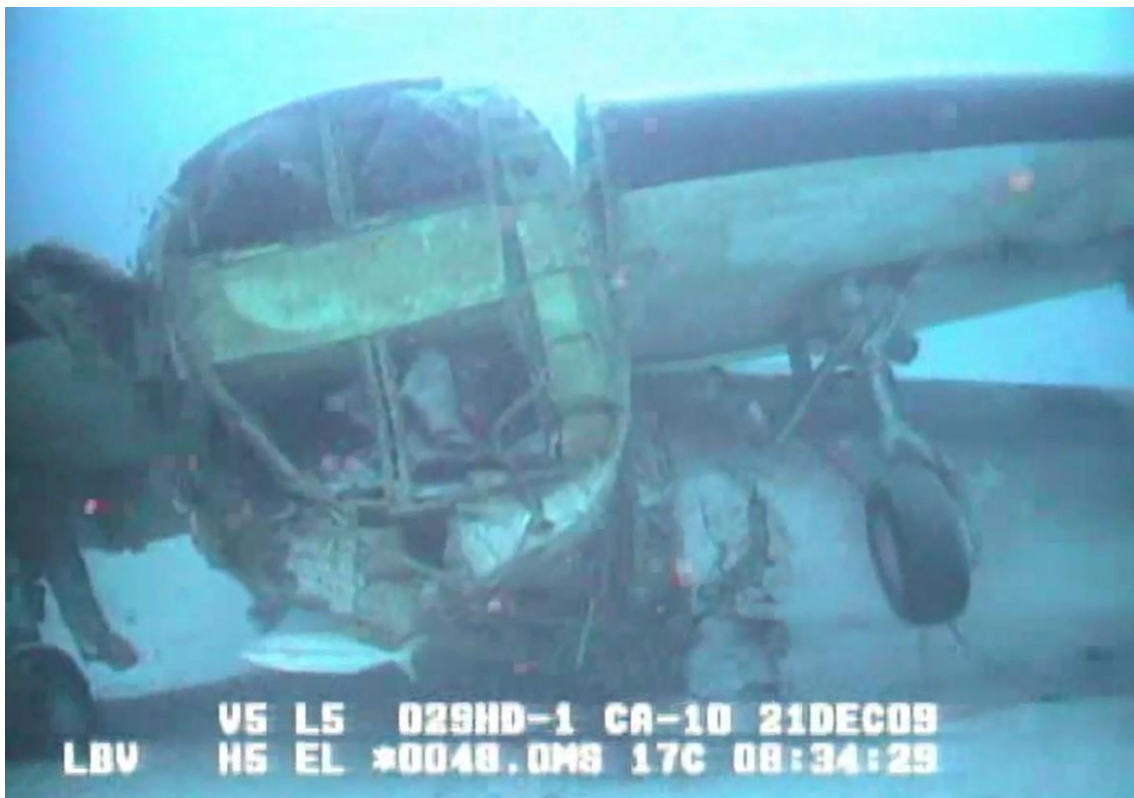
Figure 16: Front-on view of forward fuselage separation point, showing wing spar carry-through structure, main fuselage fuel tanks and damage to the underfloor fuselage section

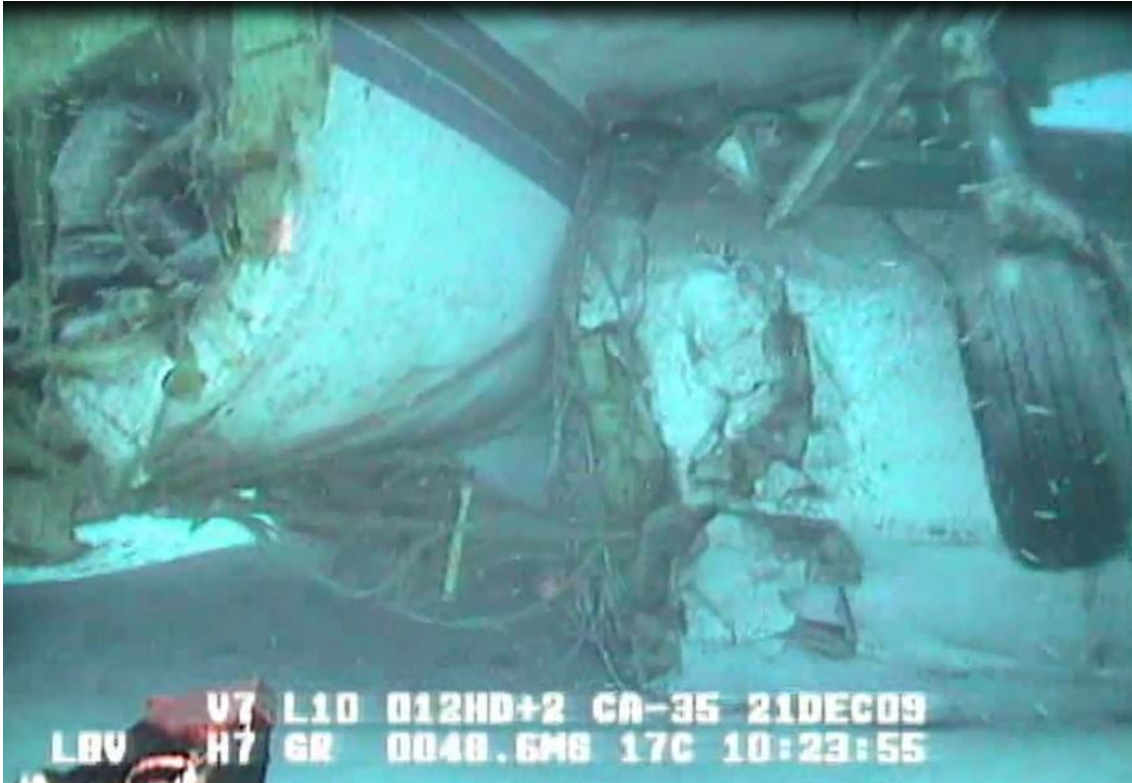
Figure 17: Fuselage separation location and damage to the forward lower fuselage section

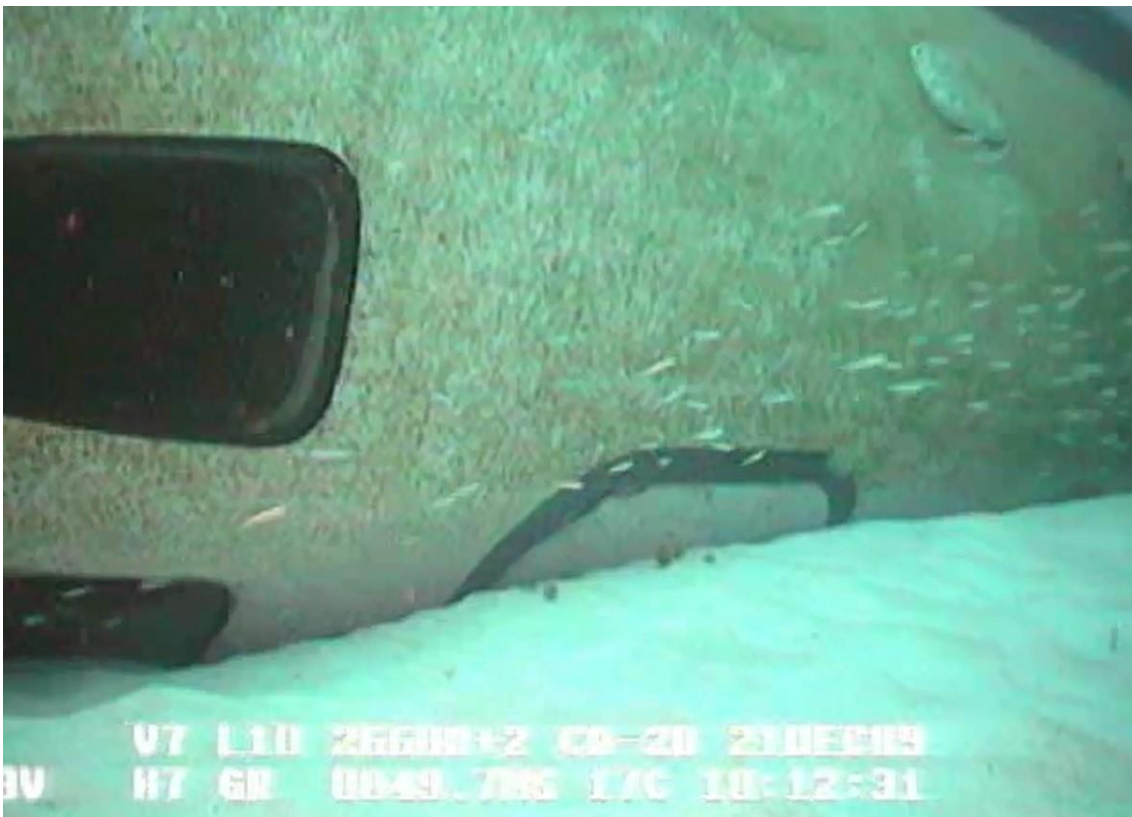
Figure 18: Top of main entry door, left cockpit side and left upper window

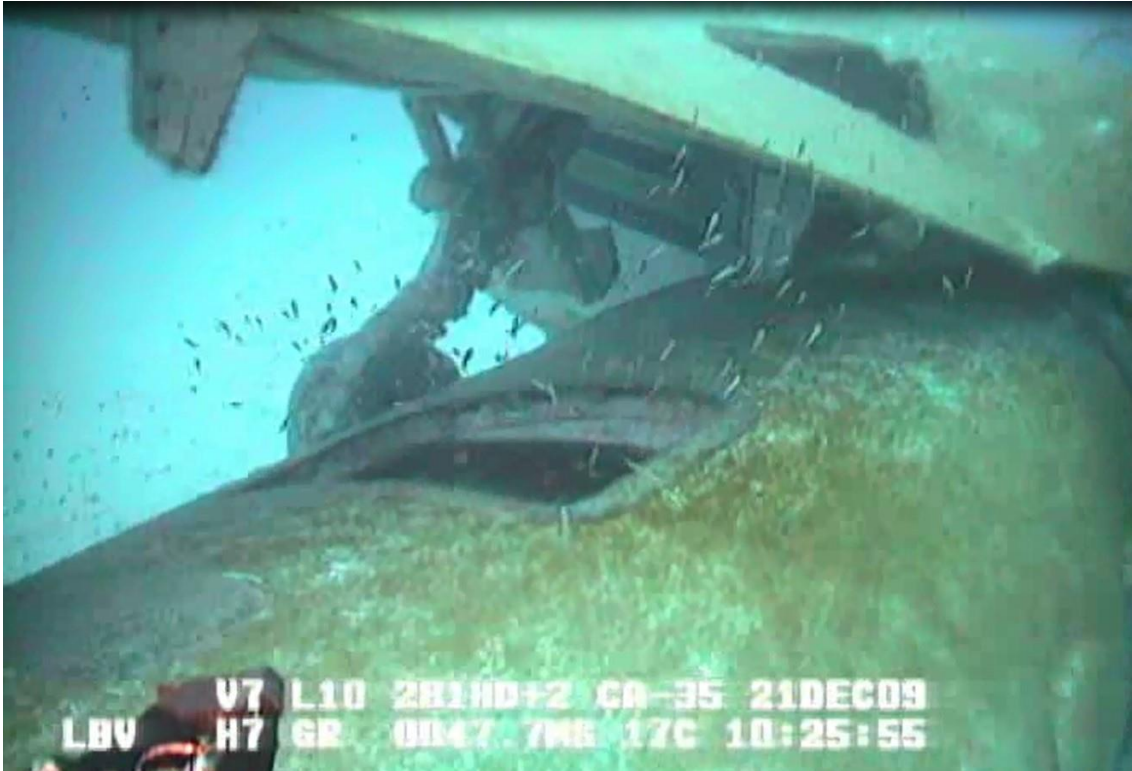
Figure 19: Right side of forward fuselage, showing open emergency exit.

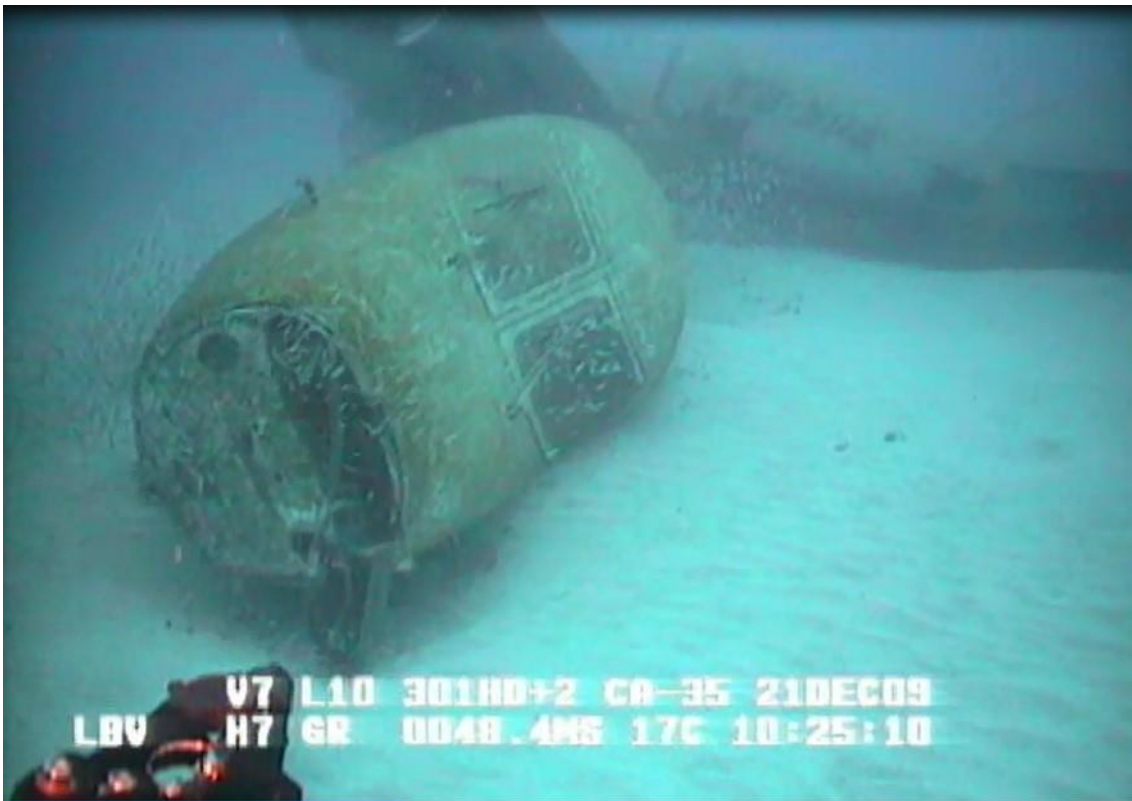
Figure 20: Forward fuselage resting on the seabed on its left side

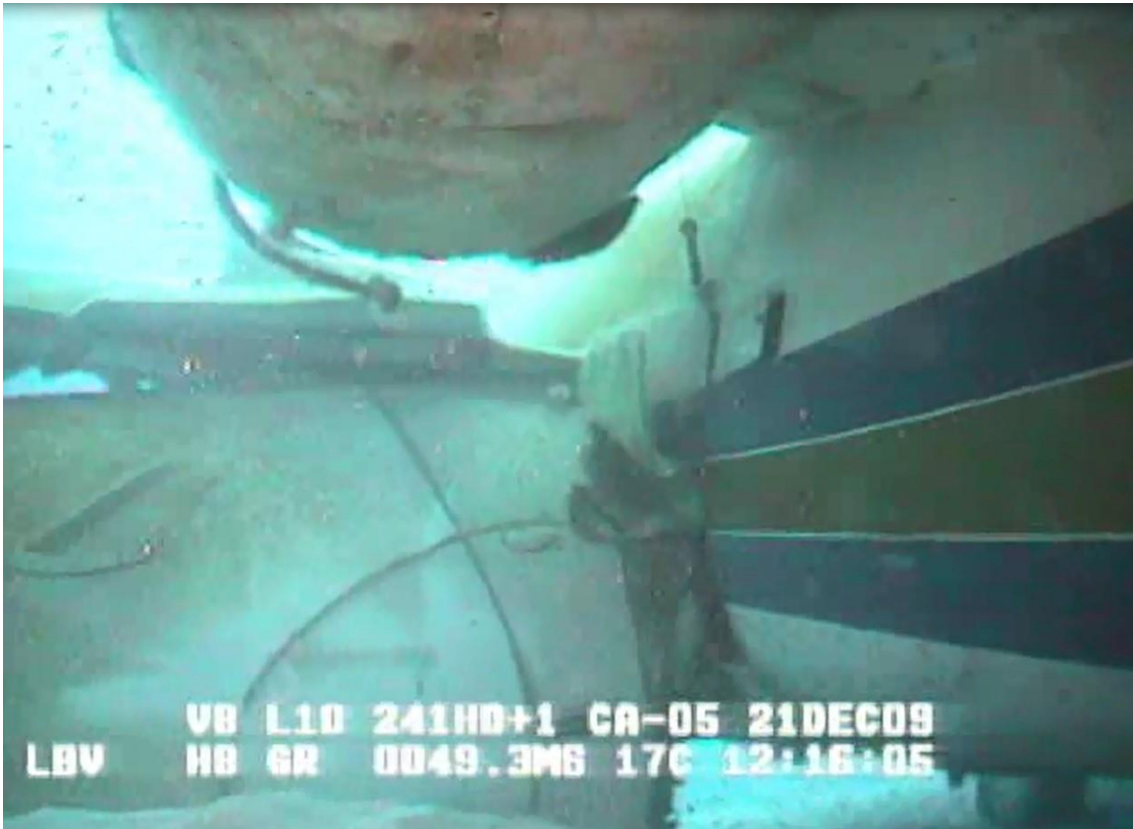
Figure 21: View looking forward from under left engine showing hydraulic damage to lower half of forward baggage compartment door.

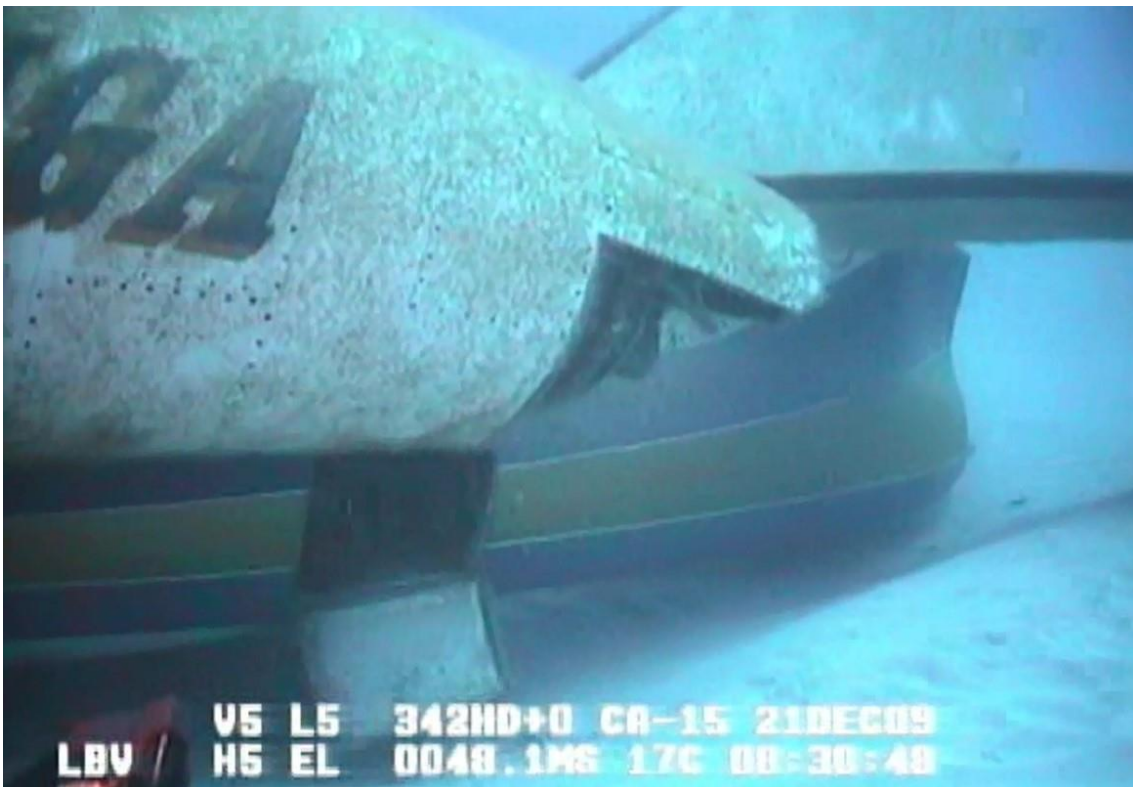
Figure 22: View from left side of rear fuselage, showing open rear baggage compartment door

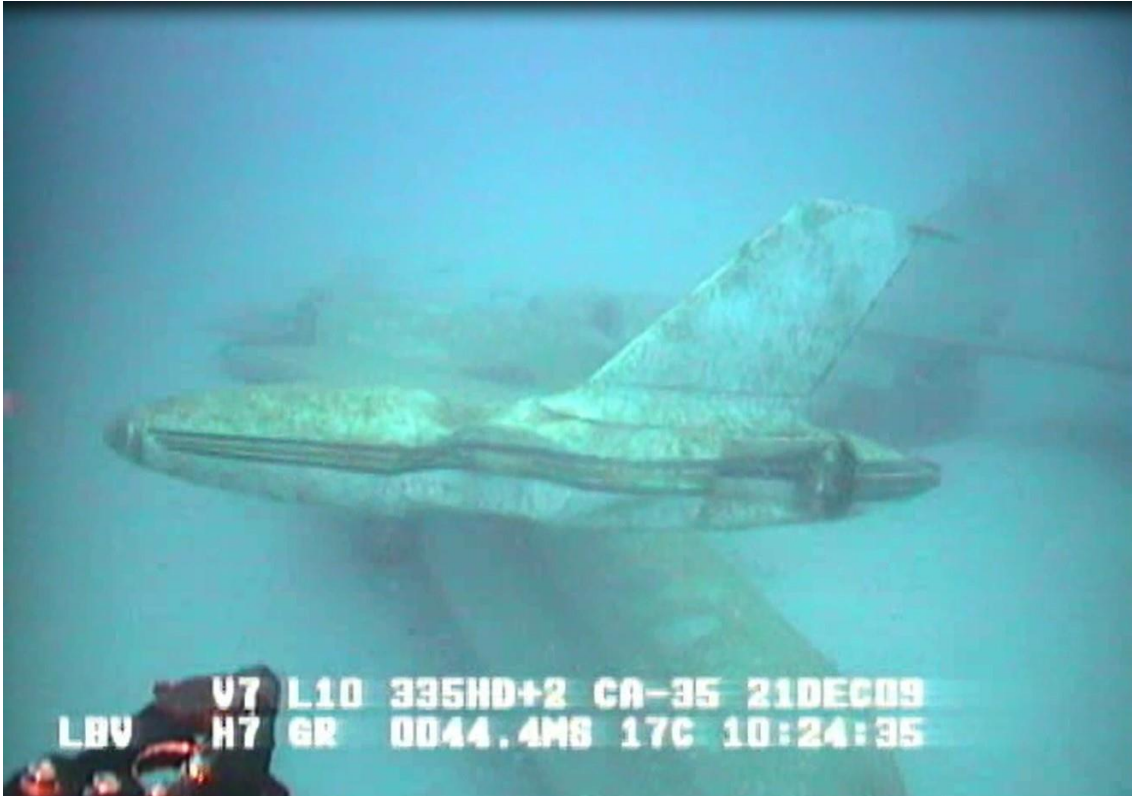
Figure 23: View of left tip tank, showing crushing damage due to water pressure

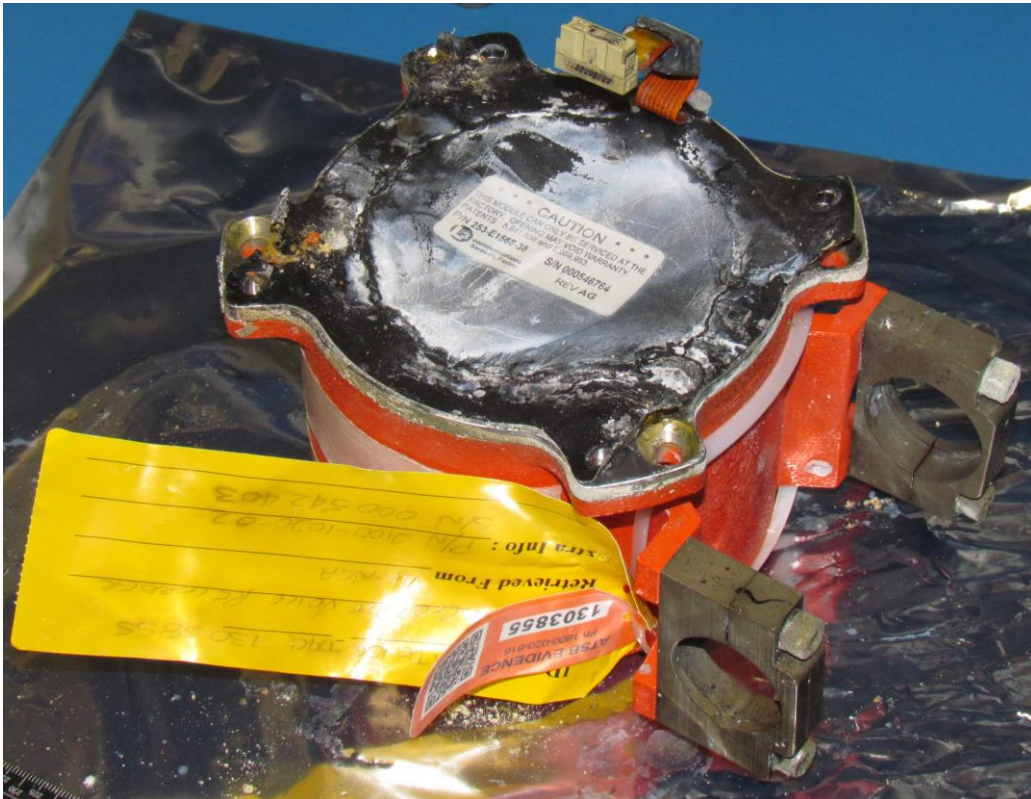
Figure A3: CVR crash-survivable memory unit, 16 November 2015
