Australian Government
Australian Transport Safety Bureau

Near hit with derailed passengers on track

Kilbride, New South Wales | 22 May 2014

ATSB Transport Safety Report
Rail Occurrence Investigation
RO-2014-009
Final – 17 January 2018

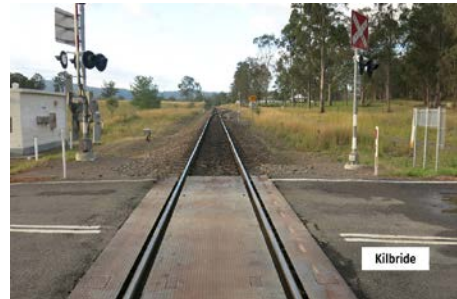
Mirari Road level crossing Kilbride

At 1137 on 22 May 2014, NSW Trains XPT passenger service NT33 departed Paterson towards Kilbride when the driver observed a bus at the Mirari road level crossing and people walking on the track ahead. The driver immediately made an emergency brake application and brought the train to a stand approximately 80 m short of the people.

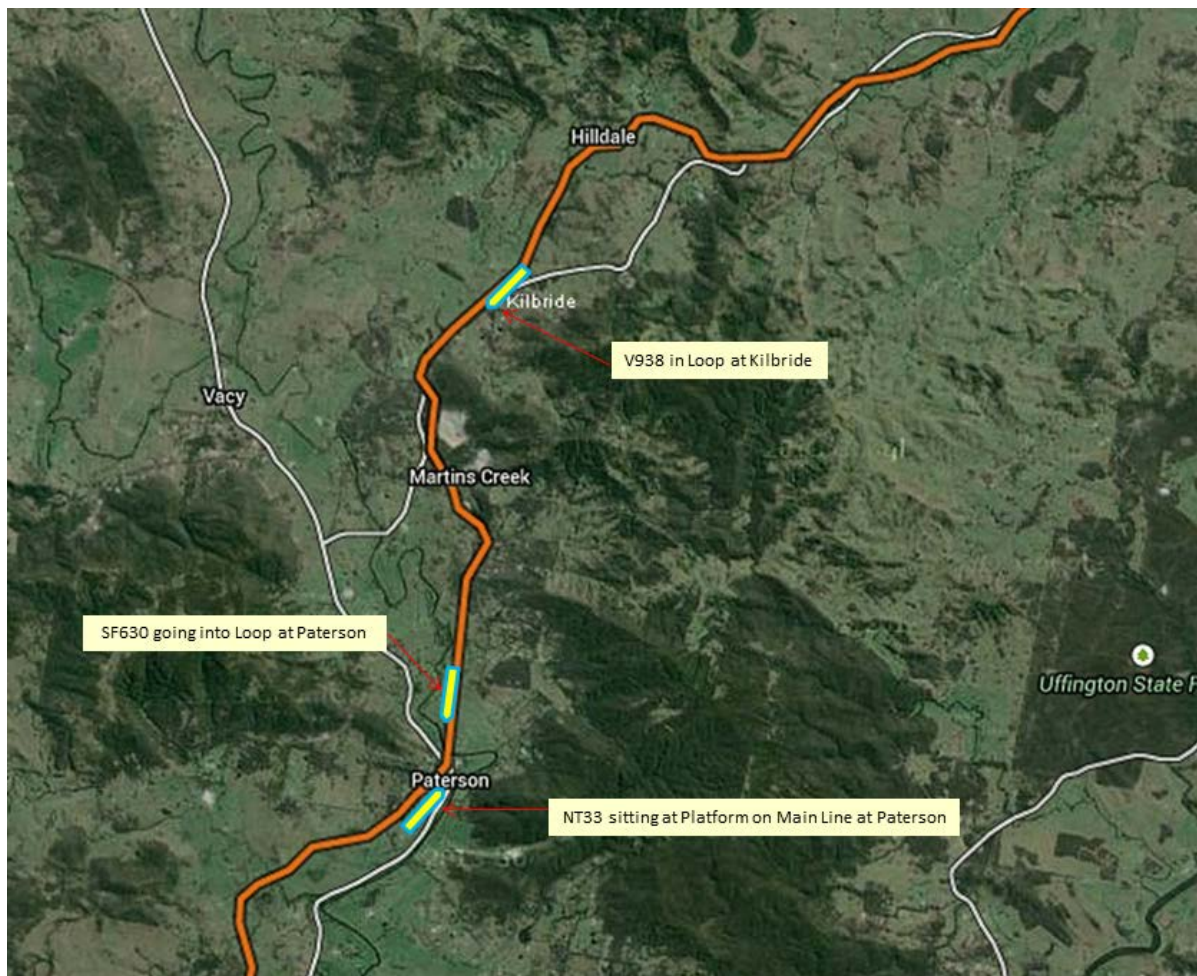
Figure 1: Position of trains SF630 and NT33 at Paterson, and train V938 at Kilbride

At 1013 SF630 was entering Paterson crossing loop (see Figure1). As it entered the crossing loop its lead locomotive 8215 suffered a mechanical problem. This forced the train to come to a stand with a portion of the train still standing foul of the main line. As a result, NT33's departure path from Paterson station platform was blocked.

Meanwhile, a two-car Hunter passenger service operated by NSW Trains (V938), had departed Dungog and was also travelling south behind SF630. At 1022 V938 entered the loop at Kilbride as scheduled and waited for NT33 to pass. V938 was scheduled to depart Kilbride at 1029 towards Newcastle.

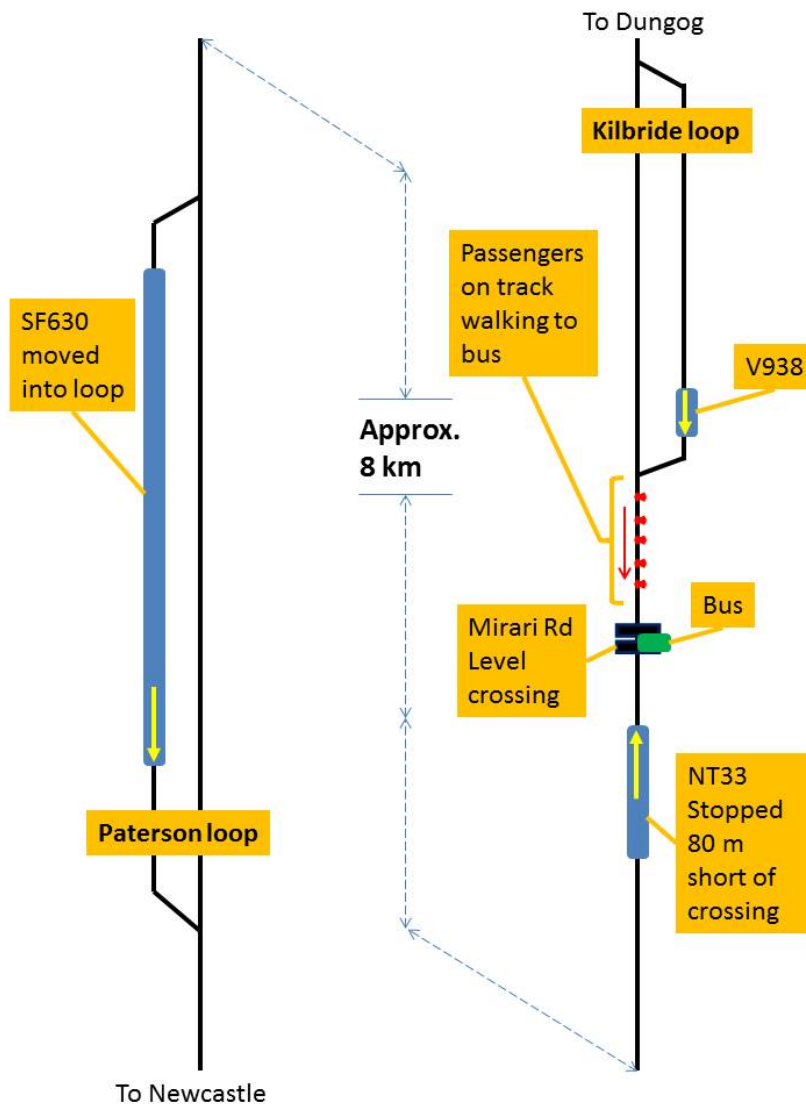
Figure 2: Position of trains, bus and people at time of incident

NT33 was approaching Kilbride at 118 km/h.³ As NT33 approached the Mirari road level crossing, the driver observed a bus at the level crossing and people walking on the track approximately 300 m ahead of the train. The driver of NT33 immediately made an emergency brake application and sounded the horn continuously as he brought the train to a stand approximately 80 m short of the bus and people.

The crew of V938 had completed assisting five of their six passengers off the train when the guard observed the level crossing activate and looked up the track to see NT33 coming towards them. The guard gave a verbal warning to the passengers to get off the track before noticing NT33 had already stopped (see Figure 2).

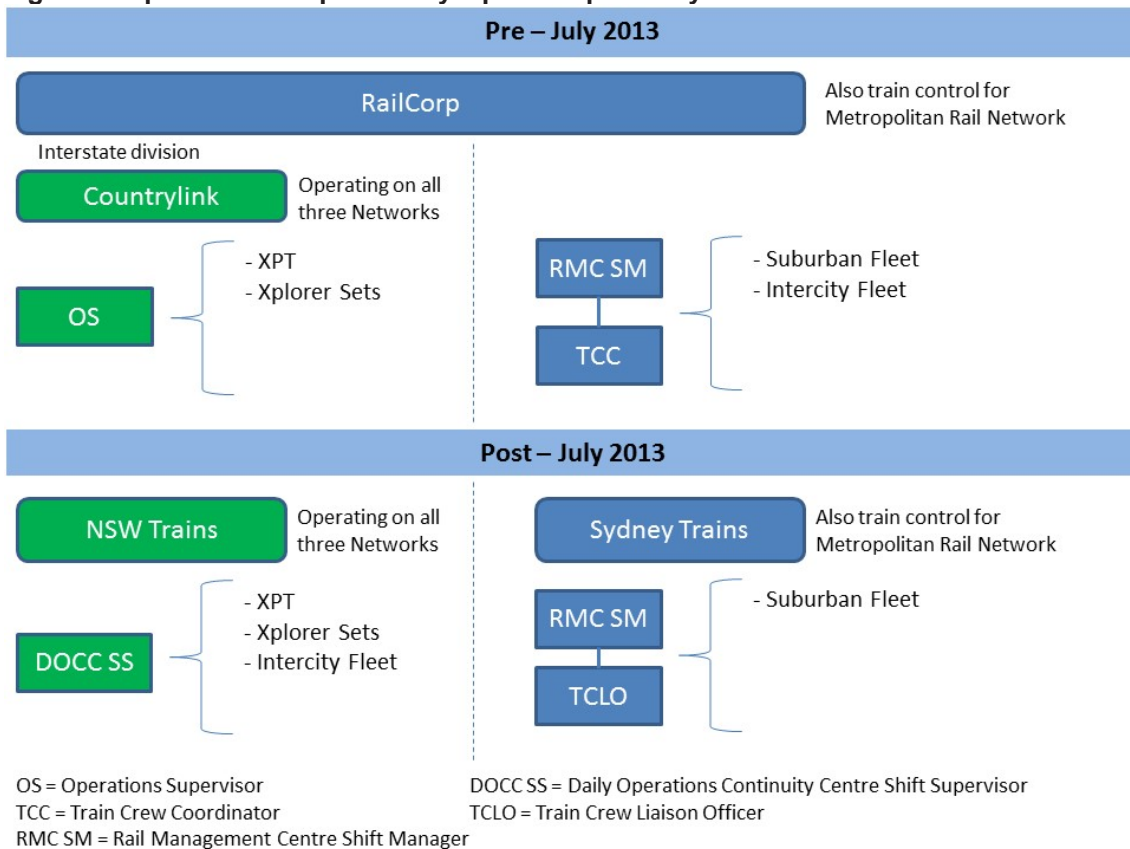
Figure 5: Operational responsibility – pre and post July 2013

Responsibility for intercity service V938 resided with the NSW Trains' DOCC SS (see Figure 5).

In contrast, the TCLO at interview indicated the transition from RailCorp and CountryLink to Sydney Trains and NSW Trains resulted in very little change to operational staff responsibilities. Whilst position titles had changed, TCC became TCLO, the tasks associated with the position had not. The TCLO was still expected, in the interim, to provide operational support for NSW Trains' intercity services.

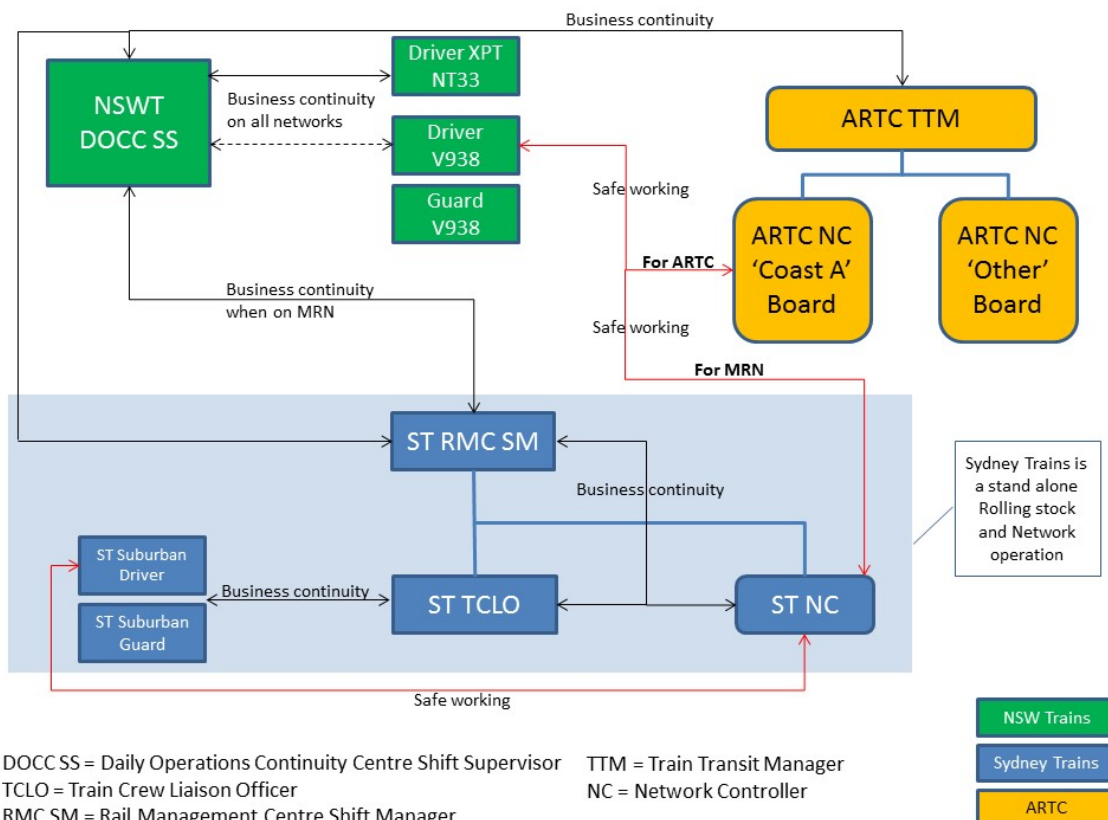
Figure 6: Communication between relevant parties

The investigation found that all safe working communications should have occurred between the ARTC NC and the driver of V938. The only evidence of a conversation between the ARTC NC and driver of V938 was when the driver called to find out how long V938 would be delayed in the Kilbride Loop. The business continuity communication, arranging alternative transport, should have taken place between the DOCC SS and the guard of V938.

At interview, the driver and the guard of V938 said they assumed the RMC were arranging protection for passengers to detrain. They made this assumption because RMC’s communications gave them the perception that train protection was also being arranged. Despite these assumptions, the train crew of V938 remained responsible for critical safe working duties (ensuring adequate protection was in place) before detraining their passengers into the rail corridor (see Figure 6).
