Level crossing collision between the *Spirit of Queensland* tilt train and a road vehicle

Denison Street, Rockhampton, Queensland | 15 July 2017

ATSB Transport Safety Report
Rail Occurrence Investigation
RO-2017-006
Final – 29 January 2018

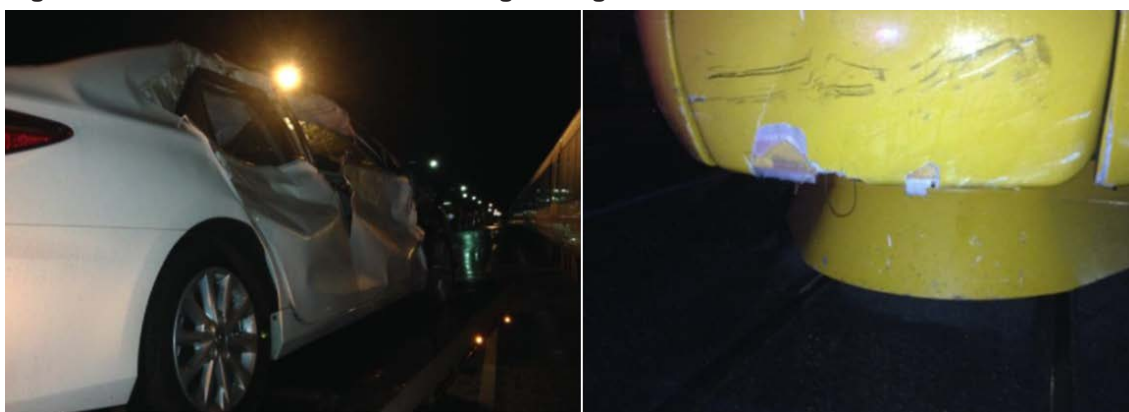
At about 0047 hours (about 8 minutes ahead of schedule) on 15 July 2017, the train approached the intersection of Denison and William Streets, Rockhampton at 21 km/h (below the posted train speed limit of 25 km/h). Both of the train's drivers identified that the intersection and its approaches were clear. When the train was in the intersection, both drivers heard a loud bang and a jolt to the power car² cab. The operating driver immediately applied the brakes and the train stopped after travelling about 40 m. The driver alighted from the train and found that the train had struck a road vehicle, a white Toyota Camry (Figure 1).

Figure 1: Vehicle and train front cowling damage

The train struck the driver's side of the vehicle causing it to spin and collide with the right-hand side of the train in the direction of travel.

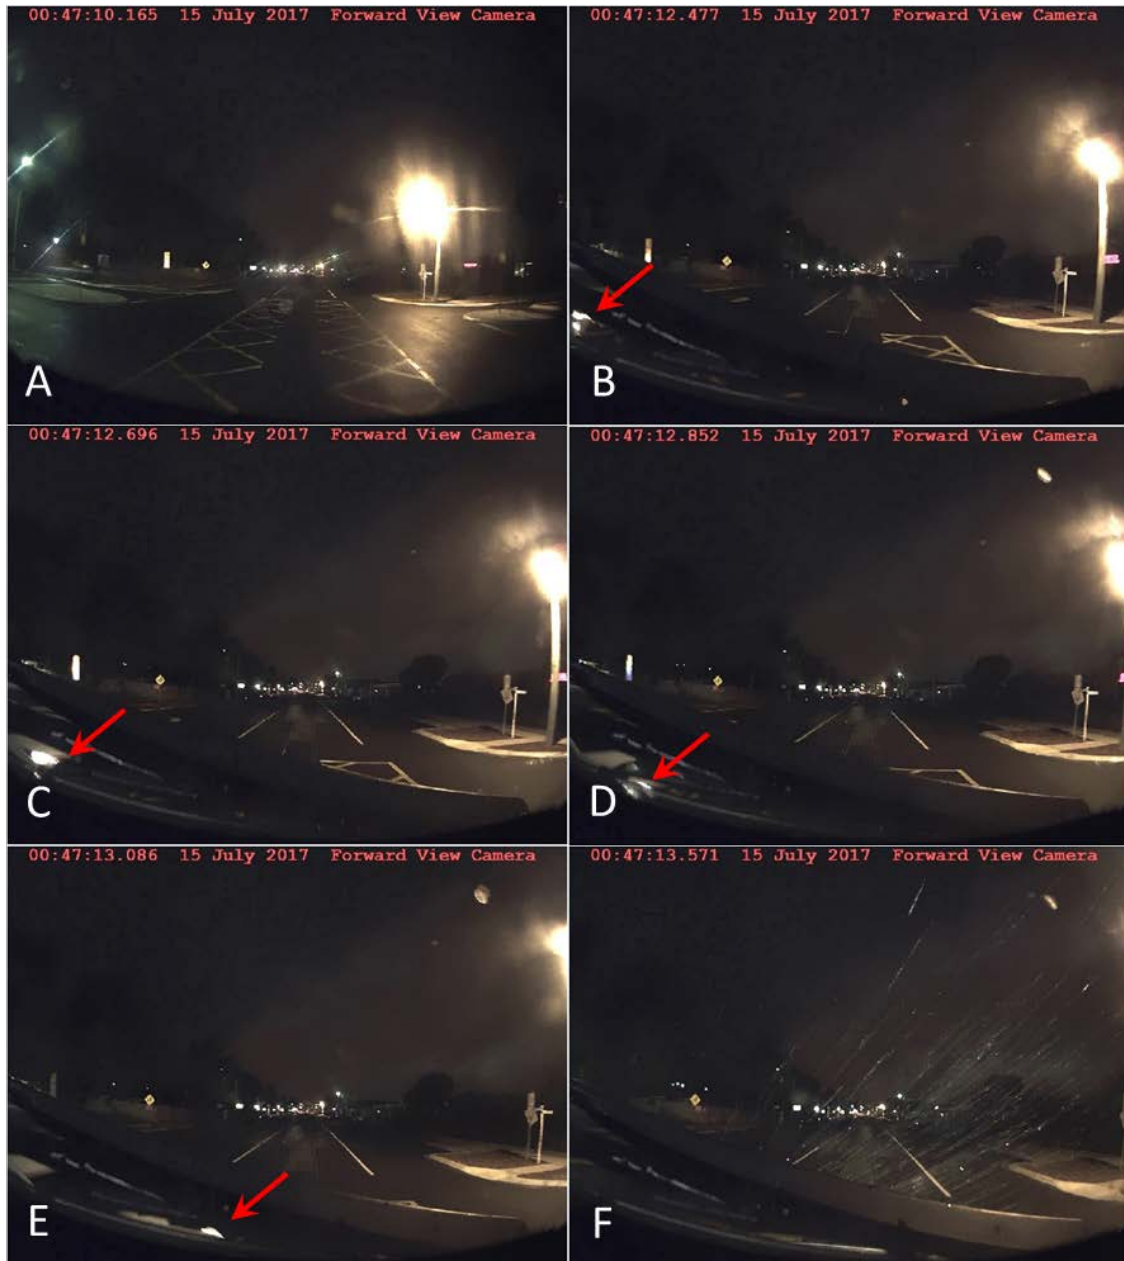
The train was fitted with a forward-facing video camera and a data event recorder. The video camera footage (Figure 2, sequential frames as identified) showed that the:

- A. Train entered a clear crossing with no signs of approaching traffic.
- B. Vehicle (indicated by the red arrow) entered the crossing from William Street, ahead of the approaching train.
- C. Vehicle continued across the intersection.
- D. Vehicle continued with no indication of slowing.
- E. Vehicle moved in front of the train, just prior to impact.
- F. Train collided with the right-hand side of the vehicle (the smashed glass from the vehicle sprayed over the train windshield).

Figure 2: Forward-facing train video camera sequential frames (red arrow shows the position of the road vehicle)

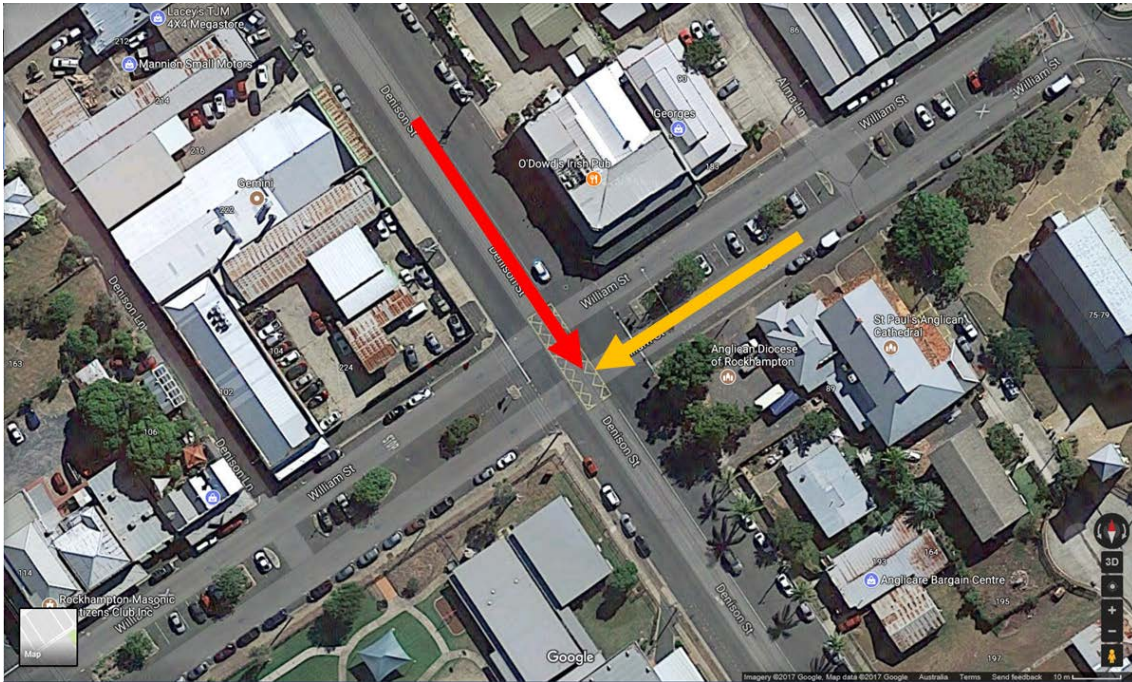
The intersection of Denison and William Streets was a level crossing with passive controls (stop and warning signs), Figure 3. Queensland Rail defined passive control as:

Figure 3: The level crossing intersection (the red arrow indicates the train movement and the yellow arrow indicates the movement of the road vehicle)

Queensland Rail has advised the ATSB that the Manager, Road Rail Interface will conduct a review of the level crossing at the intersection of Denison and Williams Streets, Rockhampton.

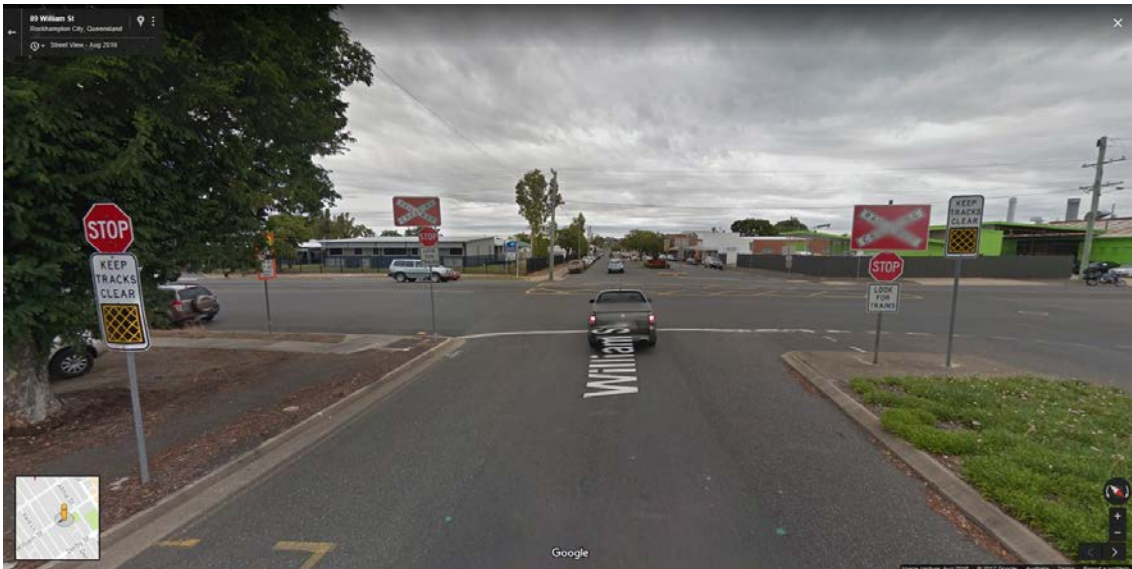
There were warning signs on William Street situated appropriately along the road in the approach to Denison Street (Figure 4). The designated speed limit on Denison Street was 50 km/h and 60 km/h on William Street. Queensland Rail found the approach signage was serviceable and appropriate.

Figure 4: Intersection signage

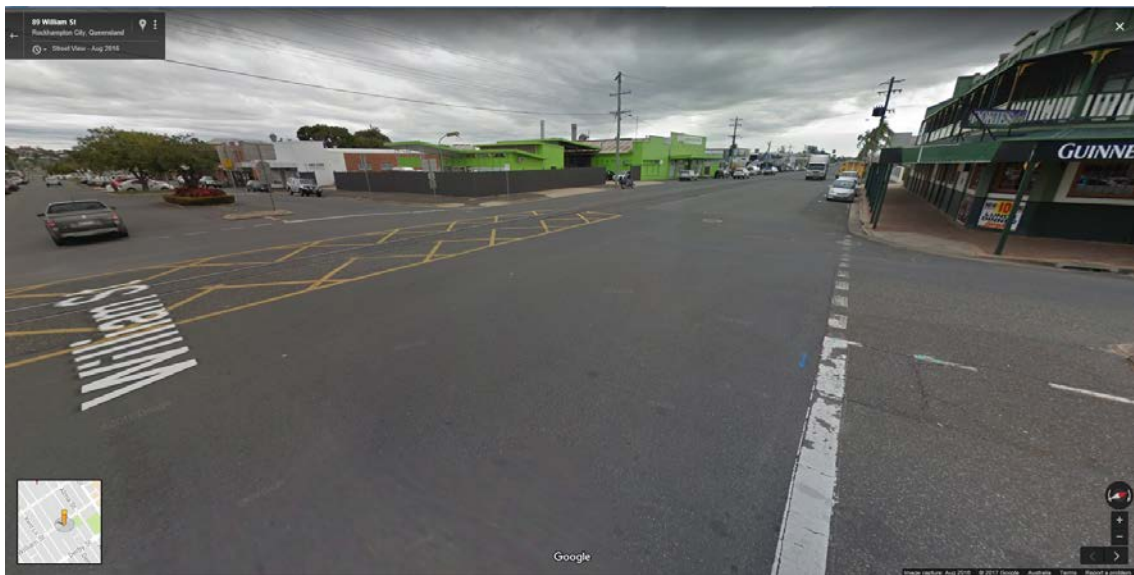
Additionally, the required sighting distances met the minimum requirements for the type of protection and road rail approach speeds. The intersection of Denison and William Streets level crossing had undergone regular inspections and maintenance by QR.

Figure 5: Intersection sighting
