Obstacle proximity warning involving Bombardier DHC-8, VH-TQM

near Adelaide Airport, South Australia | 24 April 2015

ATSB Transport Safety Report
Aviation Occurrence Investigation
AO-2015-045
Final – 5 February 2018

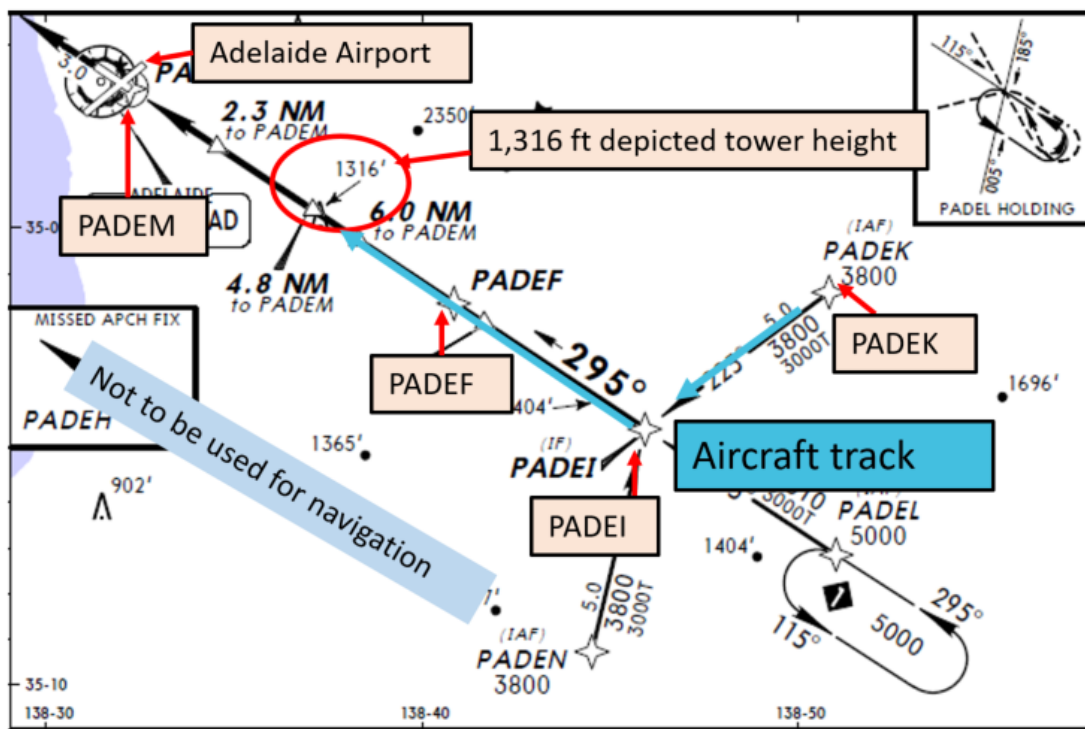
Figure 1: Extract of RNAV-Z (GNSS) Runway 30 approach

Note the 1,316 ft tower on the approach path

The terrain database installed on the EGPWS unit had the height of the tower as 1,325 ft, which was the height of 1,316 ft on the approach chart rounded up to the nearest 25 ft. The correct height of the tower was subsequently found to be 1,365 ft and the chart has since been amended. The EGPWS database, however, had not been amended at the time of completion of this report. Had the EGPWS unit had the correct tower height (1,365 ft), it still would have generated the same alert and warning. Airservices Australia advised that the height error was due to corruption of an obstacle database.

Airservices Australia amended the approach chart with the correct height of the tower. While safe obstacle clearance existed on the approach profile, they also amended the approach procedure to increase the clearance above the obstacle, with the aim of eliminating proximity alerts to aircraft on the approach profile.

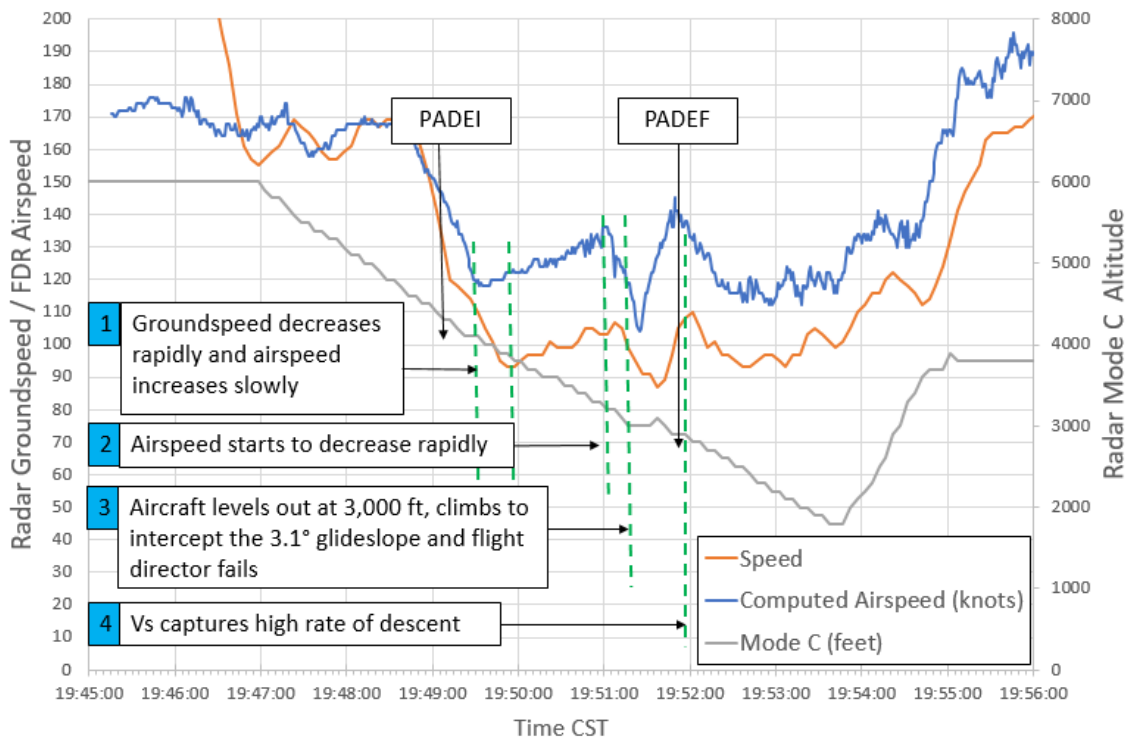
Figure 2: VH-TQM approach to Adelaide showing airspeed, groundspeed and altitude

Passing about 3,400 ft, the PM observed a decay in airspeed, with the speed trending towards the minimum reference speed ('2' in Figure 2). The PM called 'speed' and the PF responded by increasing the thrust. The speed continued to decay, so the PM again called 'speed' and the PF further increased the thrust, and the speed soon returned into the normal range (see the section titled *Speed decay*).

Passing about 3,200 ft and 8.5 NM from the threshold, uncommanded disengagement of the flight director lateral and vertical navigation modes occurred ('3' in Figure 2). The 'FD NAV DATA INVALID'⁴ message appeared on the advisory display panel (ID-802) and the flight director bars dropped out on the electronic attitude direction indicator (EADI) display, but the autopilot remained engaged.

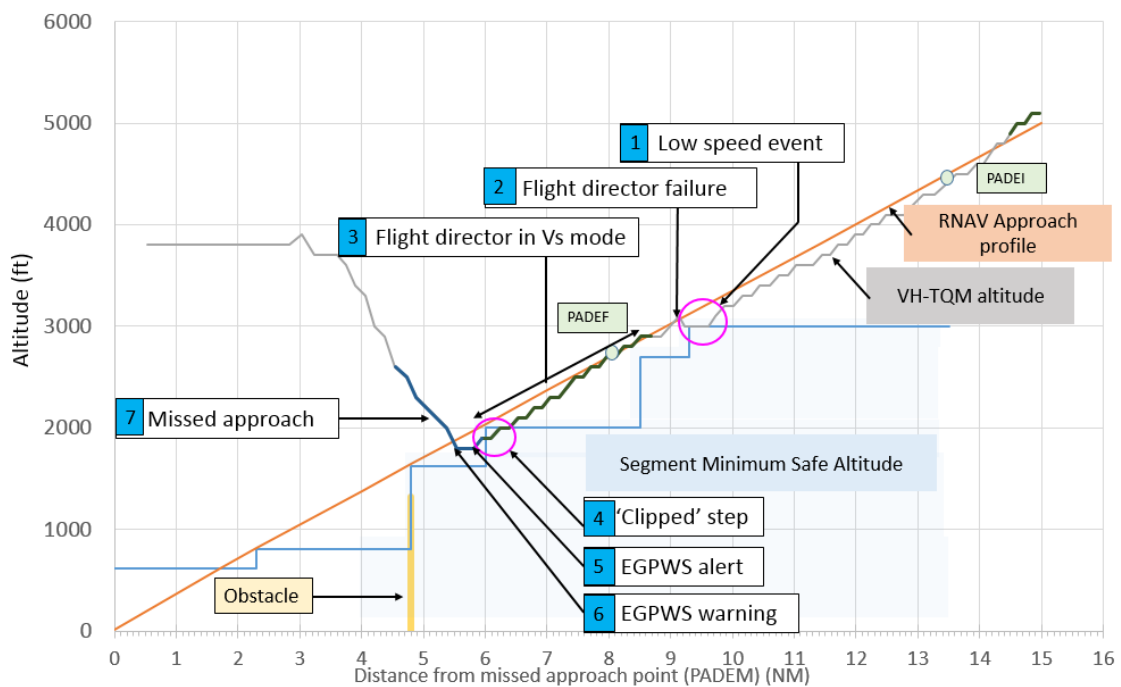
Figure 3: Plot of radar data showing vertical profile of runway 30 RNAV approach and aircraft descent

The aircraft deviated below the published approach path and, at about 6.1 NM prior to PADEM, descended 100 ft below the segment minimum safe altitude of 2,000 ft, by 'clipping' the step in the minimum safe altitude profile ('4' in Figure 3).

At 6 NM to PADEM, the segment minimum altitude decreased to 1,620 ft and although the aircraft was below the approach profile, it did not descend below that altitude restriction.

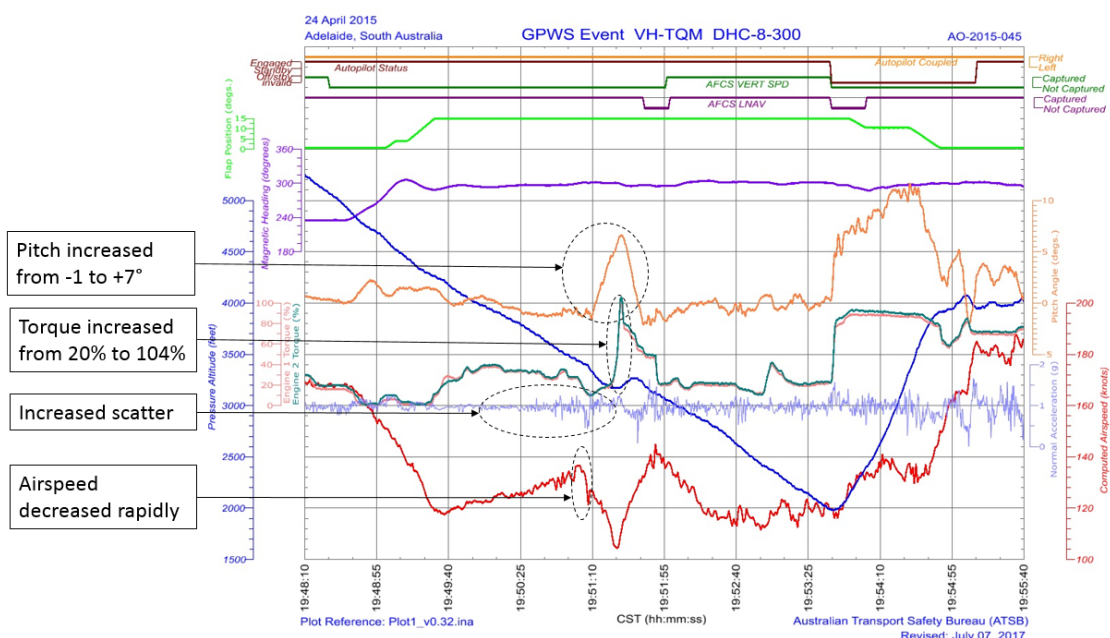
Figure 4: Extract of flight data highlighting the speed, pitch and torque changes

Recorded flight data (Figure 4) showed a reduction in engine torque concurrent with a decrease in airspeed (red) from 136 kt to 121 kt over 6 seconds from 1951:00, and then to 104 kt over the next 19 seconds. The airspeed reduction occurred following a reduction in torque with the aircraft configured for landing (landing gear and flaps extended). The change in torque over that period was likely due to pilot input.

As the airspeed decreased through 121 kt, the aircraft pitched up (orange) from -1° to $+7^{\circ}$ over 12 seconds and the aircraft's rate of descent increased from 1,440 ft per minute to 2,280 ft per minute, before again decreasing. The engine torque (green) increased during the same period from about 20 per cent to 104 per cent before decreasing. That was consistent with the PF's recollection that she had momentarily increased torque to maximum because she had been used to flying the Q400 which had a detent on the torque lever, whereas the Q300 did not.

From 1950:14, the normal acceleration parameter (G) showed increasing scatter, consistent with the presence of turbulence (Figure 4). The shorter period fluctuations in airspeed were also indicative of turbulence.
