# Flight path management and descent toward the lower limit of controlled airspace involving Airbus A320, VH-VND

On approach to Melbourne Airport, Victoria | 11 February 2015

**ATSB Transport Safety Report**  
Aviation Occurrence Investigation  
AO-2015-018  
Final – 23 February 2018

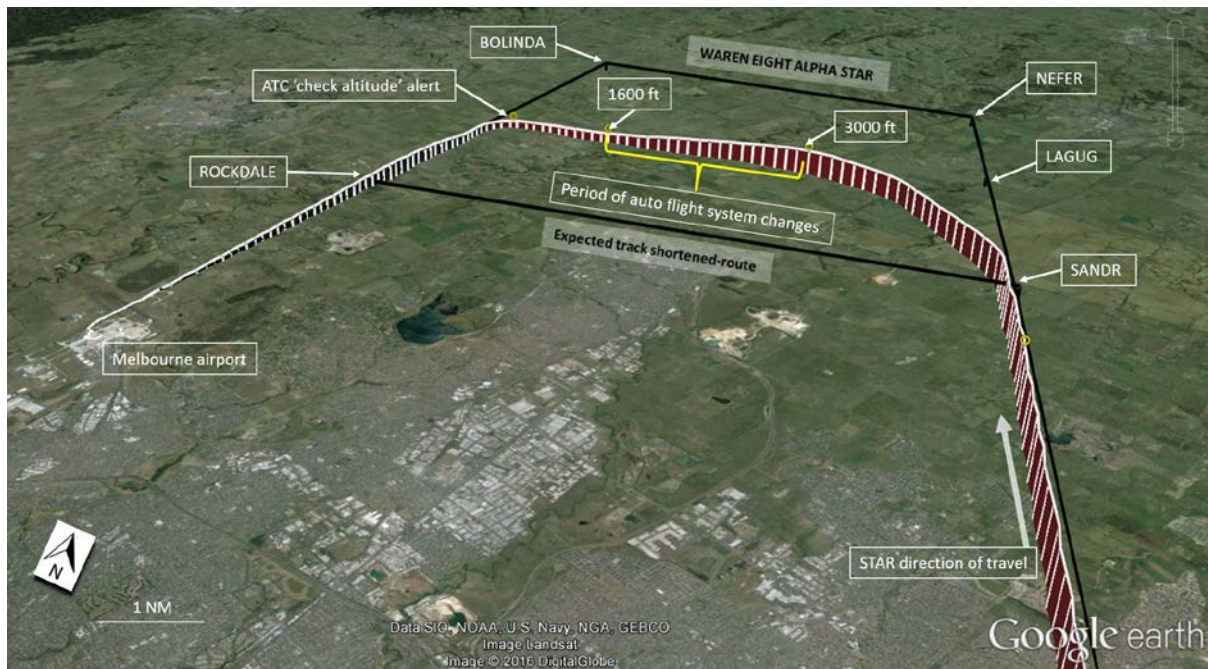
**Figure 1: Recorded flight route of VH-VND showing approximate period where flight plan modification and mode changes were conducted**

At 1748, which coincided with the aircraft being located at about the SANDR waypoint, ATC advised the flight crew that the STAR was cancelled and to turn left onto a heading of 290°M (Figure 1). To comply with ATC heading and descent instructions, the flight crew used the aircraft's heading and vertical speed/flight path angle (V/S FPA) mode selectors, both located on the aircraft's Flight Control Unit (FCU). The use of the aircraft's selected modes allowed the flight crew to vary the aircraft's lateral track and descent manually.

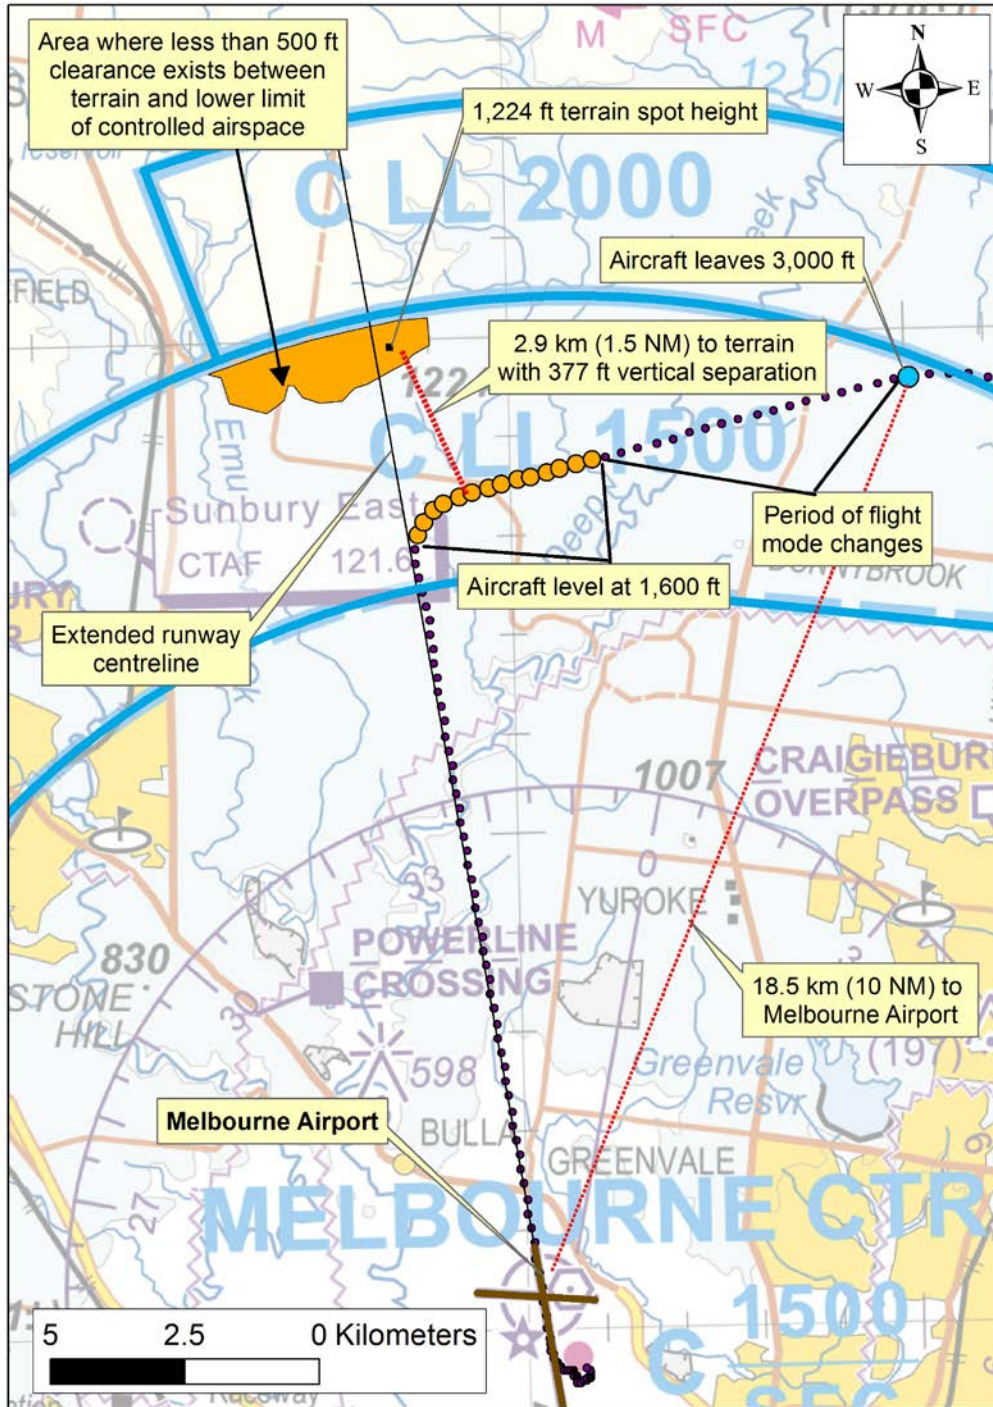
Figure 2: Flight path and altitude of VH-VND (black and orange dots) relative to the controlled area steps and terrain during the visual approach to Melbourne Airport

At 1751:59, the tower controller issued a safety alert<sup>8</sup> to the flight crew to check their altitude, as the aircraft was below profile altitude and had entered the 500 ft vertical buffer at the base of the control area (CTA) step, reducing separation with terrain and any aircraft operating outside controlled airspace.

After landing, the captain contacted Melbourne Air Traffic Control to discuss the altitude safety alert. They advised that the aircraft had descended to 1,600 ft, which was below the required altitude for flight in that section of CTA. The minimum altitude in that section of CTA for aircraft that were not visual was 2,700 ft, and for aircraft that were visual, it was 2,000 ft as they were required to maintain a 500 ft buffer above the 1,500 ft CTA lower limit (Figure 2).

The aircraft continued descent below the recommended visual approach profile and entered the 500 ft vertical buffer at the base of the CTA step, reducing separation with terrain and any aircraft operating outside controlled airspace. The ability of the flight crew to assess the aircraft's relative position accurately and manage the flight path profile was reduced after being vectored off the pre-programmed shortened route. The subsequent involvement of both flight crew to reprogram the FMGS and the conduct of various flight deck activities created a distraction. This increased workload, and distracted the crew from the primary task of monitoring, assessing, and managing the aircraft's approach path.
