Signal RS57 passed at danger, involving suburban passenger train 1W33

Roma Street Station, Brisbane, Queensland | 5 September 2017

ATSB Transport Safety Report
Rail Occurrence Investigation
RO-2017-012
Final – 6 March 2018

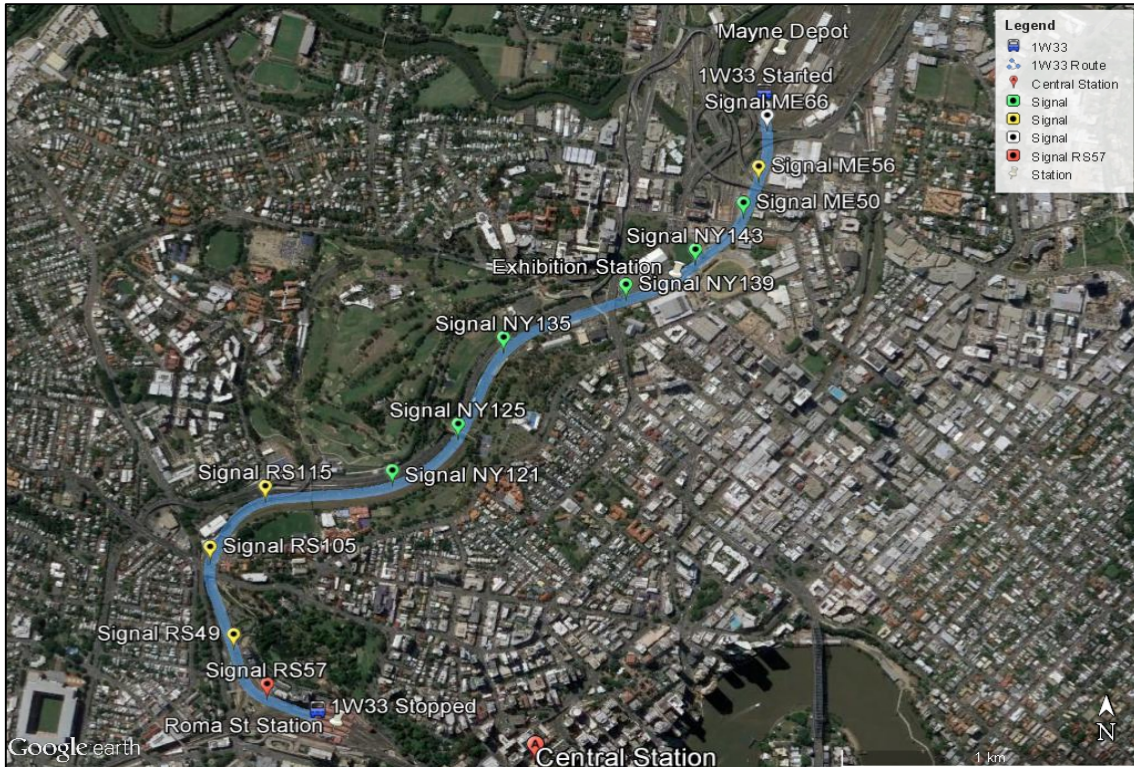
Figure 1: Train 1W33 route from Mayne depot to Roma Street Station, Brisbane, Queensland

The penultimate signal prior to Roma Street Station (RS49) displayed a restricted indication (flashing yellow aspect¹) for the driver. As train 1W33 approached signal RS49, the driver slowed down in preparation for a 25 km/h speed board placed adjacent the signal. The driver recalled that the Automatic Warning System (AWS)² generated an in-cab alert of the restricted signal RS49 indication ahead and that he acknowledged the AWS alert. At about 1628, train 1W33 continued past signal RS49 towards signal RS57, just west of Roma Street Station. Signal RS57 was displaying a stop indication (red aspect) to allow other train movements to clear Roma Street Station before train 1W33 would be authorised to continue.

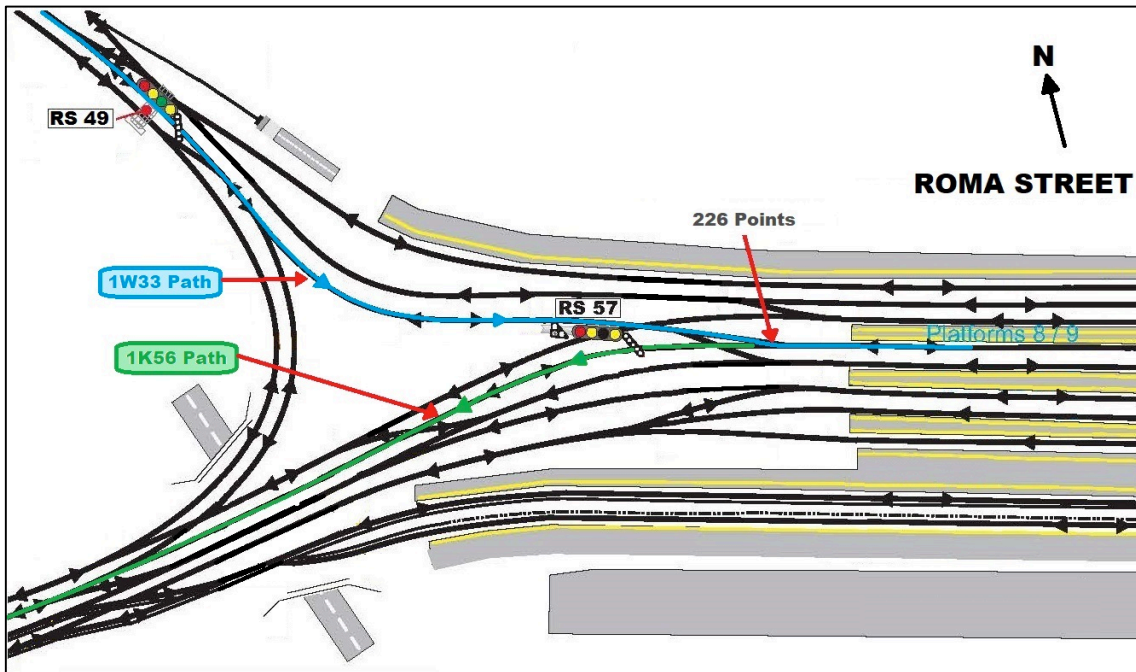
Figure 2: Western end Roma Street Station layout, Brisbane, Queensland

Meanwhile, passenger train 1K56 was preparing to depart Roma Street Station from platform 8 (Figure 2). At about 1628, train 1K56 departed Roma Street Station travelling west towards the Springfield line via points 226 set normal.³ About 11 seconds after train 1K56 cleared 226 points, train 1W33 proceeded past signal RS57 at danger. Train 1W33 ran through⁴ points 226 about 26 seconds after passing RS57 at danger and travelled east into platform 8.

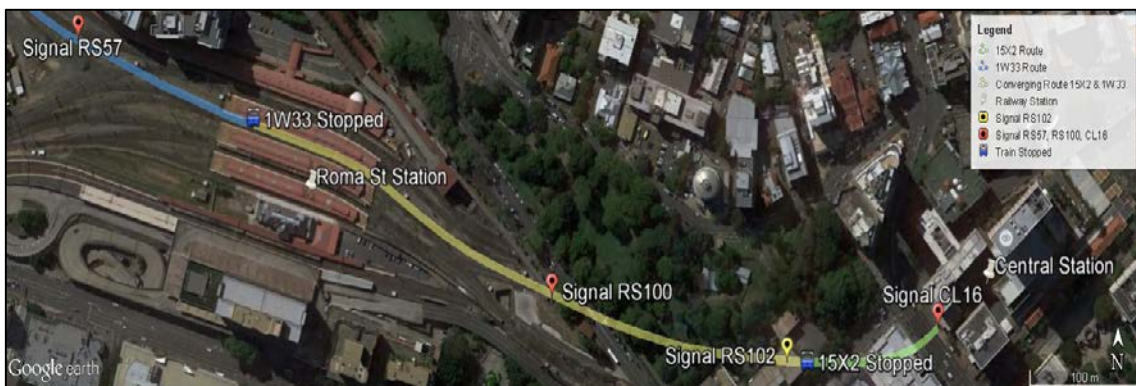
Figure 3: Train 15X2 route from Central Station towards eastern entry of Roma Street Station, Platform 8

Train 15X2 came to a stop approximately 25 m prior to signal RS102. Signal RS102 is the signal before the eastern entry signal (RS100) into platform 8 at Roma Street Station (Figure 3). Signal RS102 was displaying a single yellow caution⁵ indication at this time due to signal RS100 displaying a stop indication. The signal interlocking system had restored Signal RS100 to stop when train 1W33 entered platform 8 at Roma Street Station. The two converging trains stopped approximately 550 m from each other.

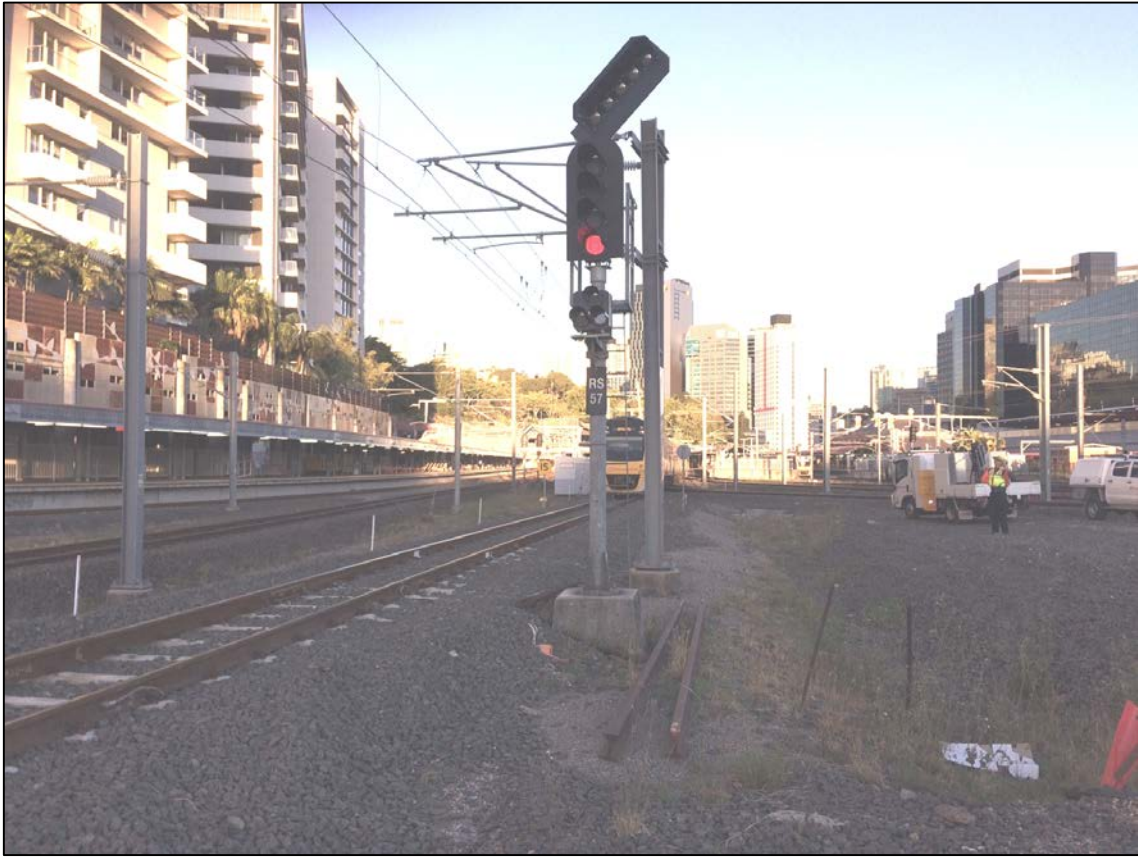
Figure 4: Signal configuration of RS57, at Roma Street Station, Brisbane

Signal RS57 was a 4-aspect⁸ main line signal fitted with a junction indicator and low speed shunt signal (Figure 4). Signal RS57 authorised train movements towards signals RS83 or RS85 located at the eastern end of Roma Street Station (platforms 8 and 7).

Signal RS57 was located at the end of a left hand curve adjacent to Roma Street Station on the right hand side of the track in the direction of travel. Due to the curvature of the track and the placement of the overhead catenary masts, RS57 signal sighting was limited to approximately 103 m.

Queensland Rail managed the limited signal sighting with the application of a 25 km/h speed restriction from signal RS49 leading up to signal RS57 and LED signal lamps had recently been installed. In addition, other controls have been considered and implemented as part of Queensland Rail's ongoing signal sighting reviews.

The ATSB found that the configuration and sighting of signal RS57 did not contribute to this incident.

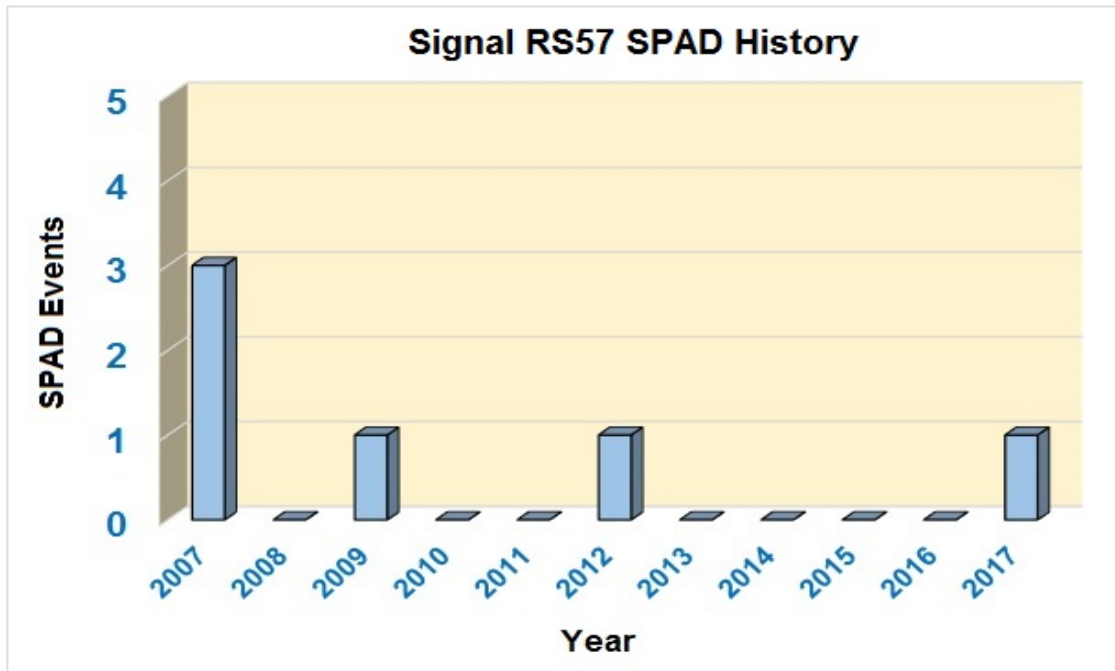
Figure 5: Signal RS57 10 year SPAD history

The ATSB found that signal RS57 had been passed at danger on six occasions since 2007. Queensland Rail records for these SPAD events noted varying sources of driver distraction as the causal factor for each event.

Following the three SPAD’s in 2007, Queensland Rail identified RS57 as a multi-SPAD signal and had undertaken SPAD risk studies and regular reviews of the signal sighting. These risk studies and reviews led to the identification and, where accepted, the implementation of additional controls. This incident is the first time RS57 had been passed at danger in five years.

- A qualitative analysis of the SPAD scenarios at RS57 using a bowtie model.
- Present a health and wellbeing strategic plan to the Executive Leadership Team which includes an organisational resilience and psychological wellbeing education and awareness program.
