ATSB Investigation No. A0-2017-109

Loss of control + collision in terrain involving
UH-BAA HOBART 7/11/17

**LOSS OF CONTROL DURING HYDRAULIC PRESSURE
FAILURE TRAINING
EUROCOPTER AS350 BA HELICOPTER, C-GPHN
HÉLI-EXCEL INC.
SEPT-ÎLES AIRPORT, QUEBEC
03 FEBRUARY 2013**

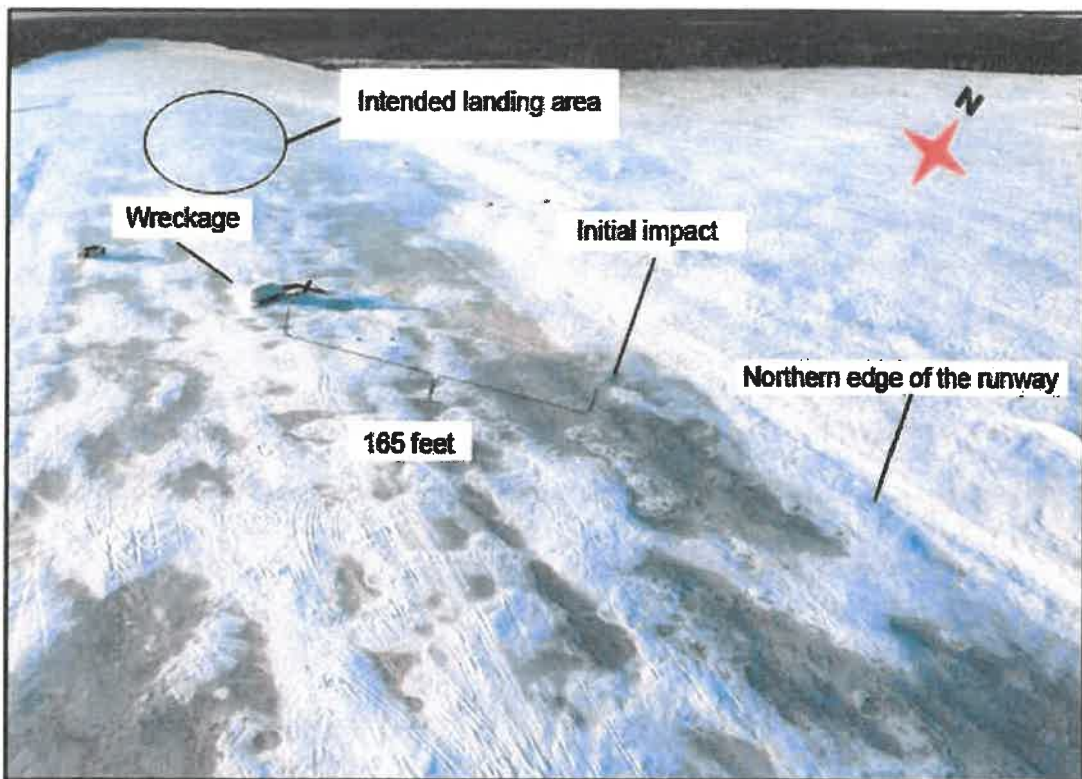
Figure 2. Aerial view of the accident site

The aircraft struck the ground in a nose-down attitude of about 45° and a left bank angle of about 100°. The first point of impact was near the northern edge of Runway 13/31 (Figure 2). The main rotor blades struck the runway first, followed by the nose of the helicopter. The aircraft slid approximately 165 feet on its left side toward the centre of the runway before coming to a stop on Runway 13/31 about 1000 feet from the threshold of Runway 13.

The collision with the ground caused major damage to the aircraft. The front part of the aircraft, including the nose, windshield, canopies and instrument panel, was torn off. The 2 pilot seats separated from their anchors. The impact caused the tail boom to bend upward and to the left; it sustained an almost full-circumference fracture about 24 inches in front of the horizontal stabilizer. The top of the fuel tank was cracked along the left side from front to rear. The 2 tail rotor blades were not damaged. The engine was still running after the crash. The observer pilot seated at the rear of the cabin had to pull the FUEL SHUT OFF VALVE lever to shut it off.

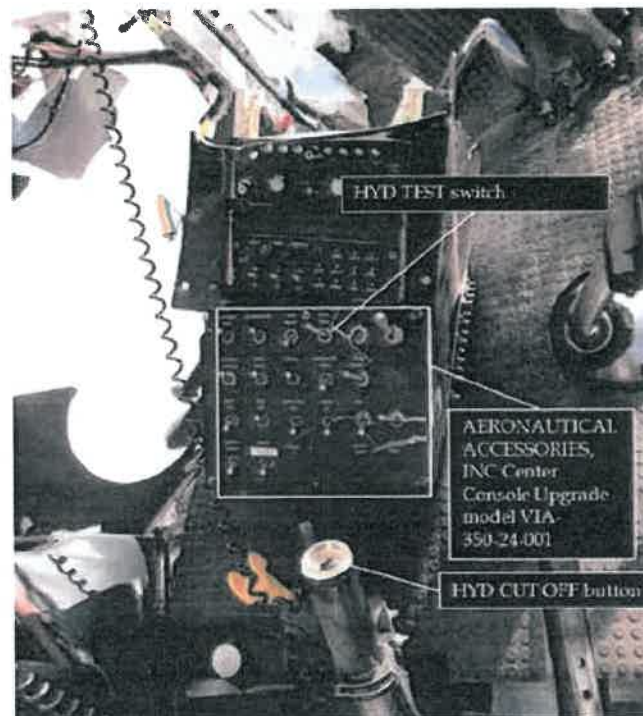
Figure 4. C-GPHN centre console, rear-to-front view in cockpit

The HYD TEST switch is located next to other similarly shaped switches (Figure 4). It was determined that the HYD TEST switch can be inadvertently actuated during flight because of its proximity to other switches. In November 2005, Eurocopter issued Service Bulletin SB 67.00.32 which recommended the installation of a retractable guard/cover (protection flap) over the switch on Honeywell centre consoles to prevent the unintentional operation of the HYD TEST switch.

The HYD TEST toggle switch on C-GPHN's Aeronautical Accessories, Inc. centre console is not of a specific shape and is not equipped with a protection flap, or have the "pull-to-unlock" design. Since AD CF-2007-19R1 applies to AS350s equipped with a Honeywell centre console, C-GPHN was not required to comply with the corrective measures set out in the AD.

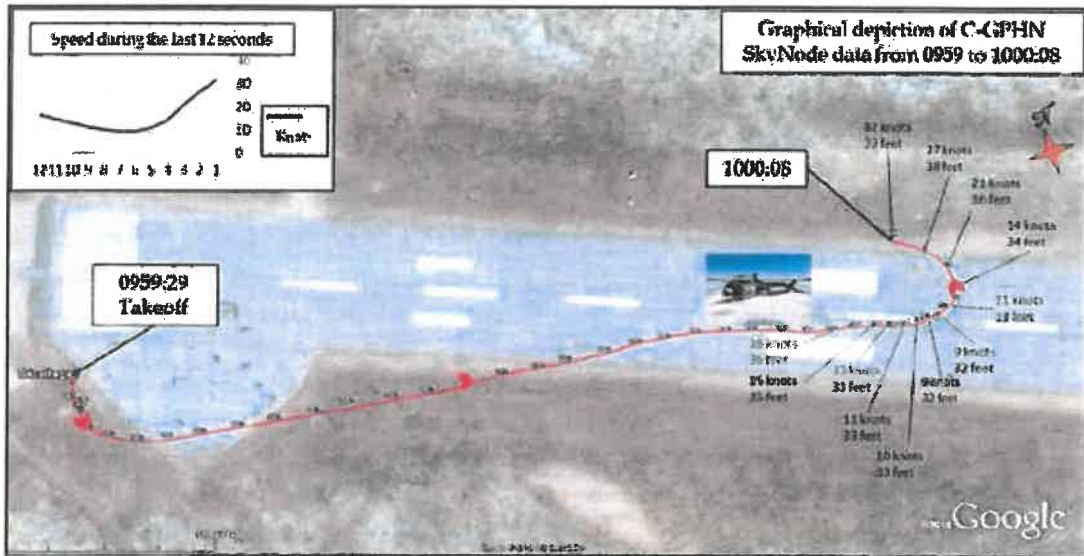
Figure 7. Flight path during last hydraulic failure drill (Source: Google Earth, with TSB annotations)

The SkyNode memory contained data from 1345:57 UTC⁹ to 1500:08 UTC. The SkyNode recorded data every 2 minutes, except for the last 2 minutes of the flight when data were recorded every second. With these data, the approximate flight path could be reconstructed (Figure 7). The last recording indicates that the helicopter was 39 feet above ground level (agl) at a groundspeed of 32 knots (Figure 8).

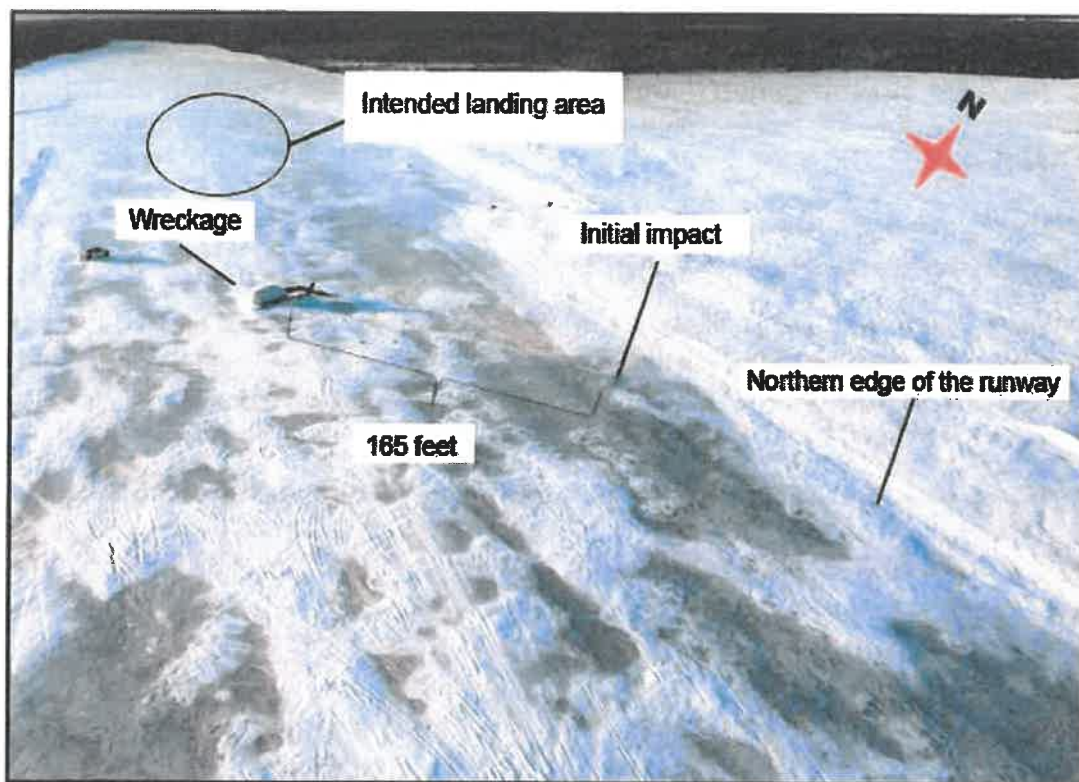
Figure 2. Aerial view of the accident site

The aircraft struck the ground in a nose-down attitude of about 45° and a left bank angle of about 100°. The first point of impact was near the northern edge of Runway 13/31 (Figure 2). The main rotor blades struck the runway first, followed by the nose of the helicopter. The aircraft slid approximately 165 feet on its left side toward the centre of the runway before coming to a stop on Runway 13/31 about 1000 feet from the threshold of Runway 13.

The collision with the ground caused major damage to the aircraft. The front part of the aircraft, including the nose, windshield, canopies and instrument panel, was torn off. The 2 pilot seats separated from their anchors. The impact caused the tail boom to bend upward and to the left; it sustained an almost full-circumference fracture about 24 inches in front of the horizontal stabilizer. The top of the fuel tank was cracked along the left side from front to rear. The 2 tail rotor blades were not damaged. The engine was still running after the crash. The observer pilot seated at the rear of the cabin had to pull the FUEL SHUT OFF VALVE lever to shut it off.

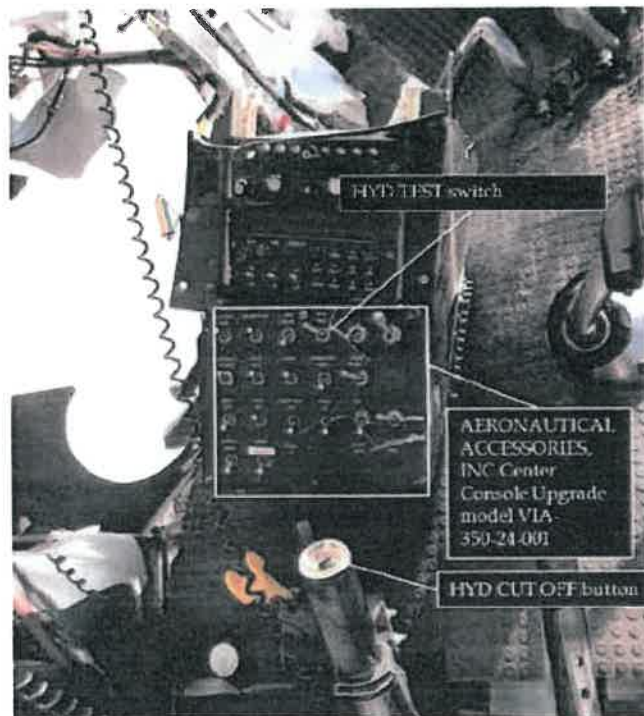
Figure 4. C-GPHN centre console, rear-to-front view in cockpit

Accessories, Inc. centre console is not of a specific shape and is not equipped with a protection flap, or have the "pull-to-unlock" design. Since AD CF-2007-19R1 applies to AS350s equipped with a Honeywell centre console, C-GPHN was not required to comply with the corrective measures set out in the AD.

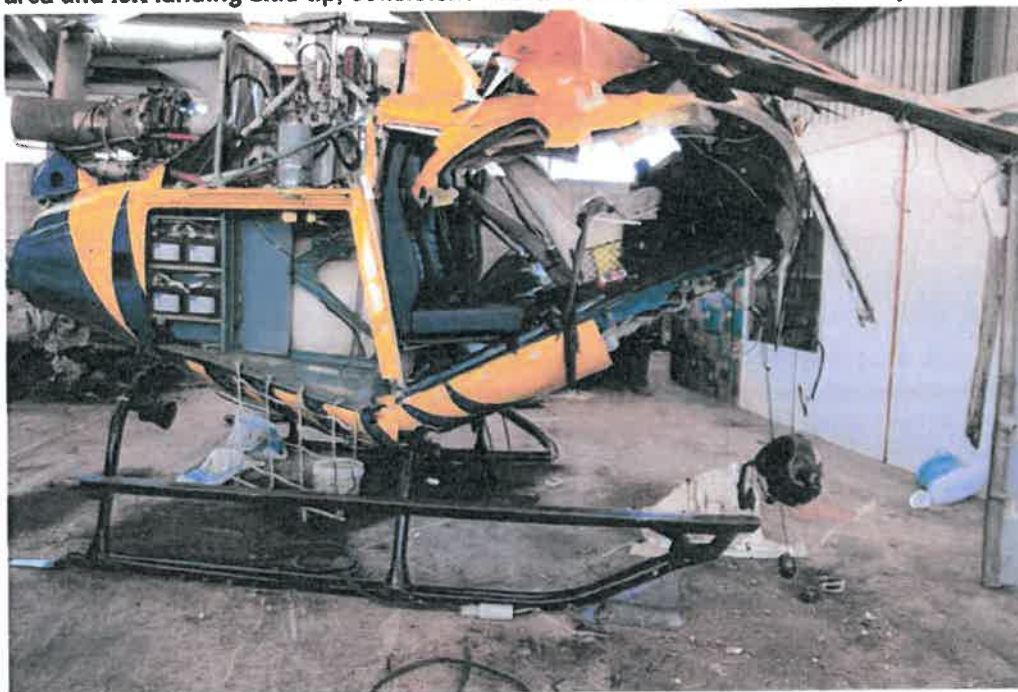
Figure 2: Damage to the helicopter showing significant impact damage to the cockpit area and left landing skid tip, consistent with a left nose-down attitude on impact.

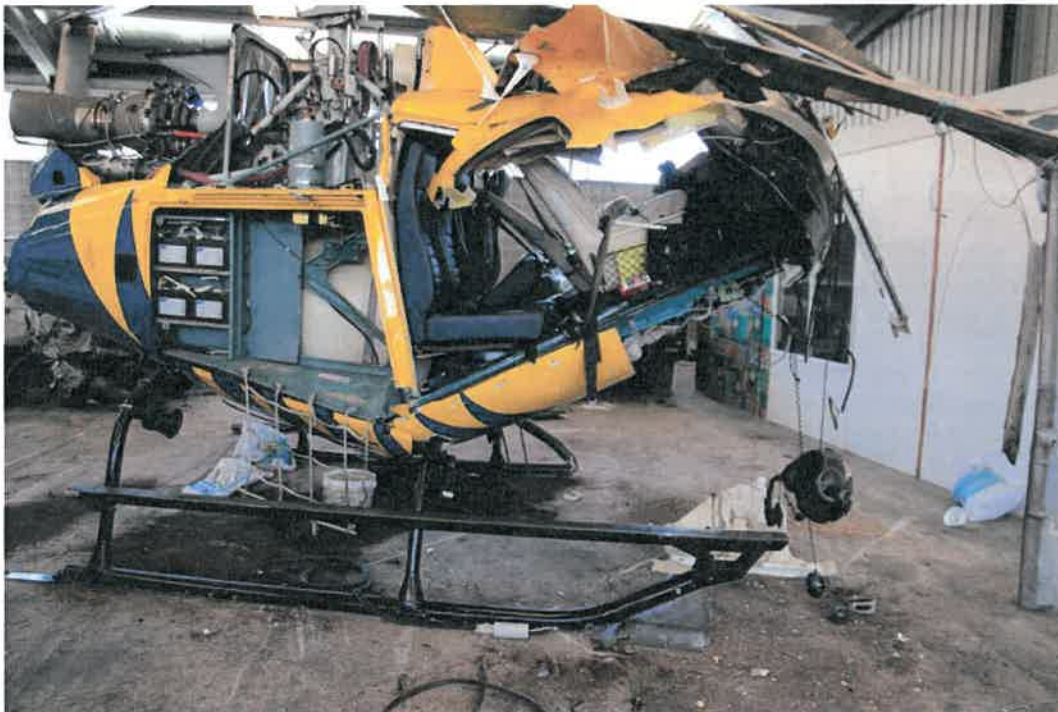
Figure 2: Damage to the helicopter showing significant impact damage to the cockpit area and left landing skid tip, consistent with a left nose-down attitude on impact.
