Descent below minimum descent altitude involving a Boeing 737-300, VH-NLK

Kosrae International Airport, Federated States of Micronesia | 12 June 2015

ATSB Transport Safety Report
Aviation Occurrence Investigation
AO-2015-066
Final – 16 March 2018

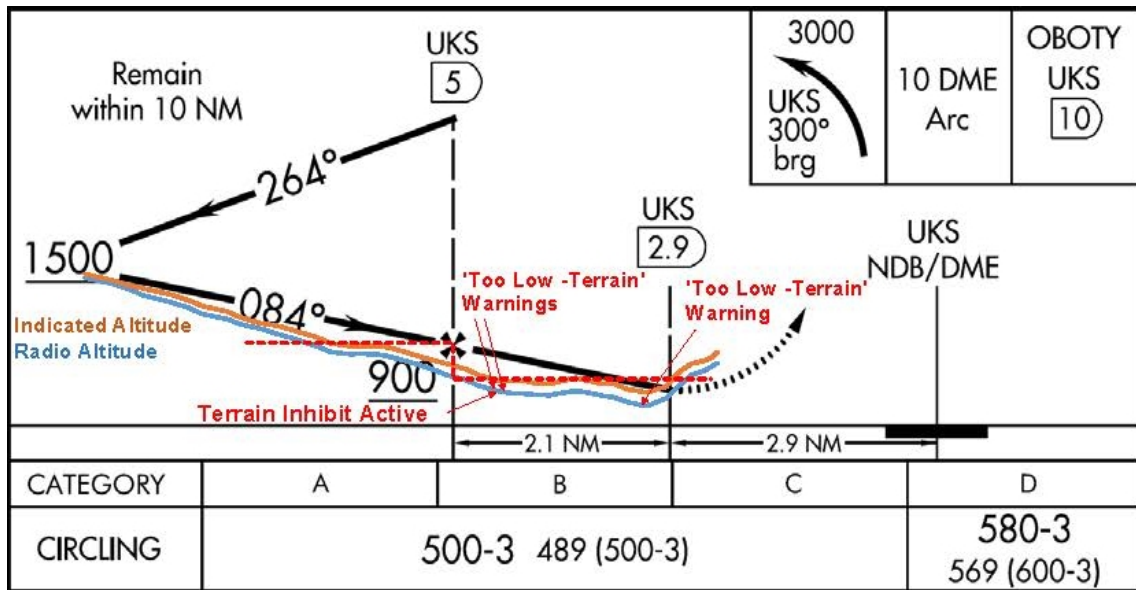
Figure 2: Approach profile annotated with indicated and radio altimeter readings highlighting the difference between the displayed and actual altitudes plus the three EGPWS Terrain Clearance Floor alerts and the Terrain Inhibit alert cancellation activation.

As the aircraft descended to the minimum descent altitude for the approach of 500 ft, the captain selected the altitude hold (ALT HOLD) mode to level the aircraft at 500 ft indicated altitude. At 0903:13, an Enhanced Ground Proximity Warning System (EGPWS) Terrain Clearance Floor (TCF) alert (see section titled *EGPWS alerts*) sounded, and lasted for 5 seconds (Figure 2). The aircraft was over water, at 368 ft radio altitude.¹⁰ The crew reported that they were in visual meteorological conditions (VMC) at night, with the runway lights in sight. The crew stated that, at the time, they believed the EGPWS alert was due to a ‘map shift’ in the aircraft’s navigation position (see section titled *The navigation function of the flight management system*). The flight crew selected ‘terrain inhibit’, which cancelled the current EGPWS TCF alert. The crew were not aware that the EGPWS had its own internal GPS.

At 0903:19, the aircraft was at 4.31 DME, 480 ft indicated altitude and 340 ft radio altitude, and descending at about 313 fpm, when the EGPWS TCF alert again sounded, and lasted for 12 seconds. The aircraft maintained 480 ft indicated altitude for about 12 seconds, before descending again.

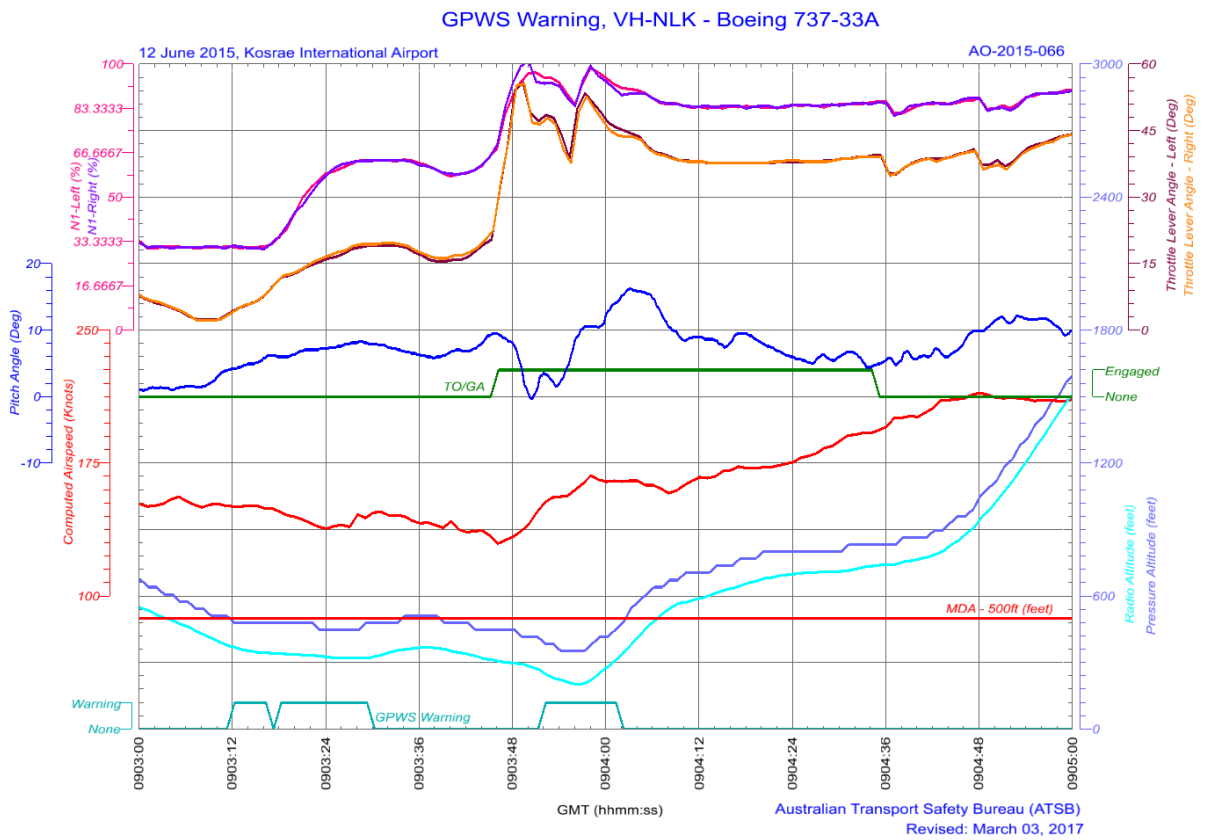
Figure 3: Selected flight data recorder data plot

At 0904:04, the flaps were retracted to 15° and the aircraft reached its maximum pitch up angle of 16°. Two seconds later, the flaps were retracted to 10°. From the time the captain set the thrust to TOGA until the aircraft was stabilised on the missed approach path (at about 0905), the recorded aircraft pitch angle varied from -0.35° to +16°.

On the decision to go-around, the captain pressed the takeoff/go-around button only once instead of twice, which resulted in a reduced thrust rather than a full power go-around. The aircraft was pitched up initially to 15° but was then pitched back down to increase the decaying airspeed. Soon after, the aircraft was at its lowest height of 200 ft by the radio altimeter. Given the increased workload of the crew, and the effects of stress and fatigue on the captain, the aircraft state, airspeed and attitude was not effectively monitored by either crew member following the go-around decision. Therefore, the execution of the go-around task and its attendant decision making was not performed effectively.

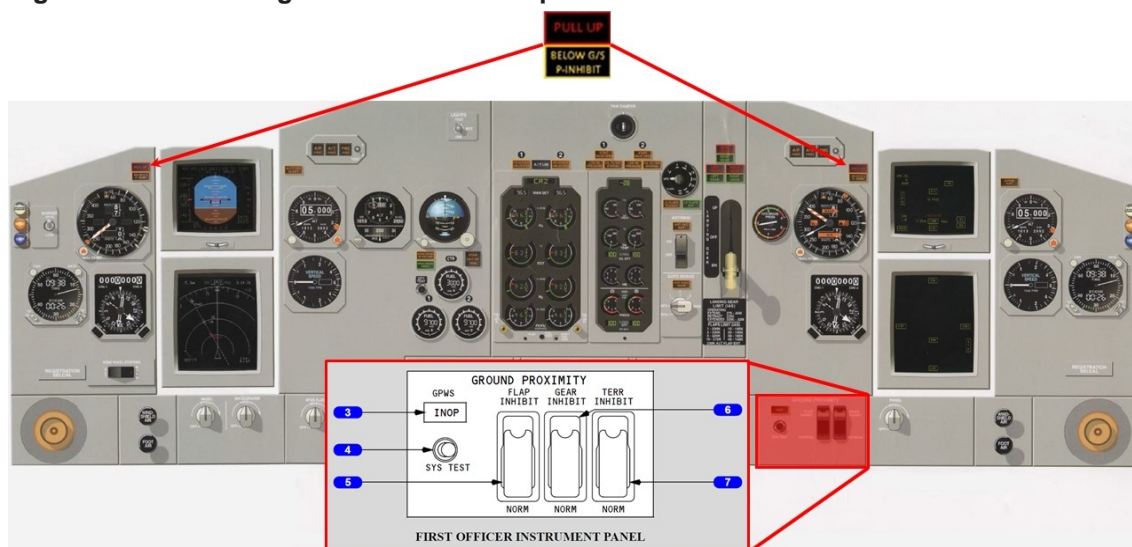
Figure 4: B737-300 flight deck instrument panel EGPWS indicators and controls

There were two EGPWS indicators and controls relevant to the unit's operation. The instrument panel (Figure 4) includes the PULL UP warning light in the field of vision of both pilots.

The lower right section of the instrument panel included the GPWS controls. The terrain inhibit switch (7) in the NORM (guarded position) enabled EGPWS features. When selected to TERR INHIBIT, terrain/obstacle alerting was inhibited. Aircraft flight data identified that the first EGPWS alert had an associated inhibit signal. This inhibit signal was due to the flight crew selecting the terrain inhibit switch to ON following the first warning alert.

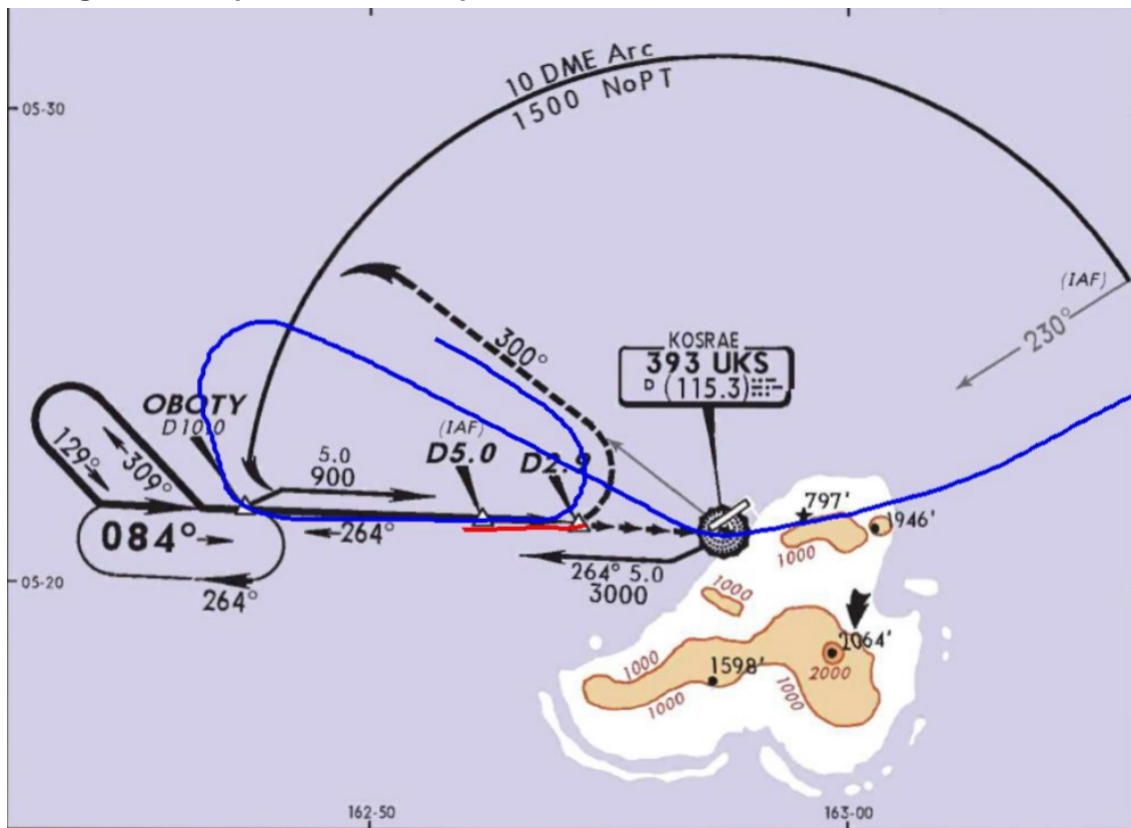
Figure 5: The flight data recorder data is shown below in blue and the EGPWS data is in red showing that, prior to the go-around, there was a 1.0 NM positional error to the flight management computer determined position.

The FMS did not have access to the EGPWS GPS information. The FMS recorded position of the aircraft at the time of the EGPWS alerts was compared against the position data recorded by the EGPWS. From the image below (Figure 5), it is evident that there was an FMS position error (approximately 1,065 m NW of the GPS position) at the time of EGPWS alerts. After the go-around, the FMS data appears to drift significantly (2,090 m north-north-west at landing), providing less reliable position information. It is important to note that the FMS derived position data was not required for the approach that was undertaken.
