Signal ME45 passed at danger, involving suburban passenger train 1A21

Bowen Hills, Brisbane, Queensland, 26 August 2017

ATSB Transport Safety Report

RO-2017-010

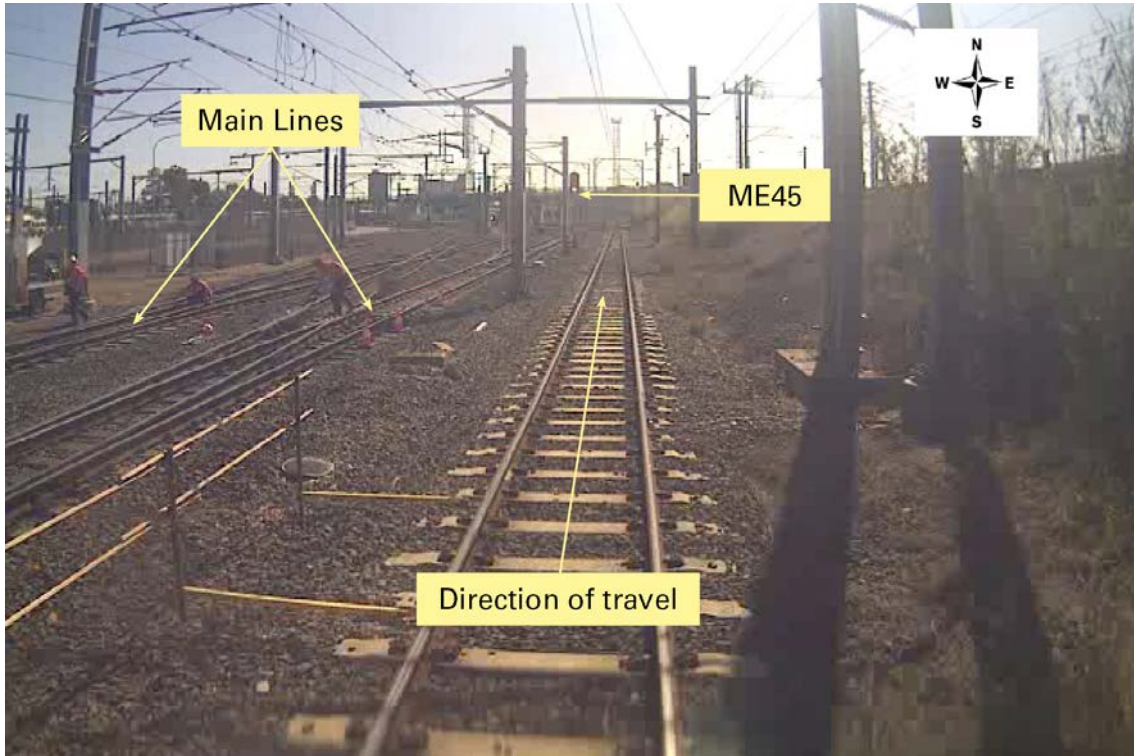
Figure 1: CCTV footage from the driving compartment of train 1A21

As the train traversed a sweeping right hand curve, the driver then observed maintenance staff working on the main lines (Figure 1). To warn the workers of the approaching train, the driver sounded the train horn on two occasions before one of the workers acknowledged him. As the train neared the workers and signal ME45, the AWS activated, warning the driver of the restricted signal indication (red aspect) ahead. The driver acknowledged the AWS, but did not respond to the signal. After passing the workers, the driver recalled looking ahead, sighting other maintenance staff in the distance, and then observing the red aspect of signal ME45. The driver responded by fully applying the train brake.

Image shows maintenance staff working on the Main Lines and signal ME45 in the foreground. Image supplied by Queensland Rail – Annotated by the ATSB.

As the train traversed the sweeping curve, it is likely the driver's attention was diverted from the primary task of observing signals toward other activities adjacent to the track. That may have influenced the driver's inappropriate response to the AWS indication and led to the train passing the signal at STOP.
