Derailment of empty coal train NB901

Kankool, New South Wales | 15 February 2015

ATSB Transport Safety Report
Rail Occurrence Investigation
RO-2015-004
Final – 6 April 2018

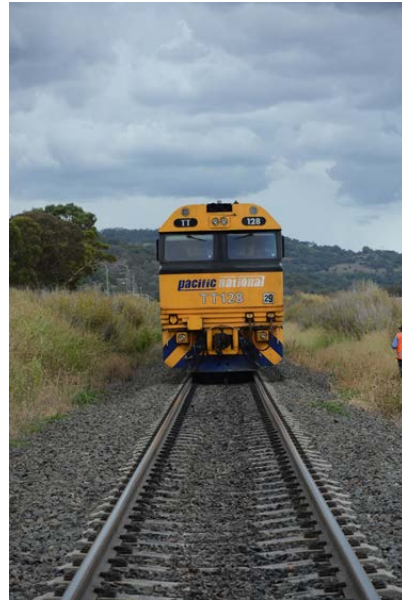
Third Locomotive of NB901

Of the 19 derailed wagons, 18 sustained severe damage and were decommissioned and the third locomotive received minor damage. The derailment damaged approximately 1,900 metres of track and 2,377 concrete sleepers. This included the total destruction of 115 metres of track, three sets of points and 1393 sleepers. The train crew did not report any injuries.

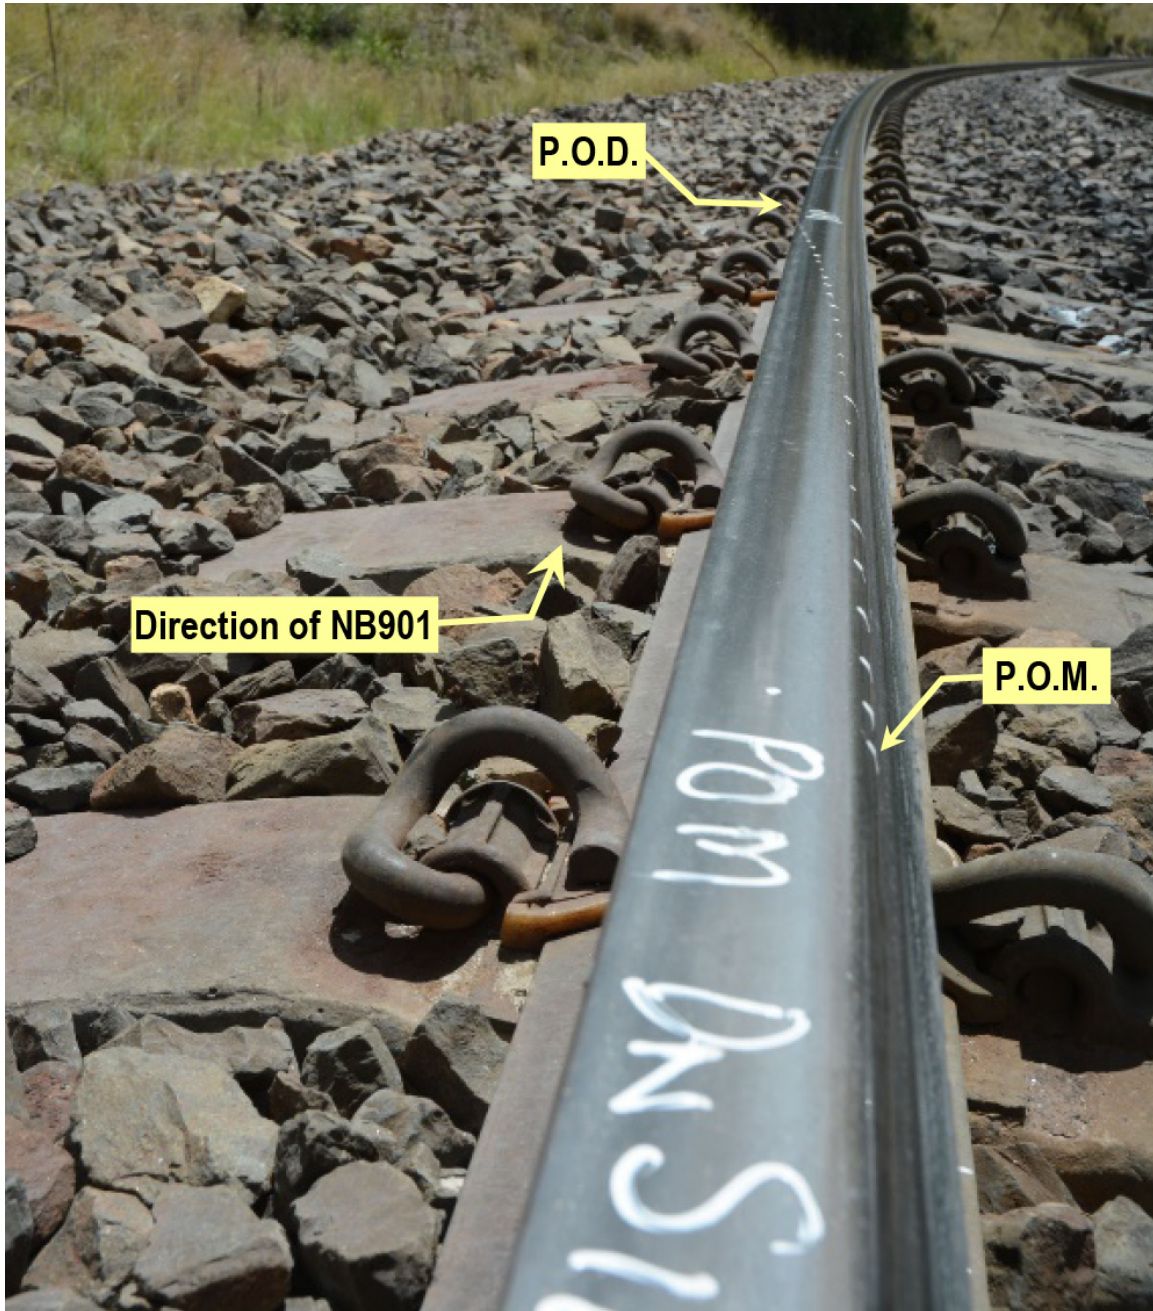
Figure 3: Point of mount and point of drop on the down side rail

- A point of mount (POM) on the down rail at 366.811 km, shortly after it had transitioned into a 240 metre radius curve, indicated that NB901 had derailed after climbing the rail head at that point. (Figure 3) The wheel mark continued for approximately one and a half metres to a point of drop (POD) where the derailed wheels had dropped from the railhead onto the sleepers and track bed.

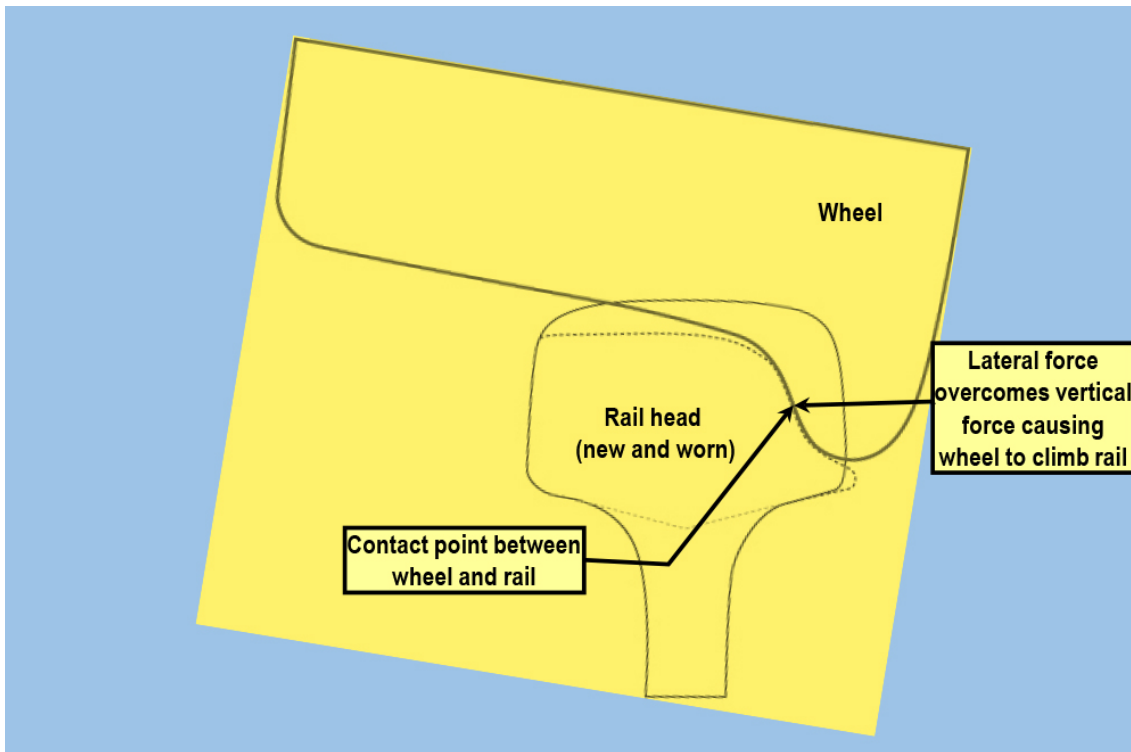
Figure 4: Diagram of rail wear, contact point and forces at POM

- Around the area of the POM, significant wear was observed to the gauge (inside) face of the down side rail. (Figure 4) Although the wear was still within prescribed ARTC limits, the worn gauge face was inducing full flange contact between the wheels and the railhead as trains traversed the curve. Similar rail wear conditions were also observed on the opposite up side rail on the reverse 240 metre curve prior.

Despite the refurbishment of the rails in August 2014, the down (outside) rail at the POM had worn heavily on the gauge face and railhead. Although still within wear limits, the wear pattern indicated that the wheels were making full flange contact on the gauge face while traversing the curve.

Subsequent measurement of the railhead wear indicated a 27% material loss, this was within ARTC's 32% maximum wear criterion. Further, the gauge face of this rail had worn to an angle of 16.5 degrees off vertical. Although within ARTC's 26-degree criterion, the angle promoted wheel climbing due to the lack of clearance between the flange tip and the rail. Subsequently, when the train compressed, the combination of elevated lateral and longitudinal forces, a light wagon weight and the full flange contact on the outside rail all increased the likelihood for a wheel to climb. The likelihood for wheel climb is particularly greater on wheels with full thickness flanges where flatter profile angles and less flange/rail clearance promote climbing on the railhead in comparison to worn wheels. The flanges on the L3 wheel of RHDH 99071M were near full thickness.

The records also indicated that the rails were programmed for replacement due to railhead wear in December 2014. However, this had been deferred to ARTC's 2015 – 2016 re-railing program. The rails were replaced post incident during track repairs.

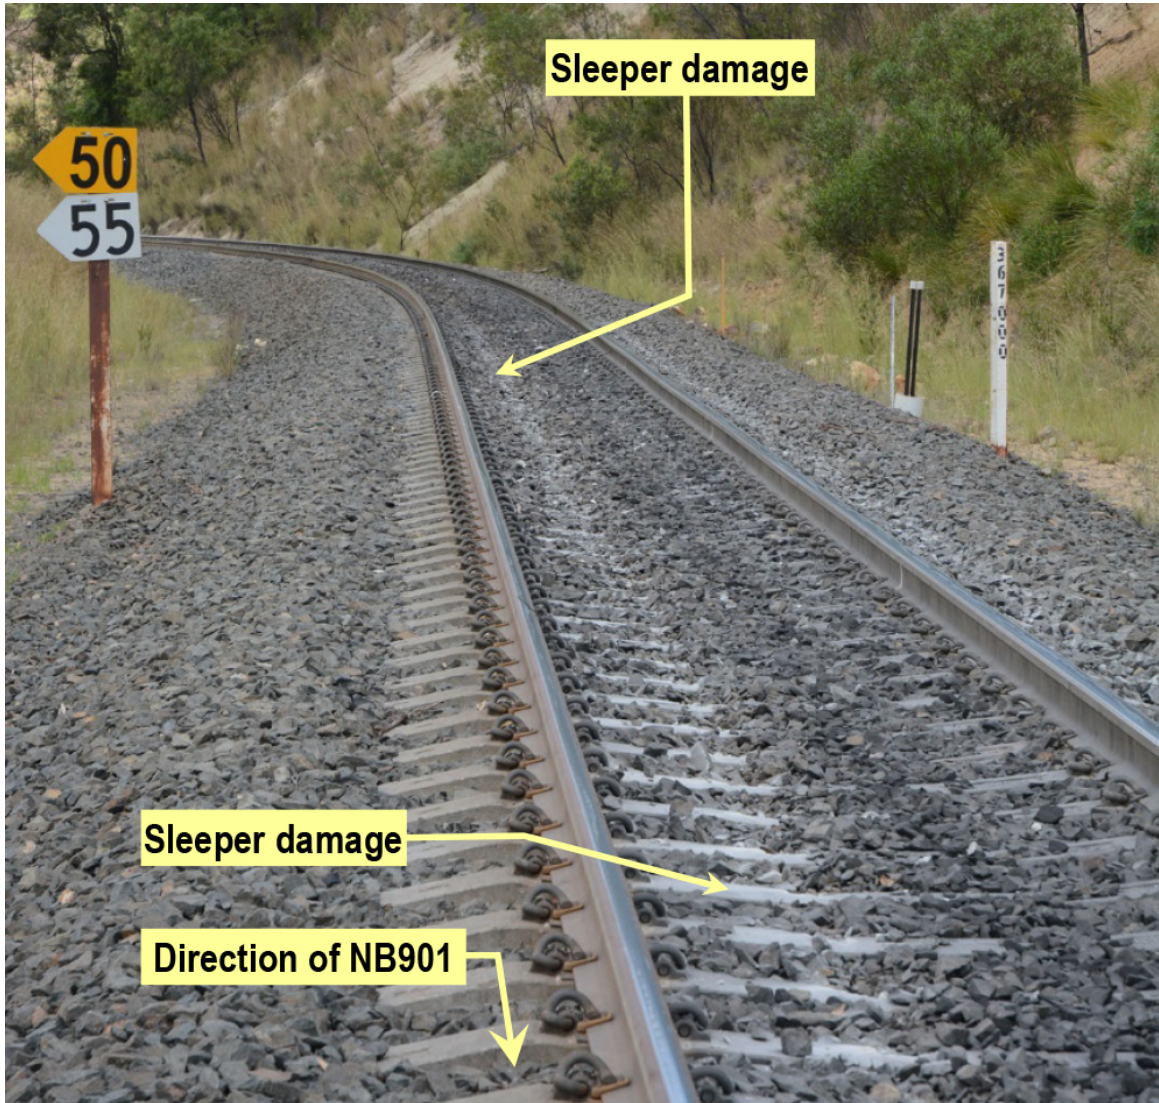
Figure 5: Sleeper damage caused by dragging bogie

- There were no rail lubrication systems fitted to this section of track or any evidence of recent rail lubrication leading up to the incident site. This was despite recommendations made in an ARTC report for higher axle loads in the Hunter Valley that the numbers and placement of lubricators be assessed to optimise lubrication effectiveness over the section between 357.000 to 374.000 kms (Pages River to Willow Tree)
- The concrete sleepers between the POM and No.51 catchpoints exhibited chipping on their approach side consistent with the derailed wheels running along the track. (Figure 5)

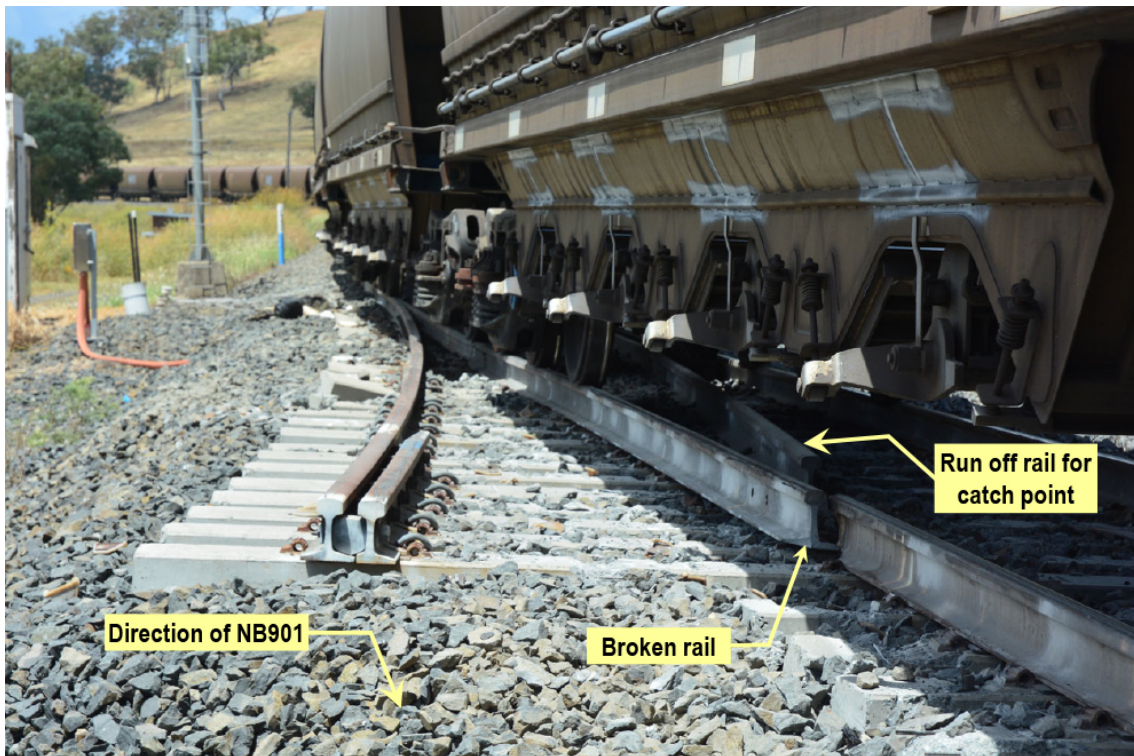
Figure 6: Damage at No.51 Points

- A number of timber sleepers prior to No.51 catchpoints also exhibited flange marks on the top of the sleepers and corners of the base plates consistent with derailed wheels running over the sleepers
- In the vicinity of No.51 catchpoints:
 - the electric point machine and drive rods for the catchpoint suffered extensive damage
 - the tip of the switch blade for the catchpoint was shattered
 - the up rail had broken at a weld.
- Most of the damage to No.51 catchpoints occurred when the derailed wheels tracked on the inside runoff rail of the catchpoints, breaking the up rail past the catchpoints and directing the following wagons off the track towards the cutting embankment. (Figure 6)
- No.52 and No.53 points were destroyed.

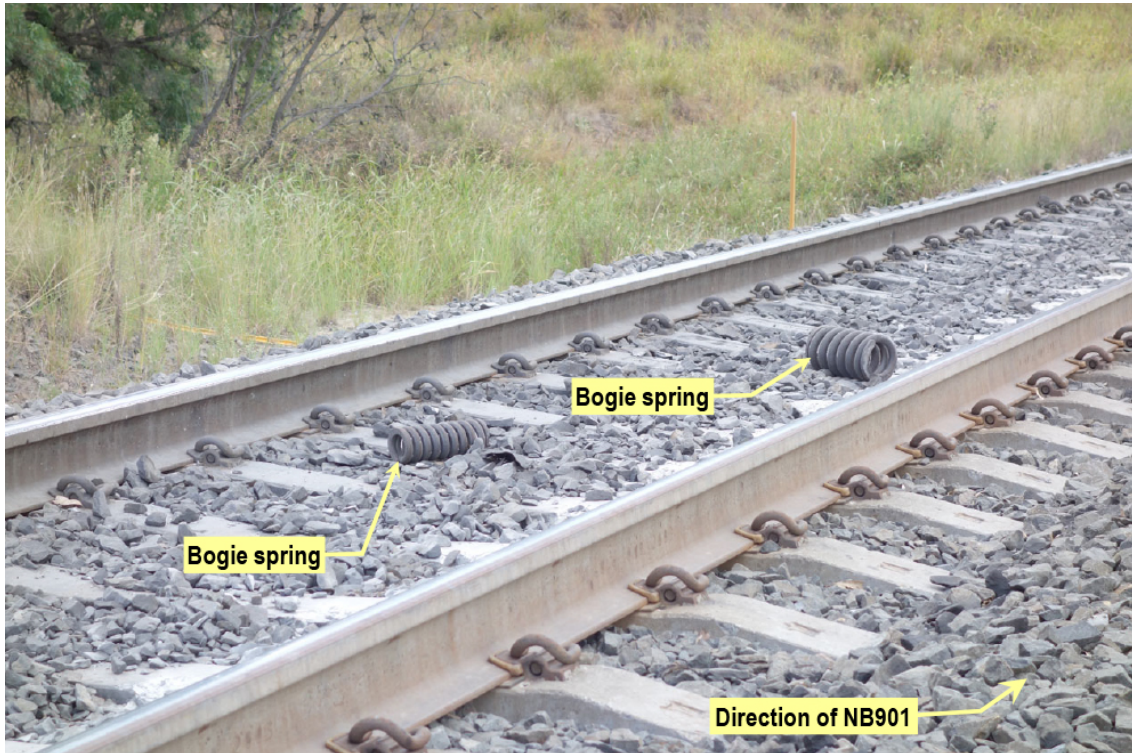
Figure 7: Bogie springs on track

- The 63 wagons remaining on track were in a serviceable condition with no obvious defective safety critical components
- A king pin, various side bearer components and a number of spring nests had been ejected from a derailed wagon and were located on the track in an area between 30 and 150 metres after the POM. (Figure 7) The presence of these components at this point indicated that a wagon body had lifted from a bogie during the derailment sequence.

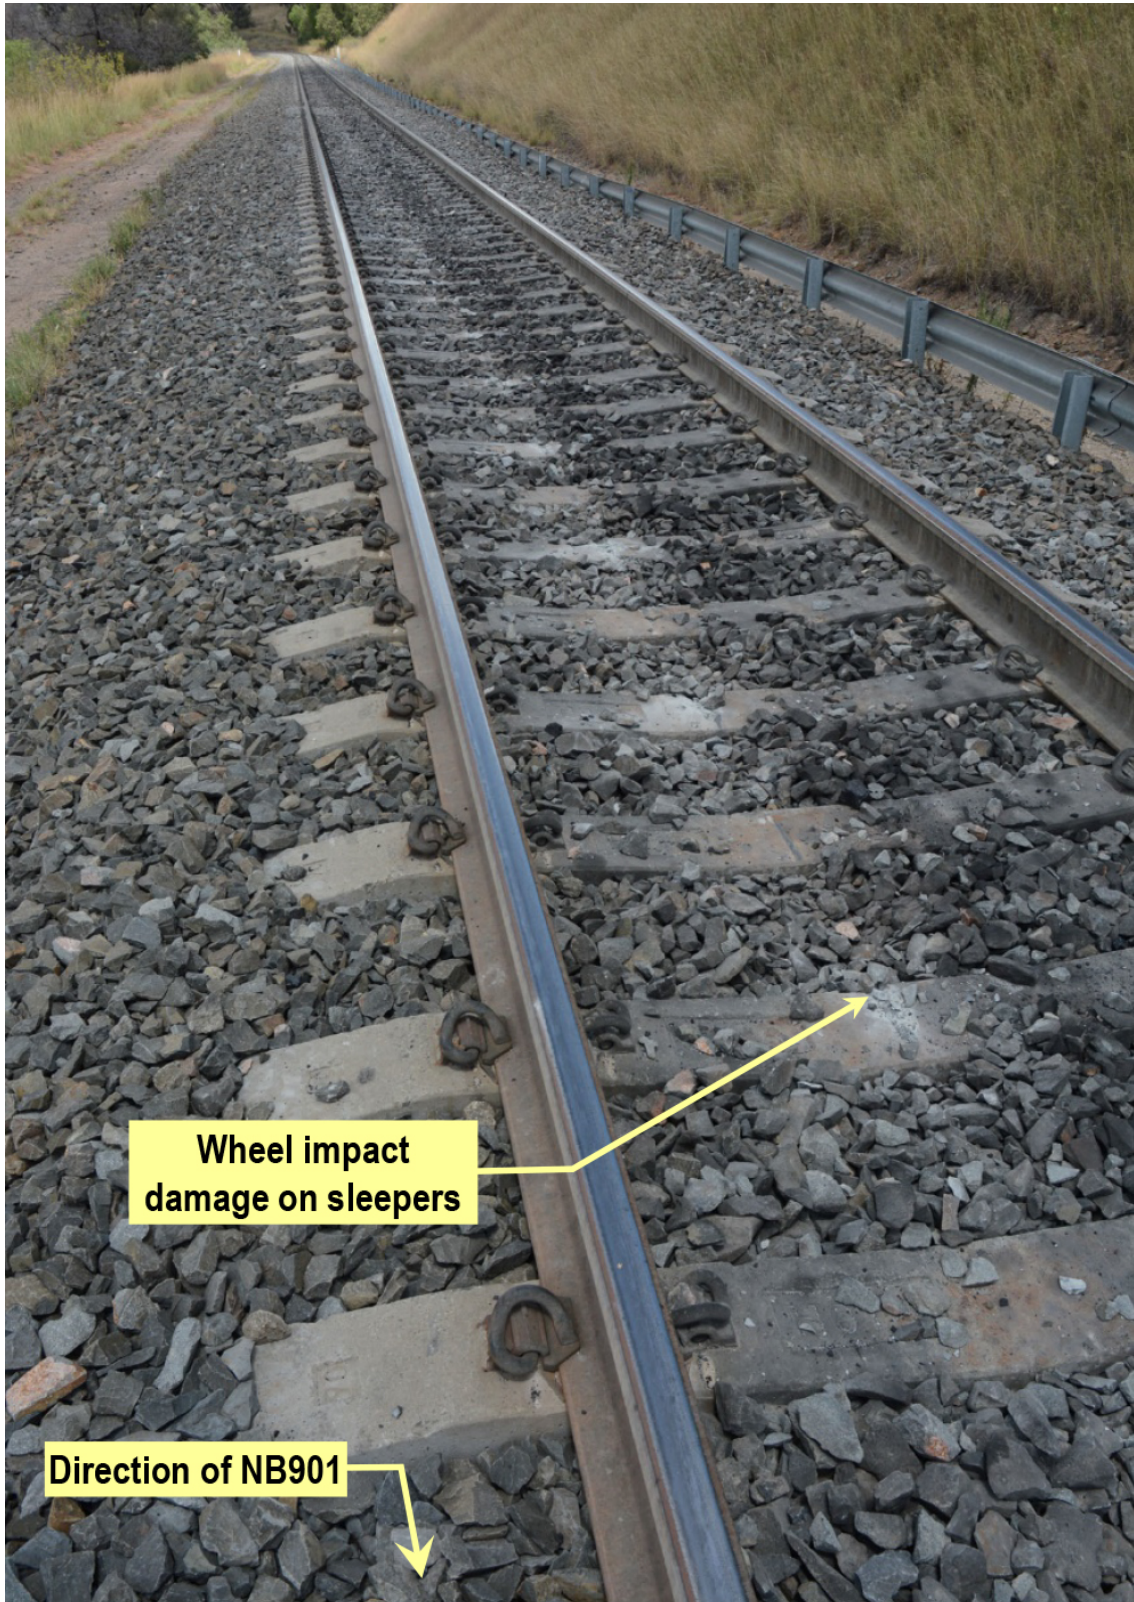
Figure 8: Wheel impact damage on track

- Although dragged from the POM to the catchpoint, the derailed bogie tracked parallel to the track centre during its passage through the section. (Figure 8) Despite lifting at one point during the derailment sequence, the alignment of the flange marks also indicated that the derailed bogie had remained attached to the wagon body, most likely by the connecting brake lever (that was later noted still attached to the wagon body). Associated with this were wheel impact or wear marks on the external face of end slope panel of the leading end of the wagon. The wheel marks on the end slope panel were further evidence that the wagon body had lifted off the bogie during the derailment sequence.

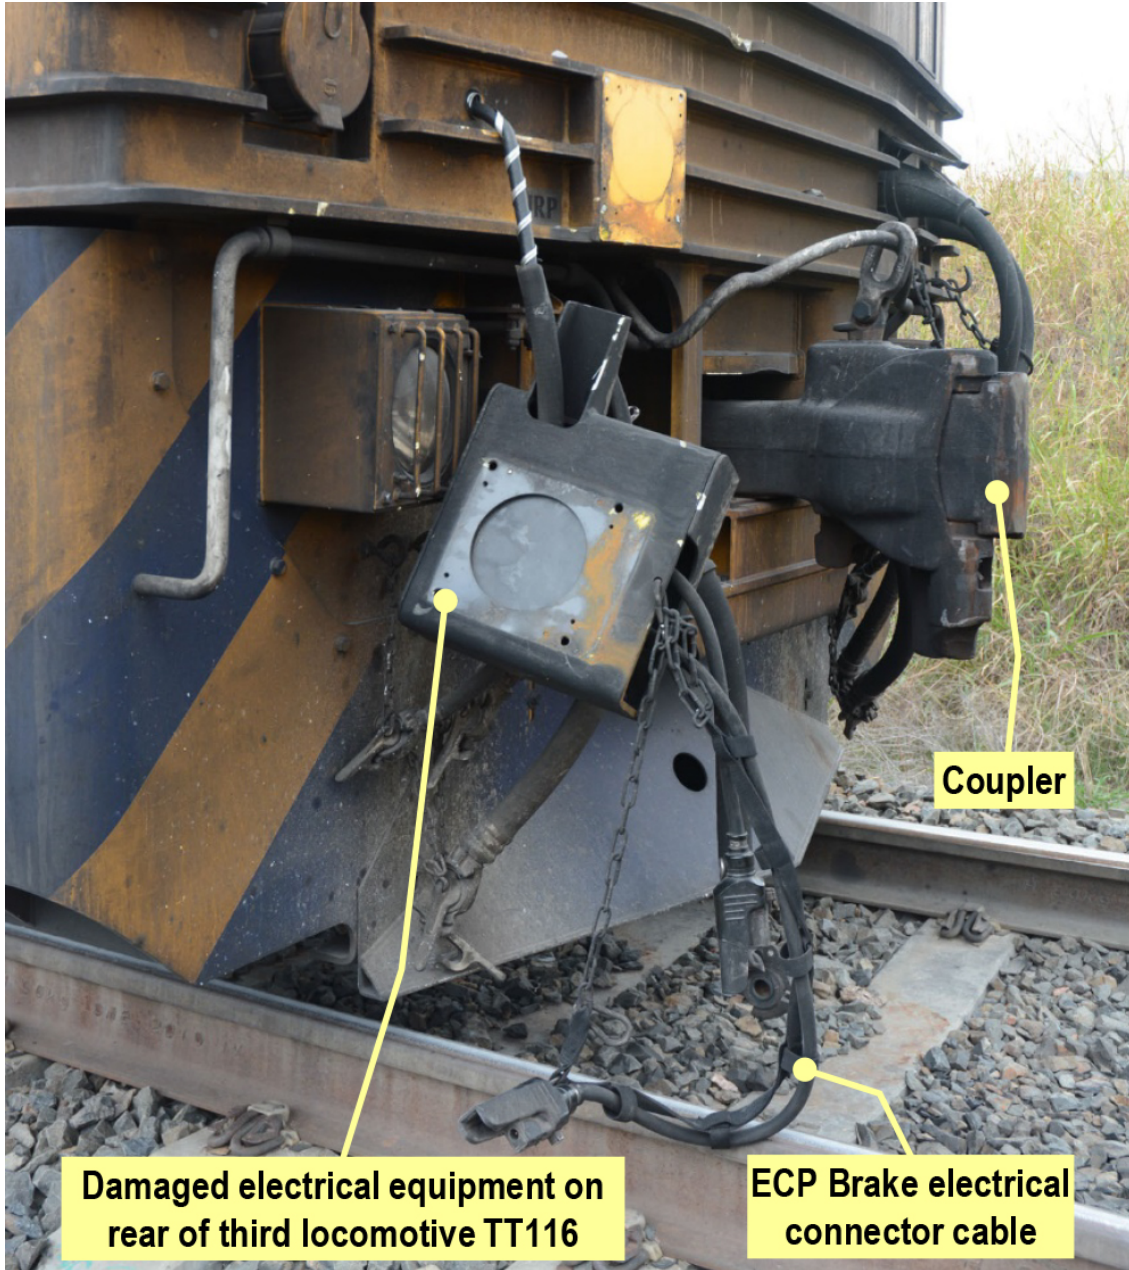
Figure 9: Damaged electrical equipment on rear locomotive TT116

- While the derailed wagons concertinaed in the cutting approximately 300 metres south of the Glenyalla Road level crossing, the locomotives continued before coming to a stand several hundred metres beyond the main incident site. Examination indicated that they were in a serviceable condition with no obvious defective safety critical components. However, minor

damage was observed on the rear of the third locomotive, TT116, and this most likely occurred during separation from the leading wagon, RHDH 99071M. The damage consisted of minor body panel damage, dislodgement of the connector cable for the ECP brake system, dislodgement of the receptacle box for the ECP brake system cable from its mounts and high force impact marks on the automatic coupler shank. (Figure 9)

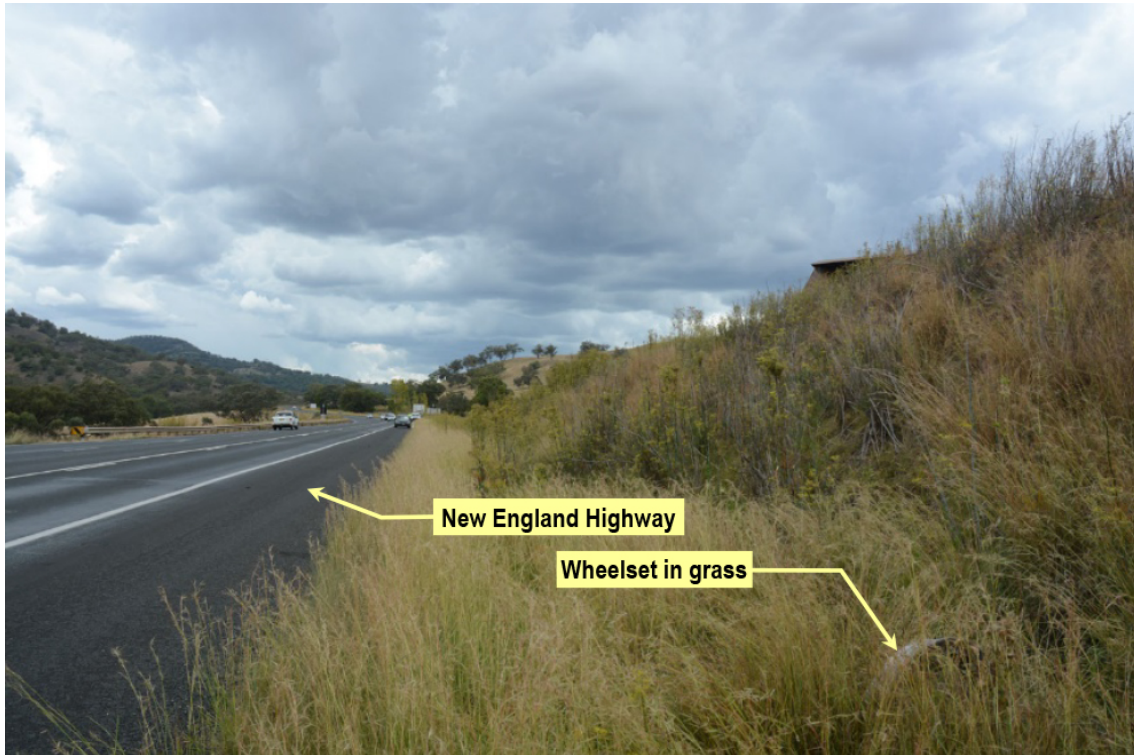
Figure 10: Position of wheelset near New England Highway

- One wagon wheel set from a bogie had detached and landed in grassy vegetation alongside the New England Highway close to passing road traffic. (Figure 10)

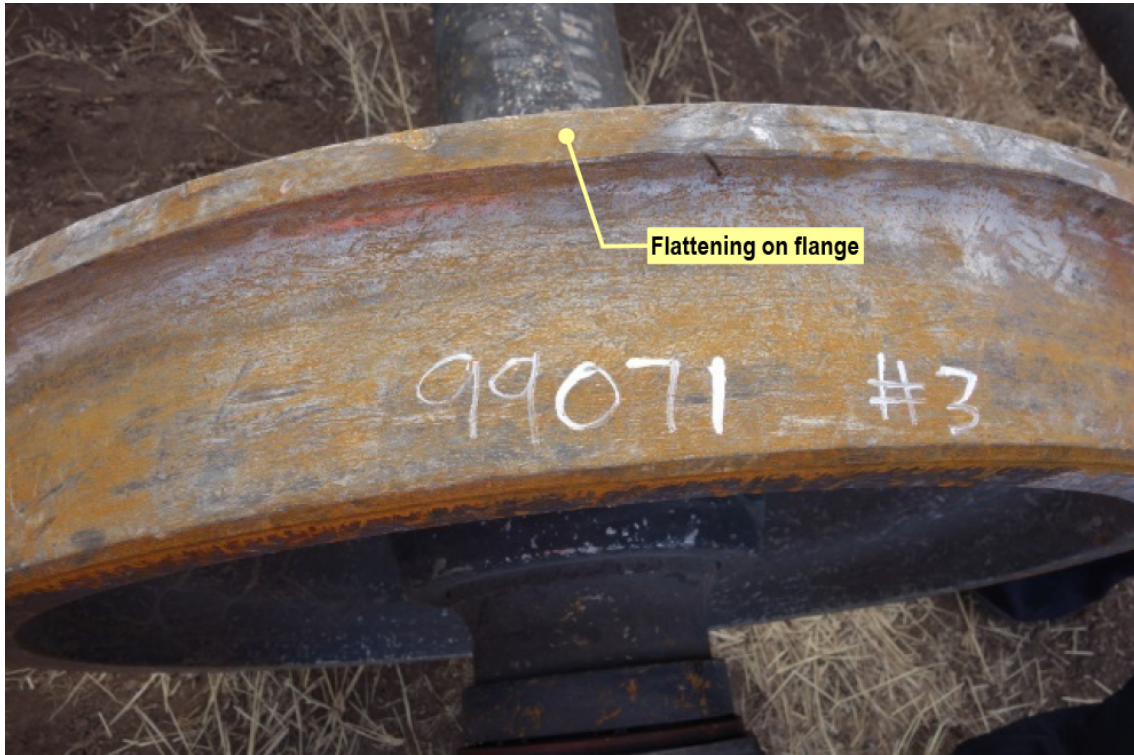
Figure 11: Damage on L3 Wheel

- The damage to the bogie frames and wagon body of RHDH 99071M was consistent with that sustained in the derailment
- Significant wear and flattening had occurred on the flange tips of the left side wheels from the leading bogie of the leading wagon, RHDH 99071M. This damage was consistent with derailed wheels running on the ballast for a significant period. The condition of the wheels indicated that this was most likely the first wagon to derail in the incident. No wheel sets from the other derailed wagons exhibited such flange damage. (Figure 11)

There were no abnormal conditions observed on the wheel tread or flange of L3 wheel with recent machining marks still evident. Further, despite the tight track curvature over the Liverpool Ranges, there was no evidence of any flange lubrication on the wheels of the derailed wagons. This indicated that no lubrication transfer had occurred when passing over prior flange lubrication systems. ARTC have subsequently installed additional flange lubricators in the section between Kankool and Ardglen.

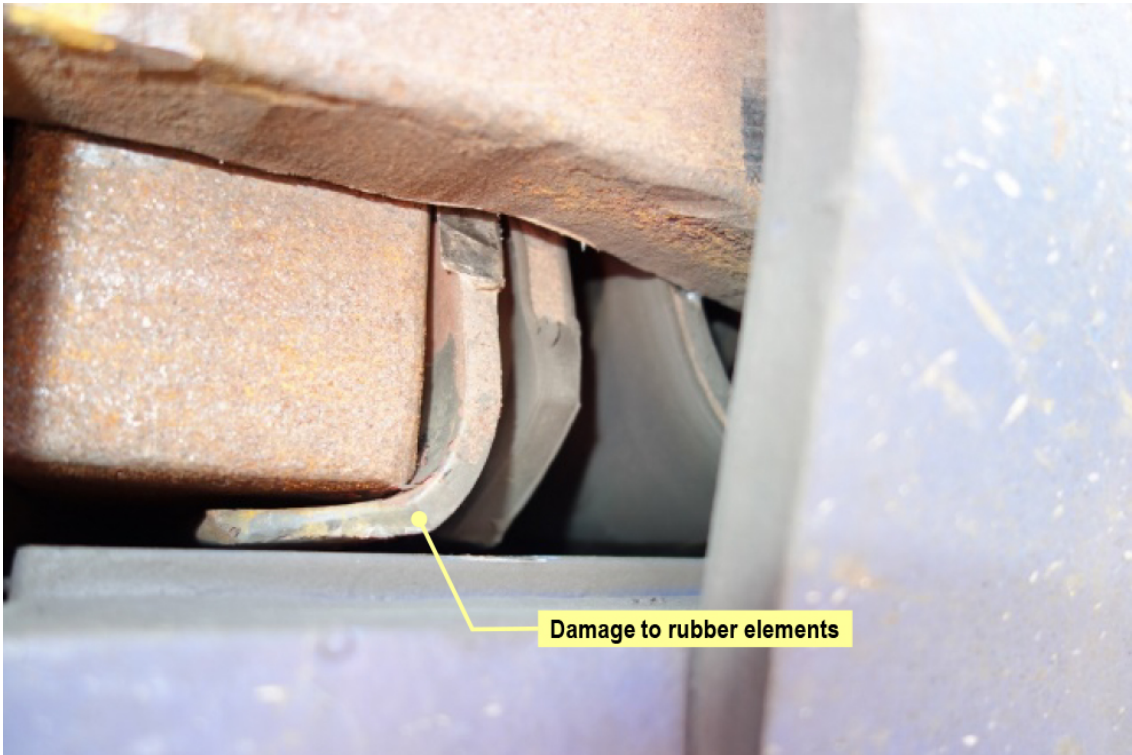
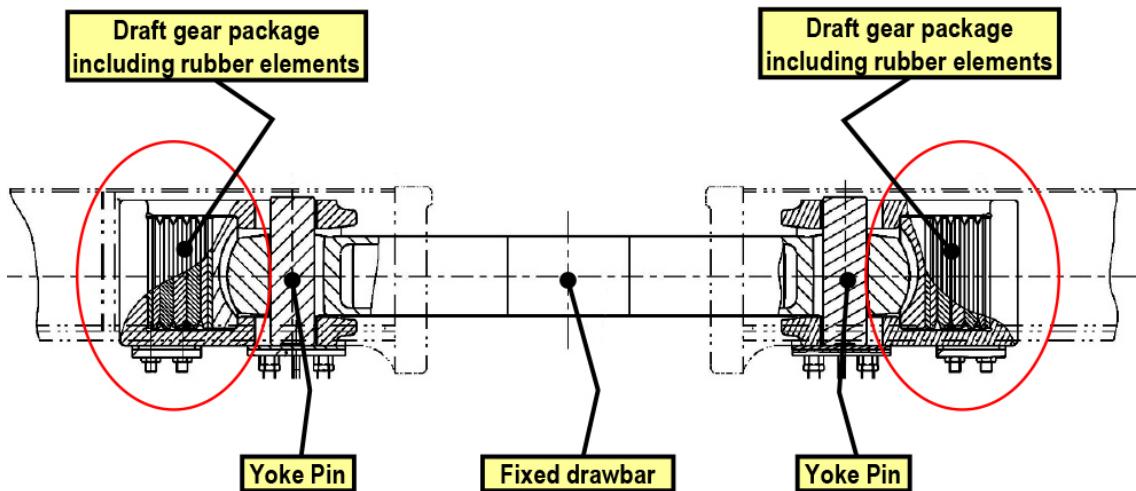
- There was significant twisting and deformation observed on the rubber element plates in the draft gear packages on various wagons that dampen the longitudinal in-train forces between wagons. However, this damage did not appear to be recent or accident related. (Figures 12 and 13)

Although controlling in-train forces, it could not be positively concluded that the condition of these rubber elements contributed any role in the derailment sequence. Despite this, PN commenced a change-out program for the draft gear package. Amongst other issues, PN also commenced a program of continued monitoring of the train handling techniques for drivers and introduced an updated inspection regime for the replacement draft gear packages.

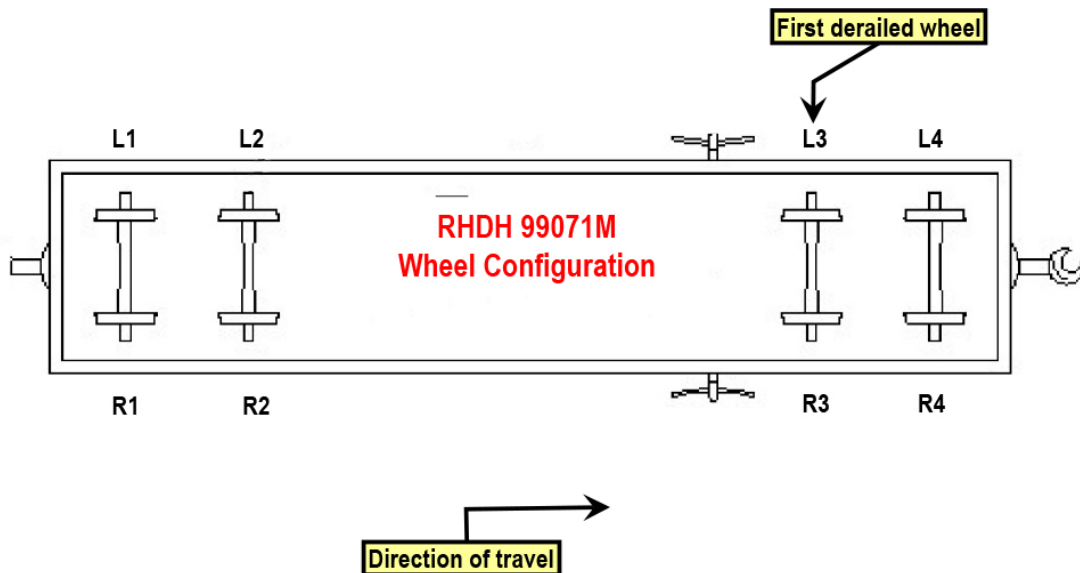
Figure 14: Wheel configuration of first derailed wagon

Two main factors were considered likely for the wheel to climb. The first factor related to the train management of NB901 as it traversed the Ardglen to Kankool section and the non-conformance to the LSN. The second factor related to the wheel/rail interface.

The L3 wheel of the leading wagon RHDH 99071M climbed the down (outside) rail and derailed at 366.811 km when the lateral and longitudinal in-train forces of the train exceeded the vertical forces keeping the wagon on significantly worn track. Although the wear to the rails was within ARTC specifications and standards, compounding the likely causes of the derailment were a combination of full flange contact by the wheel, a lack of lubrication on the rail and dry weather conditions. Subsequently, the wagon body also lifted off the bogie. The in-train forces were not adequately managed because an ECP brake application, designed to keep the train stretched and control the in-train forces, was not made as prescribed by the LSN. The derailed wheel then continued undetected until it struck No.51 catch points where the following 18 wagons also derailed. The remainder of the train stayed on track.
