Descent below minimum permitted altitude involving Airbus A319, VH-VCJ

Near Melbourne Airport, Victoria | 15 May 2015

ATSB Transport Safety Report
Aviation Occurrence Investigation
AO-2015-048
Final – 24 November 2017

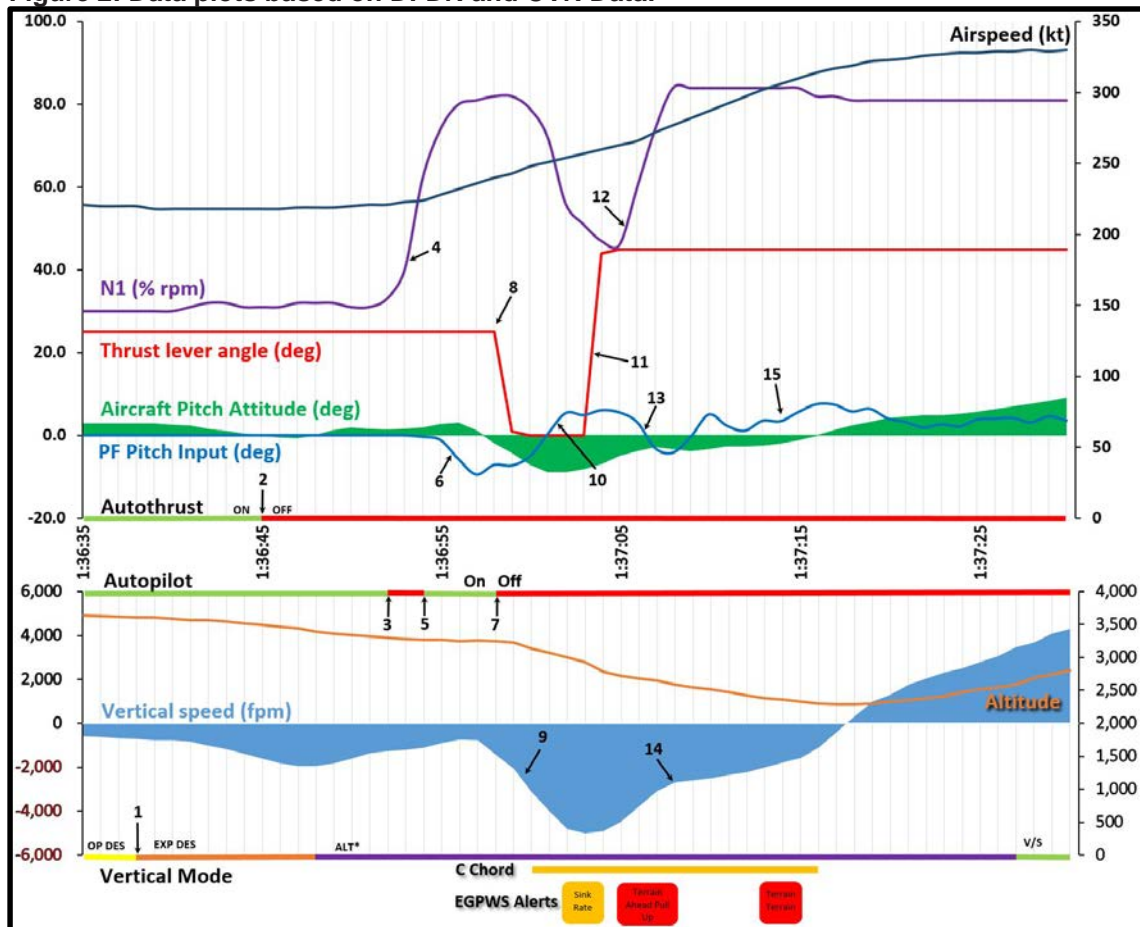
Figure 2: Data plots based on DFDR and CVR Data.

The sequence of events from 0136:35 is graphically presented in a data plot at Figure 2. Specific points on that data plot⁷ are identified to enable a clearer understanding of the rapidly changing events.

The arrowed numbers identify specific events referred to in the sequence of events. The vertical grid lines each represent 1 second. Source: ATSB

At 0136:51, the PM announced that the aircraft had captured the target altitude. At about the same time the PF recognised the thrust lock condition and pressed the 'instinctive disconnect' buttons on both the side stick and thrust levers (see Figure 3). The PF later recalled that the intent behind that action was to reduce the aircraft's airspeed and to retard the thrust levers. The use of the instinctive disconnect pushbuttons had the following effects:

- The action of pressing the instinctive disconnect pushbutton on the sidestick disconnected the autopilot (point 3), which in turn triggered the autopilot disconnect aural alert ('CAVALRY CHARGE'). The CAVALRY CHARGE sounded for 1 second.
- The pressing of the thrust lever instinctive disconnect pushbutton caused the thrust lock condition to disengage. It also removed the THR LK message from the electronic centralised aircraft monitoring system and the pilots' flight mode annunciators. As the thrust levers remained set to the climb detent, the commanded thrust changed from idle to climb.

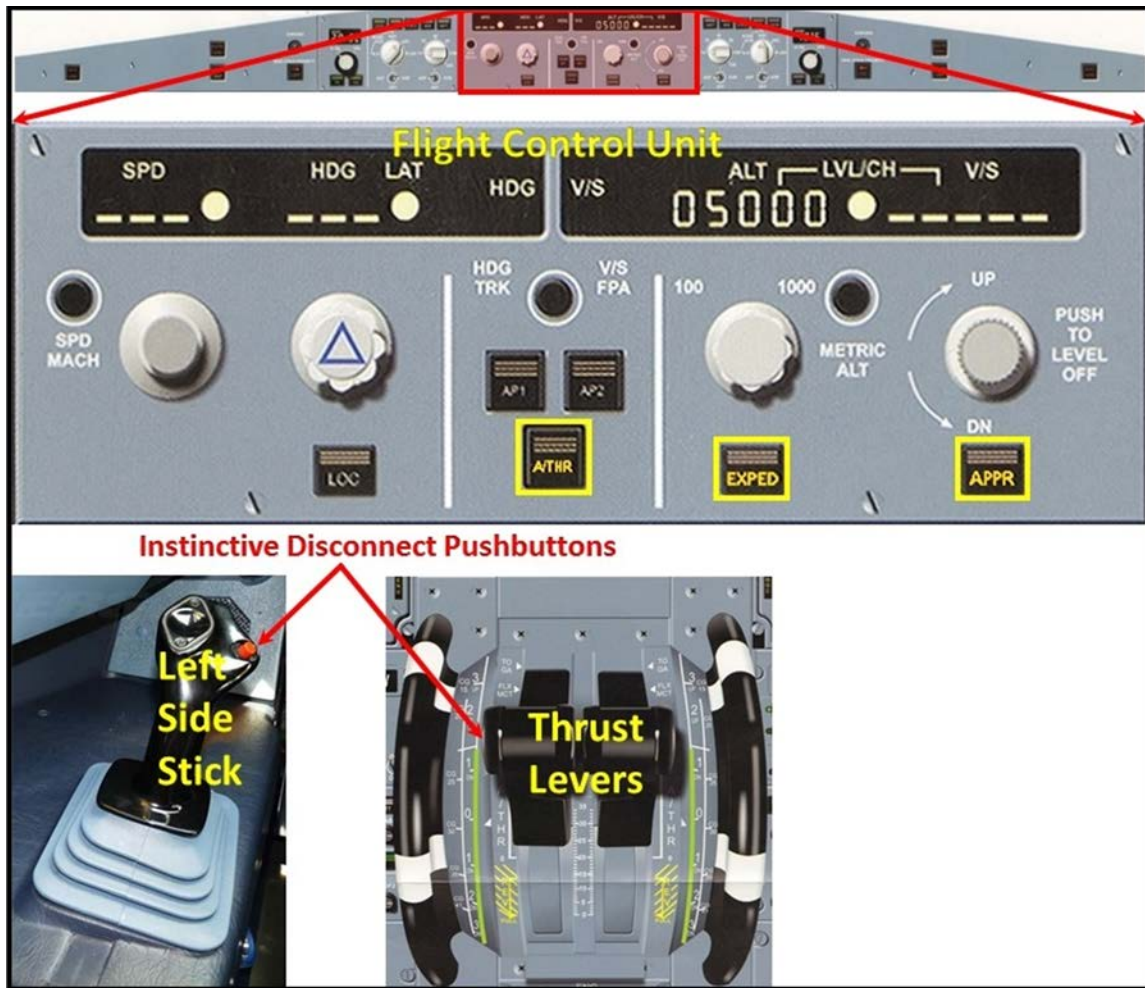
Figure 3: Autoflight controls.

The flight control unit is expanded and, from left to right, the A/THR, EXPED and APPR buttons highlighted. The PF's instinctive disconnect buttons on the side stick and thrust levers are also identified. Source: Airbus and ATSB

The pressing of the A/THR was an apparent instinctive reaction to realising that an error had been made. Both selections were consistent with unintentional slips. Furthermore, the similar size, shape and colour of the EXPED and APPR buttons on the FCU, as well as their close proximity, may have contributed to the error. The lighting conditions in the flight deck may have increased the difficulty for the pilot monitoring (PM) to monitor the actions of the PF.

- The pilot flying inadvertently selected the EXPED pushbutton instead of the APPR pushbutton, and, in an attempt to correct the error, pressed the A/THR pushbutton, creating a thrust lock condition.

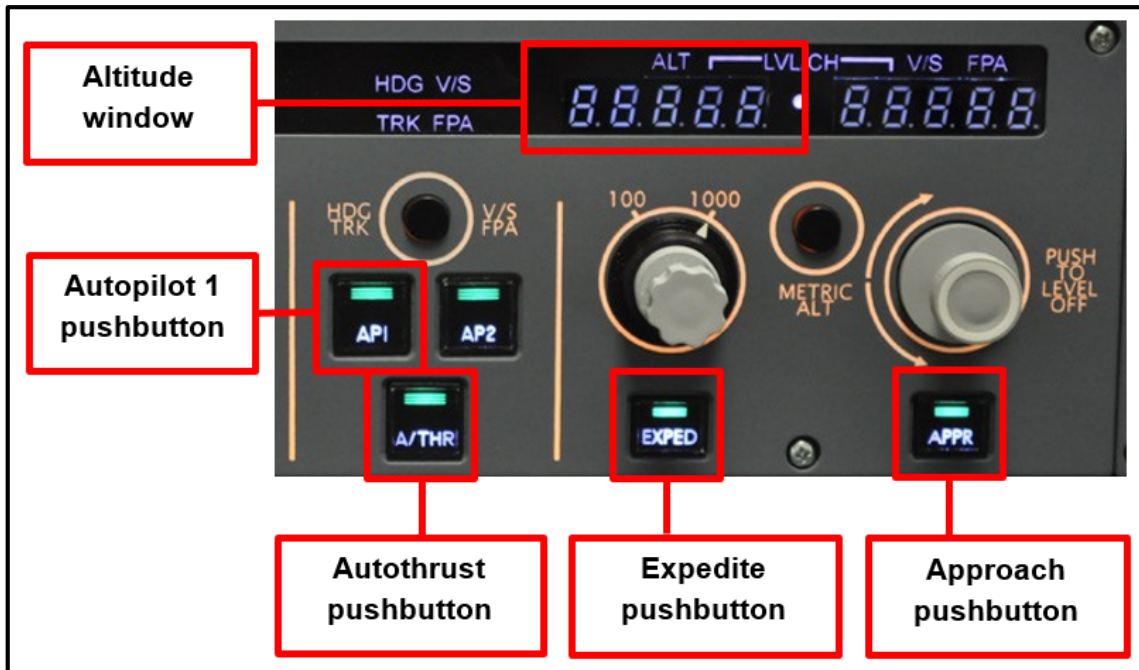
Figure 5: Part of the FCU with AP1, A/THR, EXPED and APP pushbuttons as well as the altitude window highlighted in red.

In the event of a failure of the instinctive disconnect pushbuttons, an alternative method of disconnecting autothrust is to press the A/THR pushbutton on the FCU (Figure 5). This is not a recommended method of disconnection as it will result in the engines entering the thrust lock mode. In the thrust lock mode:

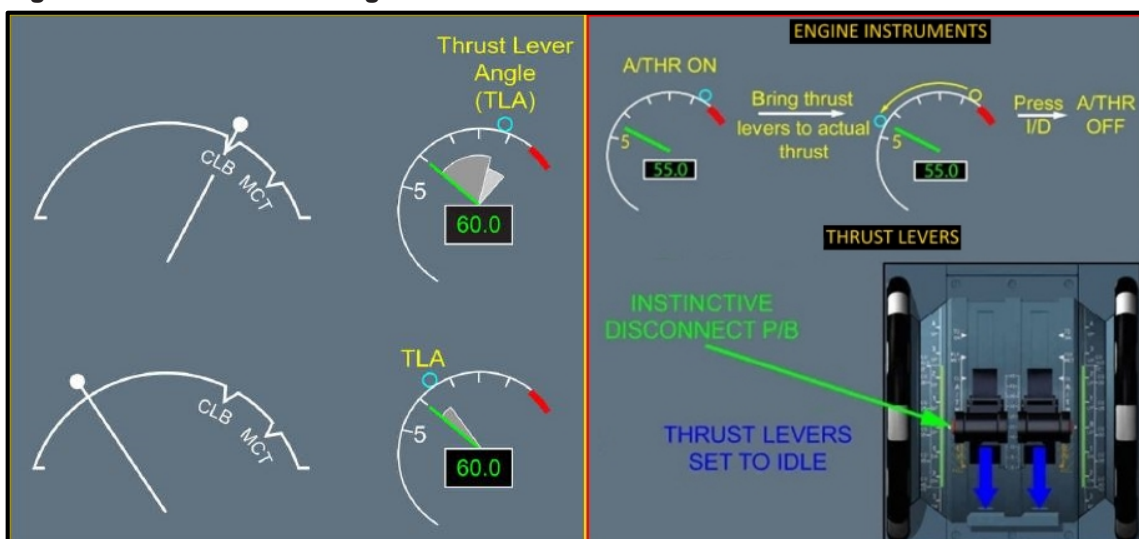
Figure 6: The thrust lever angle.

Engine instruments showing the relationship between the thrust lever angle and the TLA, (left hand diagram) and the autothrust disengagement procedure (right hand diagram).
Source: Airbus, modified by ATSB

The normal method for disconnecting autothrust is by pressing the instinctive disconnect pushbutton on the thrust levers (right side of Figure 6). Pressing the instinctive disconnect

However, in disconnecting the autothrust, the PF did not match the thrust levers to the current power, or set a desired power. This was likely to be a lapse, which is 'simply omitting to perform one of the required steps in a sequence of actions' (Harris, 2011). As to why this lapse occurred, the PF's incomplete response to the 'thrust lock' condition may have been a result of a response consistent with a perceived urgency to handle an undesirable state, particularly as the instinctive disconnect pushbuttons were designed for a quick response

- In attempting to remove the thrust lock condition, the pilot flying pressed the instinctive disconnect pushbutton but did not move the thrust levers to match the locked thrust setting. As the thrust was locked at idle while the thrust levers were set to climb thrust, this resulted in an unexpected, significant thrust increase.

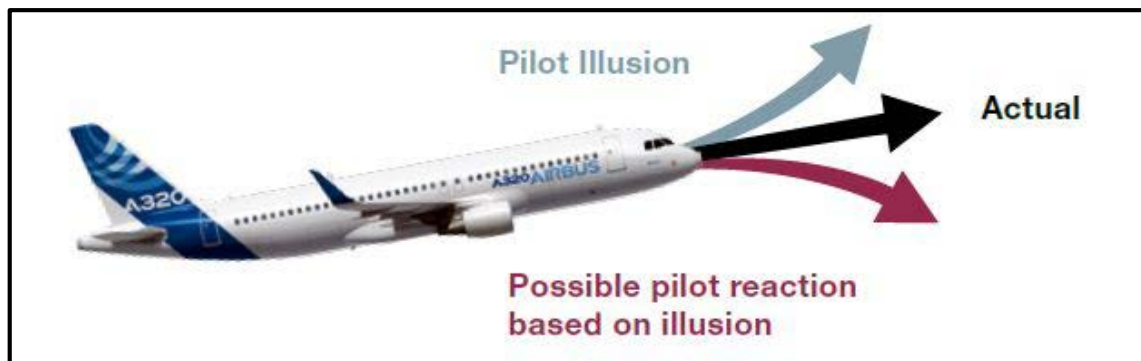
Figure 7: Pitch-up illusion.

Pitch-up (somatogravic) illusion, experienced as a result of acceleration during the go-around manoeuvre, showing the illusion as experienced by the pilot and the possible response to pitch-down.
Source: Airbus

During a manual Go Around, if the required pitch is not reached or maintained, linear acceleration will result. Research has shown that this may cause a “false climb illusion”. The false climb illusion may lead a pilot to believe that the aircraft is already above the required pitch. Consequently, a pilot may respond with an opposite and dangerous pitch-down input.

The PF did recall applying pitch-down side stick input during the rapid thrust increases and did not identify the increasing rate of descent, resulting from the nose-down attitude. The PF did, however, recall thinking that the aircraft was pitching up. Throughout the occurrence, the night conditions and operations within cloud resulted in the absence of a natural horizon. It was therefore likely that the PF's pitch-down side stick inputs were in response to pitch-up (somatogravic) illusions caused by the unexpected and rapid increase in thrust. The PF's susceptibility to the effects of pitch-up illusions was possibly exacerbated by also experiencing a high workload, which would likely reduce monitoring of flight instruments.
