Collision with terrain involving Robinson R44, VH-HBV

Julatten, Queensland, 15 August 2017

ATSB Transport Safety Report
Aviation Occurrence Investigation
AO-2017-083
Final – 22 March 2018

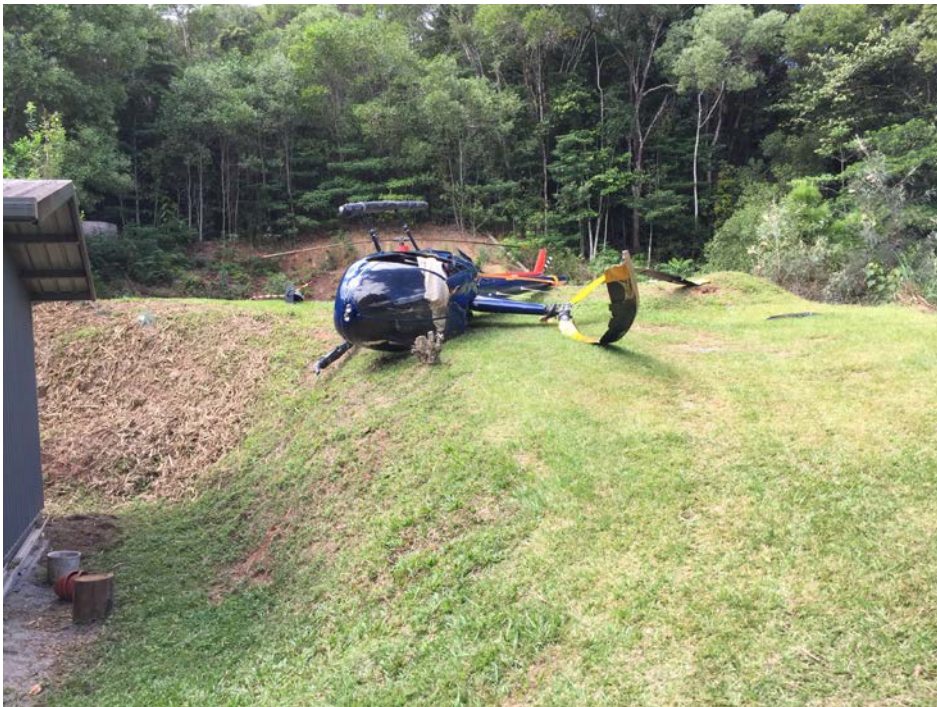
As the helicopter completed a 360 degree turn with the skids about 3–5 ft above the ground, the pilot lowered the collective⁴ in an attempt to land on the helipad. The helicopter was still yawing as the skids contacted the helipad. It rolled over, the main rotor blades struck the ground and the helicopter came to rest on its left side.

The pilot was uninjured and the helicopter sustained substantial damage (Figure 1).

Figure 1: Accident site showing damage to VH-HBV

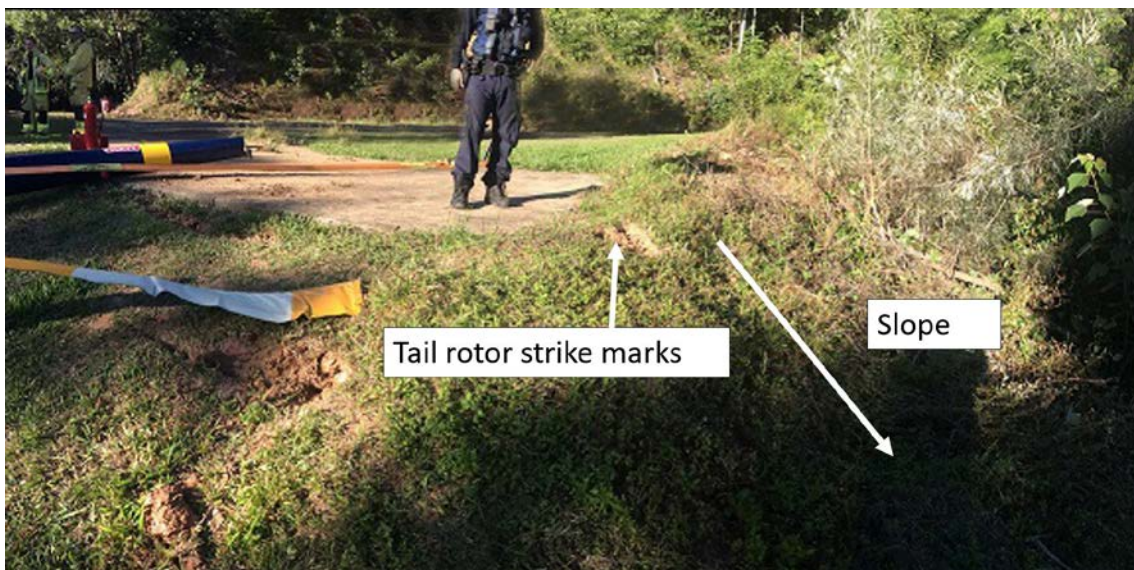
The pilot applied aft cyclic just prior to touchdown, which resulted in a slightly tail-low attitude for landing. The tail stinger would normally contact the ground and prevent a tail rotor strike. However, because the ground sloped away behind the concrete landing pad, the stinger was over the slope, allowing the tail rotor to strike the ground and detach without prior warning (Figure 2).

Following separation of the tail rotor and gearbox, the helicopter yawed rapidly to the right through 360° in response to the torque associated with the still-powered main rotor. As the pilot did not roll the throttle off quickly enough to reduce the rate of yaw of the helicopter prior to lowering the collective, the helicopter was still yawing when the skids contacted the ground. Consequently, it rolled over and the main rotor blades struck the ground.

Figure 2: Sloping ground away from helipad and tail rotor strike marks

- Company pilots were briefed immediately following the accident, and subsequently trained, with regard to flying alone or with very little cargo. R44s are inclined to have a nose-high attitude when light, which often results in tail and stinger encroaching too close to terrain.

- The company hazard register was updated to highlight the issue and company pilots were required to read the updated register. Pilots were advised that higher flare and slower approaches can mitigate the hazard.

- Company pilots were briefed regarding hazards associated with helicopter landing sites and bush landing sites with sloping terrain and any obstacle that may come into contact with tail rotor or helicopter.
