Operational non-compliance involving GIE Avions De Transport Regional ATR72, P2-ATR

Cairns Airport, Queensland, 4 September 2017

ATSB Transport Safety Report
Aviation Occurrence Investigation
AO-2017-091
Final – 4 May 2018

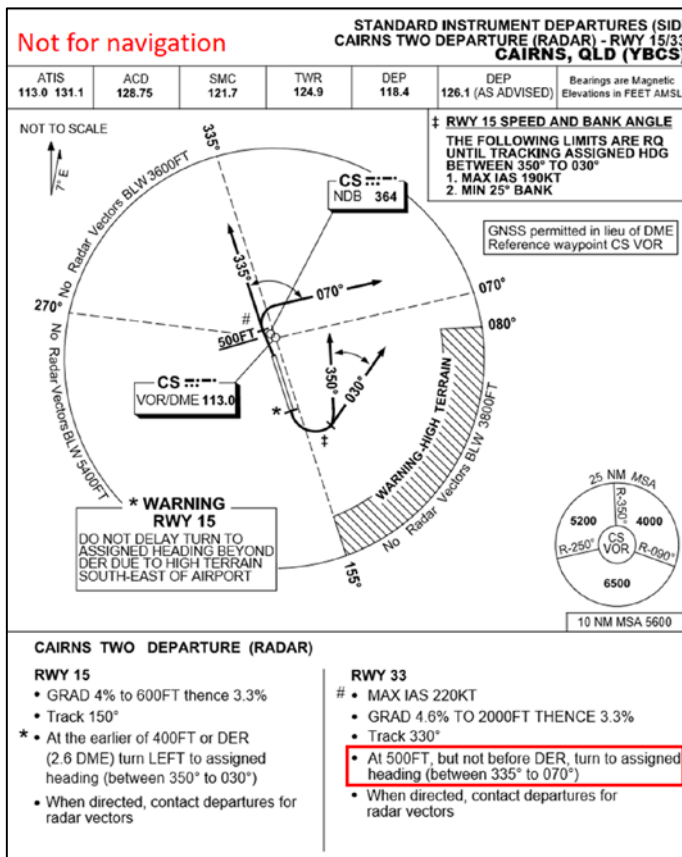
Figure 1: Cairns Two standard instrument departure

The figure shows the CAIRNS TWO departure including the direction to turn to an ATC assigned heading after passing the departure end of the runway (DER) and upon reaching 500ft. Source: Airservices Australia, annotated by ATSB.

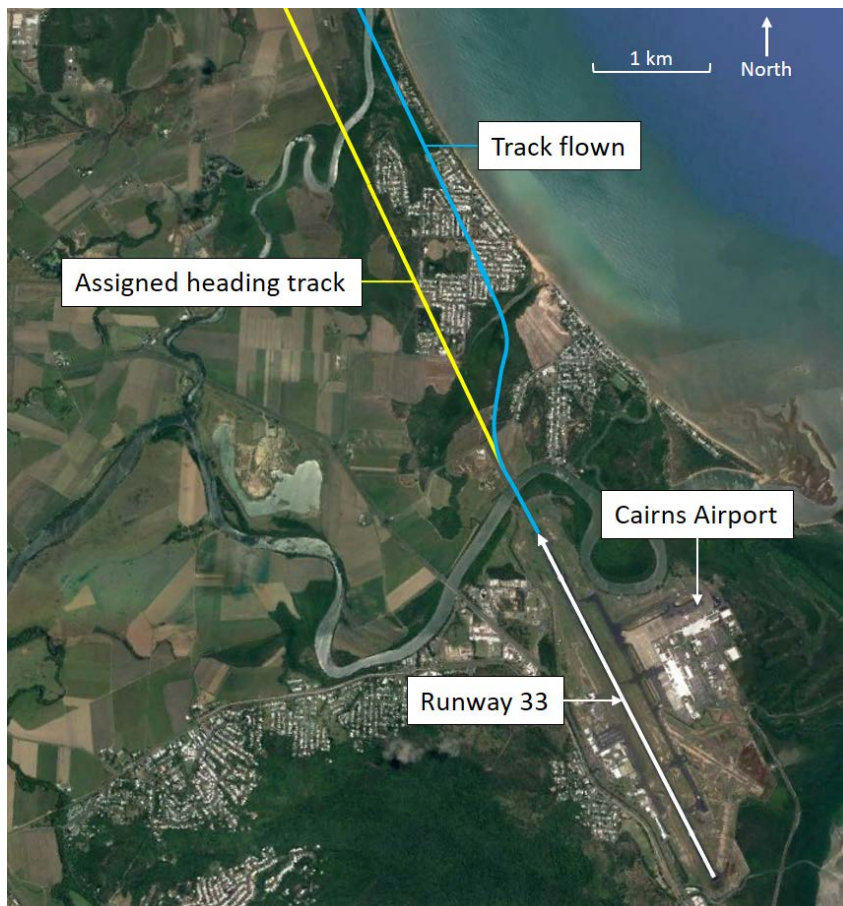
Figure 2: Overview of departure

The take-off was conducted normally and as the aircraft climbed through 500 ft, the FMS, in lateral navigation mode, directed a right turn past the assigned heading. The captain followed the FMS direction and turned the aircraft right. As the aircraft turned to 335°M the FMS continued to command a right turn. The captain followed the FMS direction and continued the turn past the assigned heading (Figure 2).

An overview of the initial departure showing both the assigned flight path and actual flown flight path.
Source: Google earth, annotated by ATSB

After take-off, the FMS directed a turn past the assigned heading of 335°M to a heading of 025°M. The flight crew initially followed this guidance, incorrectly turning the aircraft to a heading of 013°M before selecting heading mode and detecting the error. At about the same time, ATC observed the aircraft turning beyond the assigned heading and contacted the flight crew. The error was then managed by both ATC and the flight crew and the flight continued without further incident.

- Aircrew notices were circulated to all flight crew, providing education on SIDs and operations at Cairns.
- The simulator training program has been changed to include a greater focus on SIDs and Cairns operations.

- To avoid a sharp right turn during a take-off using an incorrect AFCS mode, the runway 33 CAIRNS TWO SID navigation database commanded heading has been changed from 025°M to 335°M.
