Derailment of MTM train TD1064

Near Rushall Station, Melbourne, Victoria | 6 February 2016

ATSB Transport Safety Report
Rail Occurrence Investigation
RO-2016-002
Final – 16 May 2018

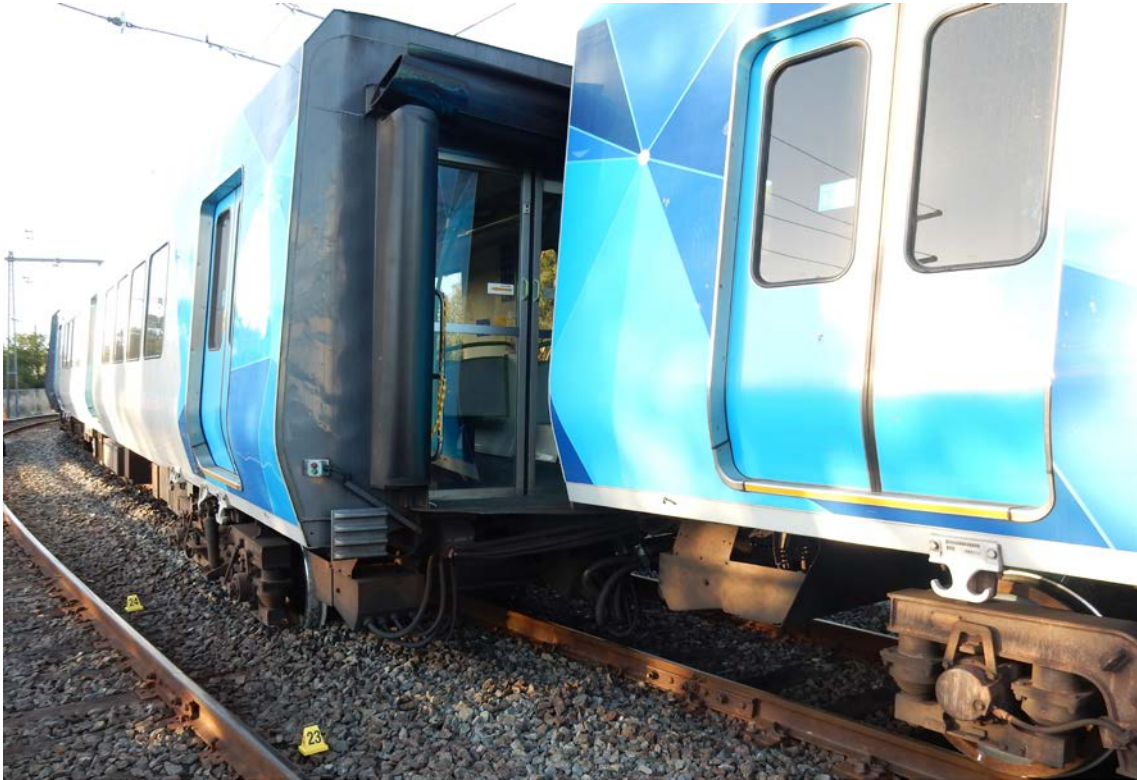
Figure 2: View of the derailed leading-end bogie of the second car

The train quickly came to a stop with the leading-end of the second car foul of the adjacent line (Figure 2). The driver was initially unsuccessful in attempts to contact Metrol² via the train radio system³. The driver subsequently established contact using a company-issued mobile phone about six minutes after the derailment. It was then about another minute before any approaching rail traffic could be halted.

*The leading-end of the second car derailed, and is shown sitting foul of the clearance of the opposite (adjacent) running line.
Source: Chief Investigator, Transport Safety (Vic)*

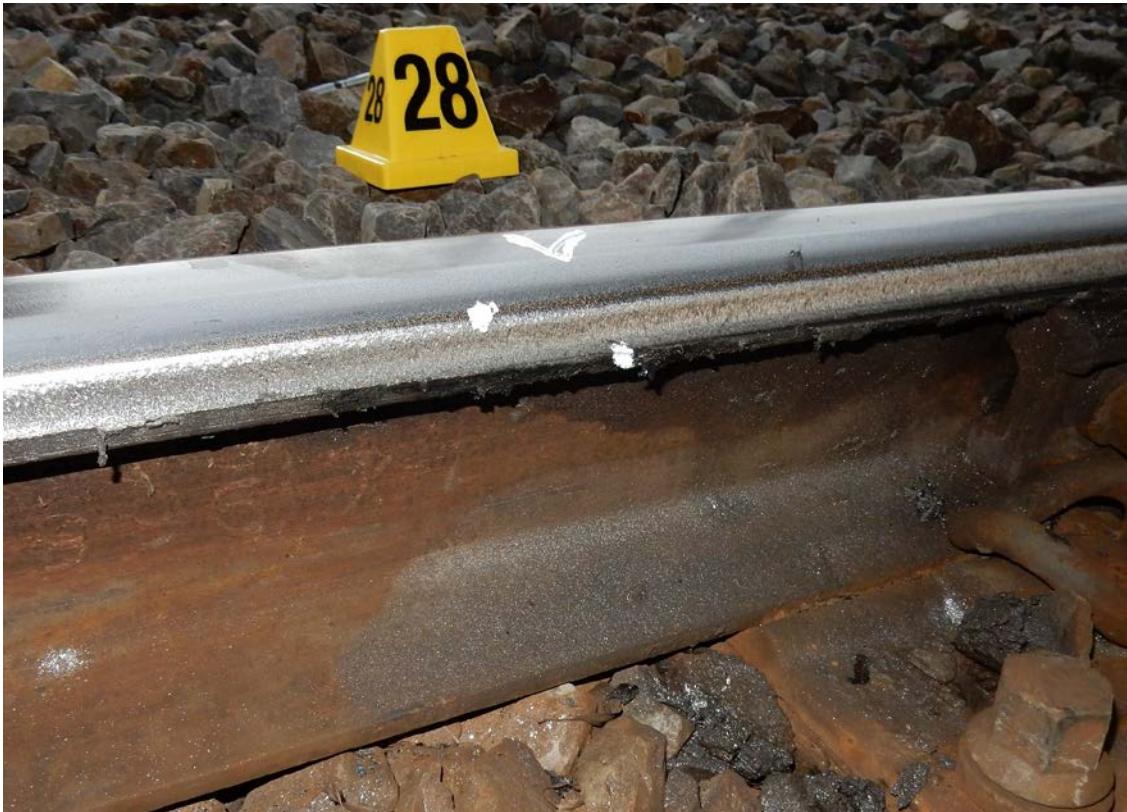
Figure 6: Gauge-face at estimated point-of-flange-climb

The gauge-face of the outer rail was clean and dry, with no visual evidence of either lubricant or contaminants and with a roughened surface (Figure 6).

The presence of both the rough gauge-face surface and metal filings below the rail were indicative of high friction and wear conditions and hence indicated a probable deficiency of lubrication between gauge-face and wheel-flange.

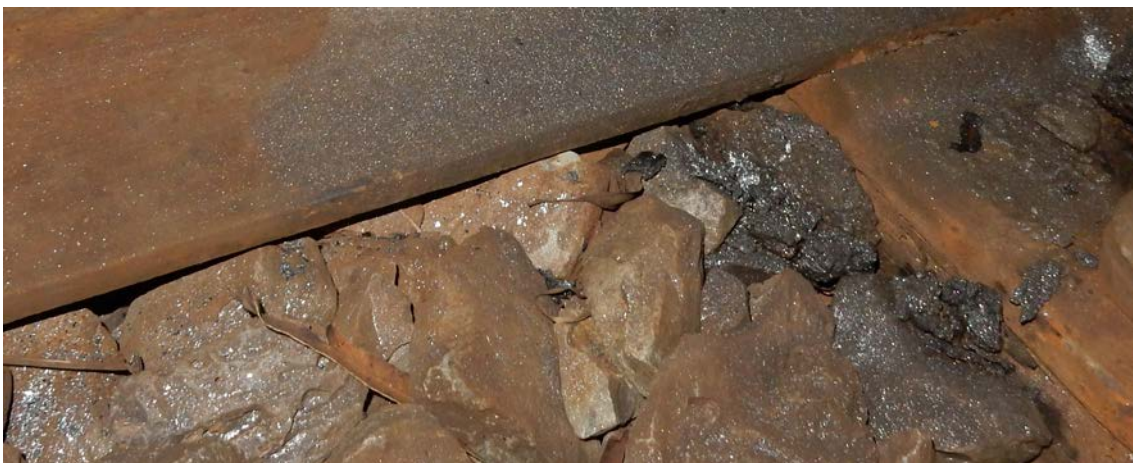
Figure 7: Metal filings deposited on the track ballast

Below the worn gauge-face there were steel filings (snow) on the rail foot and ballast (Figure 7).

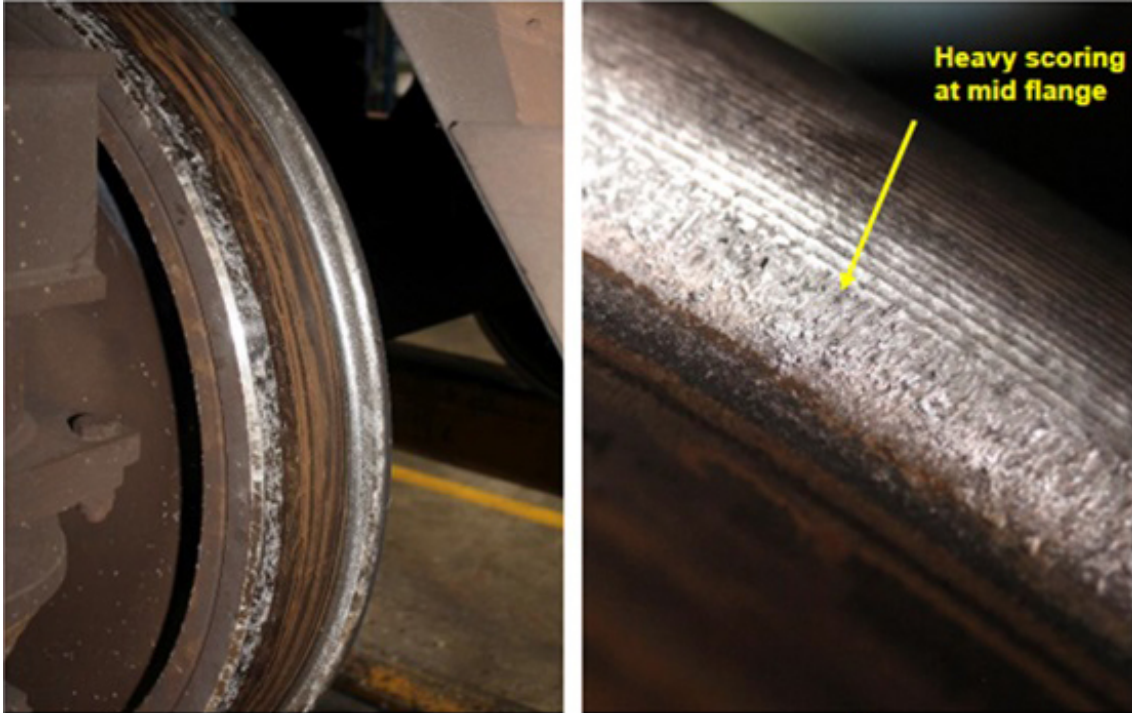
Figure 8: Views of the leading right-hand wheel of car 1305T showing observed wear

The wear condition of the first wheel to derail was consistent with other wheels on the right-hand side of the train. The wheel exhibited a band of scoring about 10 mm wide, located within the radius and onto the flange (Figure 8). The location of the wear, like other wheels on the right-hand side of the leading three-car set, indicated that the flange had been riding high on the rail head during curving prior to the derailment.

The left-hand photograph shows a general view of the wheel's condition. The right-hand photograph shows the heavy scoring within the throat (the tread-to-flange radius) and extending to mid-flange. The machining marks can also be seen to the outside of the scoring. This wheel was the first to derail and also exhibited ballast abrasion markings at the outer edge of its tread.
Source: ALS Industrial

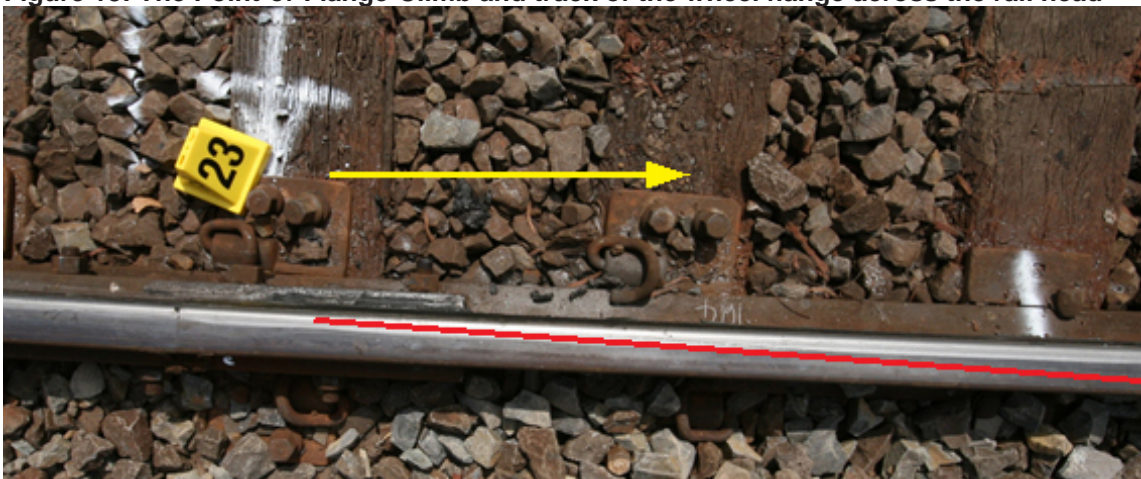
Figure 13: The Point-of-Flange-Climb and track of the wheel flange across the rail head

The photograph is annotated to show the direction of train travel (yellow arrow) and the flange track along and across the rail head (red line). Note that the point of flange-climb commenced immediately after the rail joint.
 Source: Chief Investigator, Transport Safety (Vic)

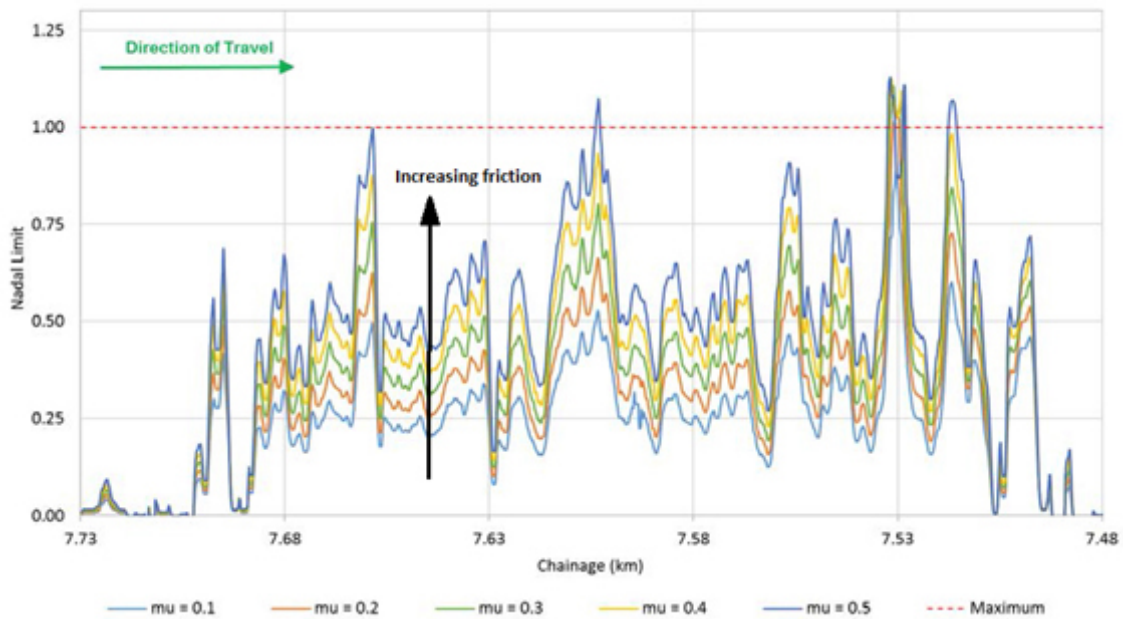
Figure 14: Simulation results for the derailed car (1305T) for a range of friction conditions

The coefficient of friction between the wheel and rail has a significant influence on the risk of flange-climb derailment. Simulations applying flange-climb criterion to this curving scenario showed that the potential for flange-climb increased significantly with increasing friction (Figure 14).

The diagram shows the estimated Nadal index through the Rushall curve for a range of wheel-rail coefficients of friction. The higher the coefficient of friction, the greater the likelihood of flange-climb derailment.
Source: Institute of Railway Technology (Monash University)

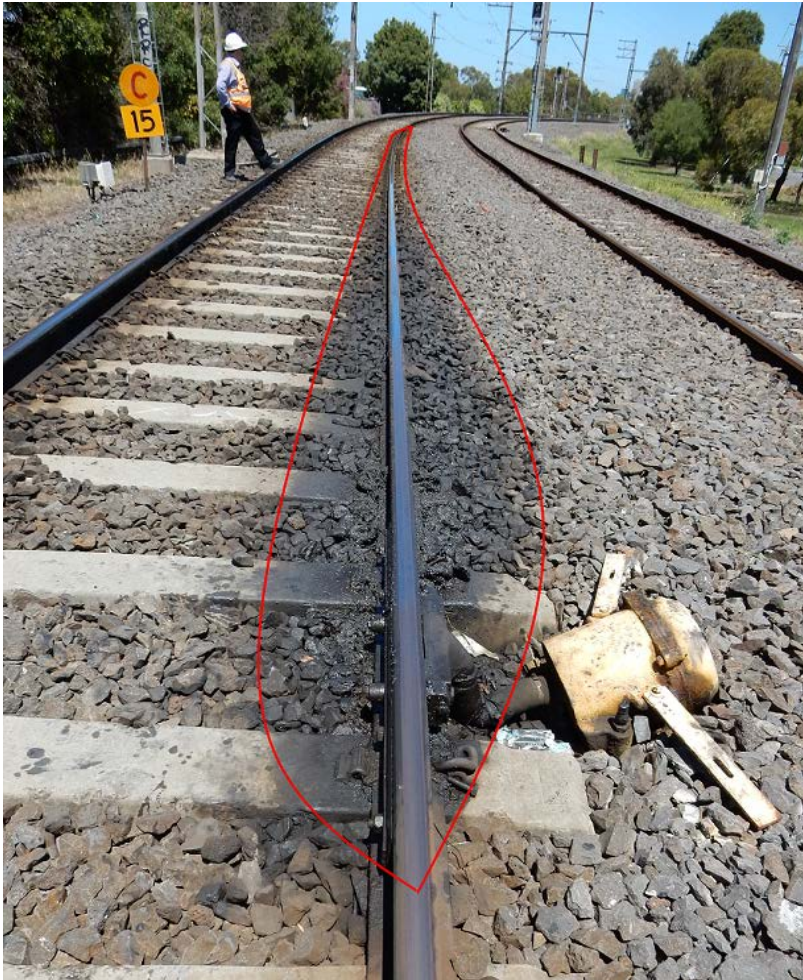
Figure 15: Rail lubricator for the Rushall curve Up track and grease plume

The lubricator that was provided to service the gauge-face of the outside rail of the left-hand Rushall curve (Up track) was located on tangent track in advance of an intervening right-hand curve. This would have led to less-effective pick-up of lubricant, and where pick-up did occur, too much of that lubricant being deposited directly back onto the track (Figure 15).

This image shows the rail lubricator for the Rushall curve, located on tangent track. The grease plume indicates that much of the lubricant has been flung off the wheel and deposited on the track. Note that the right-hand curve in the distance is an intervening (opposite) curve, and is not the one intended to be served by this lubricator. The left-hand Rushall curve is further in the distance and not shown on this photograph. Source: Chief Investigator Transport Safety (Vic)

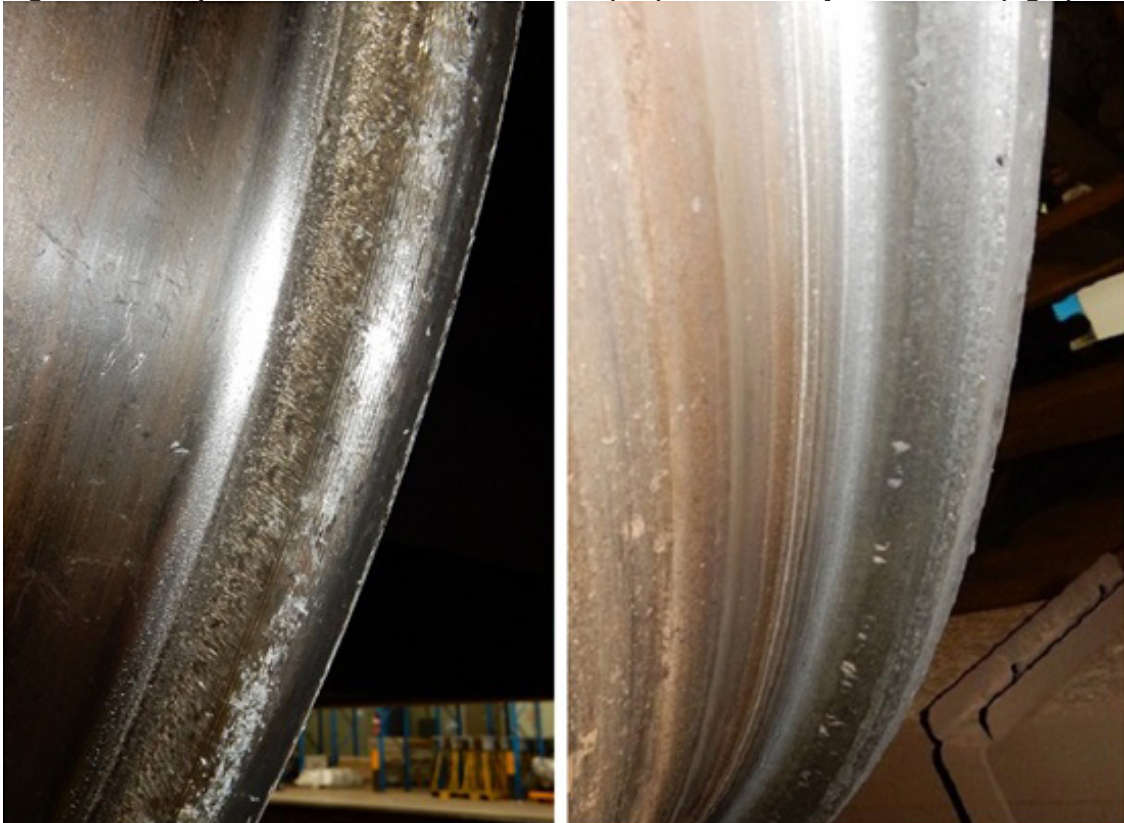
Figure 16: Comparison between derailed wheel (left) and normally worn wheel (right)

Compared to a typical worn wheel, the recently-machined wheels of train TD1064 had roughened flanges. There was heavy scoring of the throat, and some remaining circumferential machining grooves towards the flange tip (Figure 16). The scored and grooved area was within the band that would contact the rail gauge-face, and it is probable that this roughened surface contributed to an increased coefficient of friction between wheel and rail.

This image depicts the difference between the surface condition of the derailment wheel (left) and a typical worn wheel (right). The derailment wheel shows heavy scoring within the throat (the tread-to-flange radius) and residual machining grooves, compared to the relatively smooth finish on the normally-worn wheel.
 Source: Chief Investigator, Transport Safety (Vic)

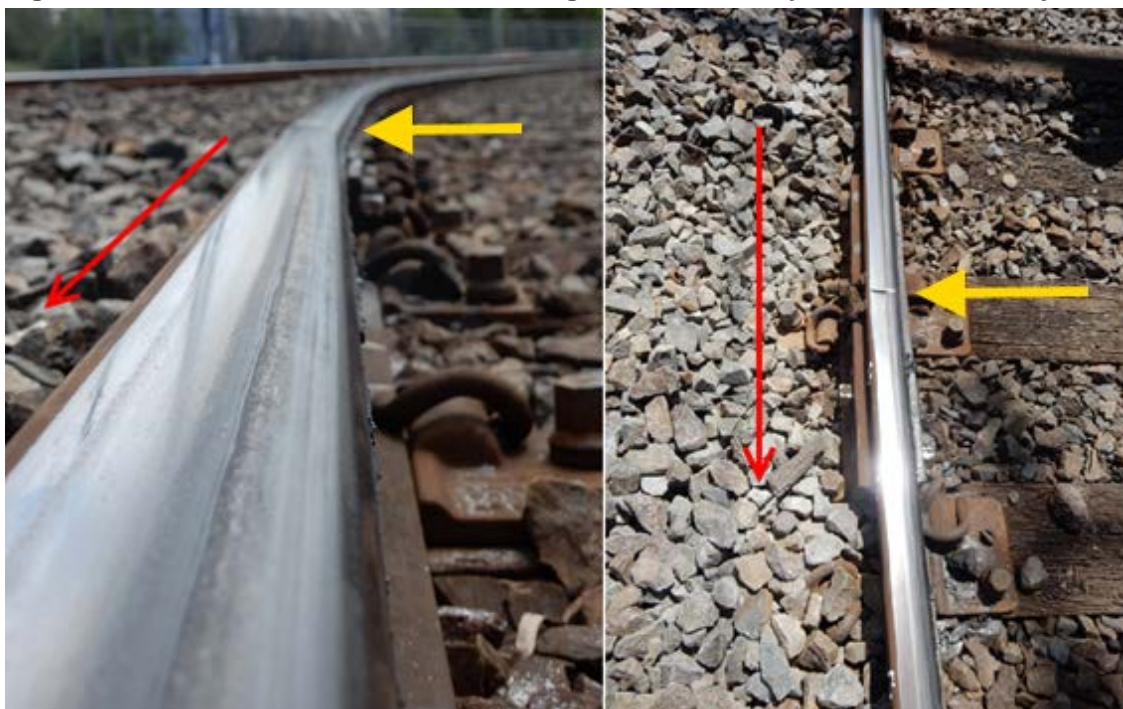
Figure 19: The outside rail and the lateral angular discontinuity at the mechanical joint

The two images depict the angular change in the line of rail at the mechanical rail joint (indicated by yellow arrows) that was about 0.6 m ahead of the first detectable point of flange climb. The train's direction of travel is shown by the red arrows.
Source: Chief Investigator, Transport Safety (Vic)

The angular discontinuity at the mechanical joint would have had the effect of increasing the wheel-to-rail angle-of-attack to the rail and causing a peak in the wheel-to-rail lateral force. This peak is also evidenced by the peak in rail head side-wear at this location (Figure 20).

It is therefore probable that in the context of poor lubrication and existing track geometry, the angular discontinuity at the mechanical joint was sufficient to initiate flange-climb at this particular point on the curve. A second derailment a few days later involving a track machine, was also the result of flange-climb by its leading right-hand wheel just beyond a subsequent mechanical joint.

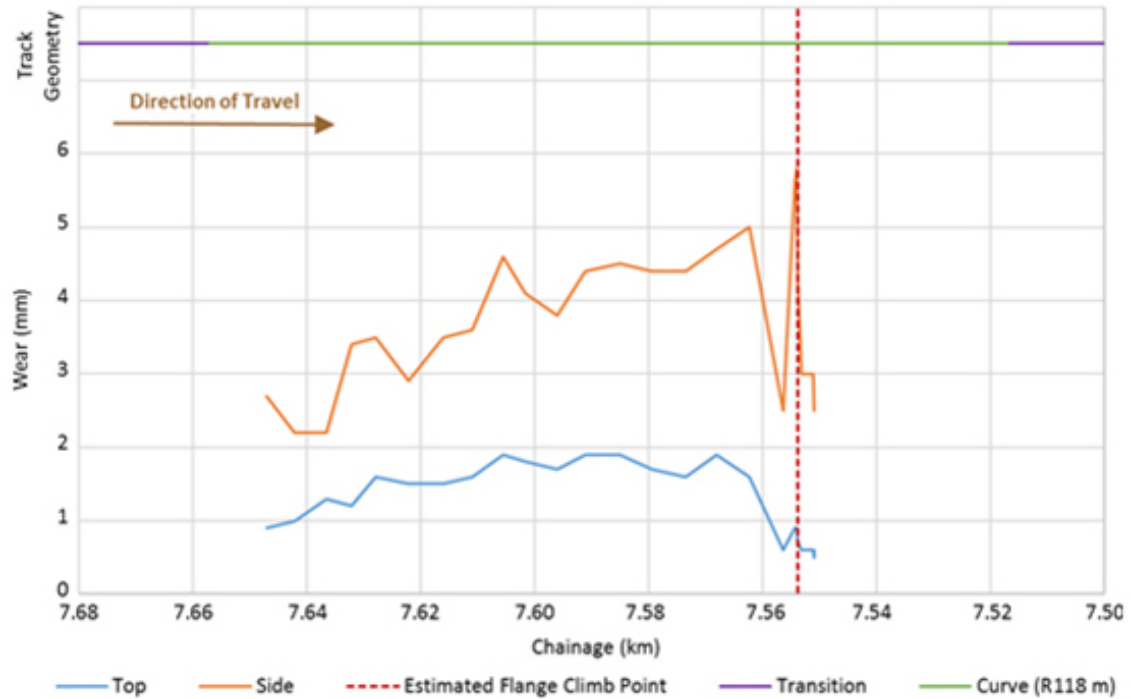
Figure 20: Top and side-wear for the outside rail of the derailment curve

This figure shows the sharp increase in side-wear at the estimated PoFC, just beyond the mechanical joint. The sharp increase in side-wear correlates with the angular discontinuity at the mechanical rail joint.
 Source: Institute of Railway Technology (Monash University)

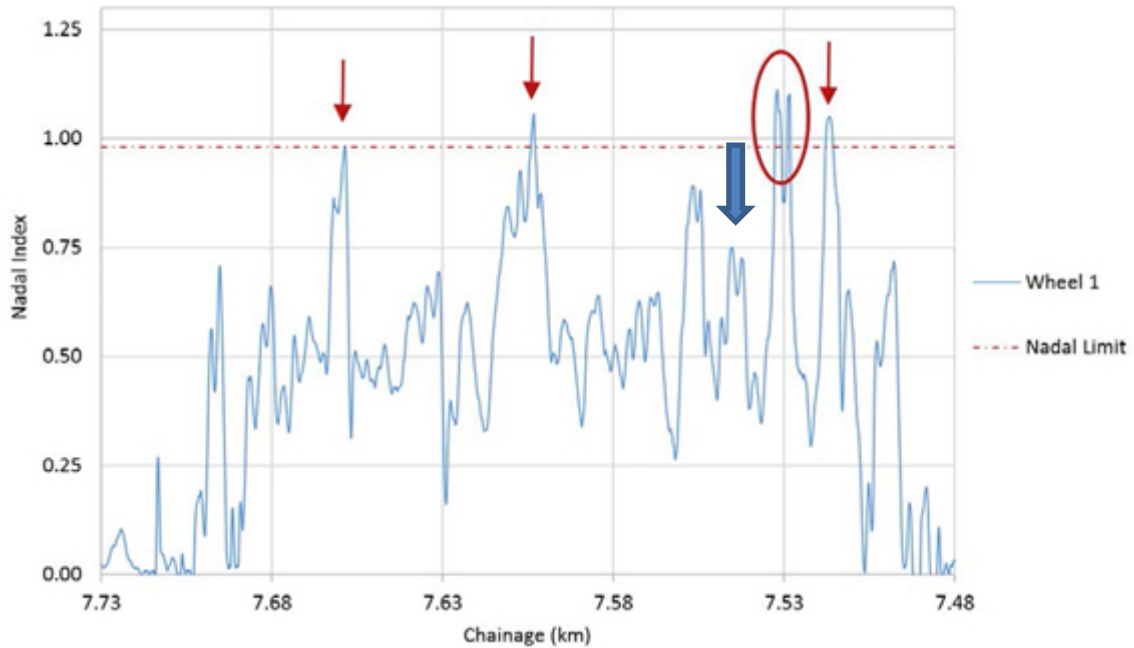
Figure 23: Results of the simulation (the Nadal index) for a coefficient of friction of 0.5

The simulation showed that the Nadal index of 1, that is the threshold for derailment, was potentially exceeded at four locations. The greatest exceedance is circled on the figure. The PoFC was at a smaller peak with an index of about 0.75 (identified by the blue arrow). This data resolution and modelling used in the simulation did not account for the localised effect of the joint.
 Source: Institute of Railway Technology (Monash University)

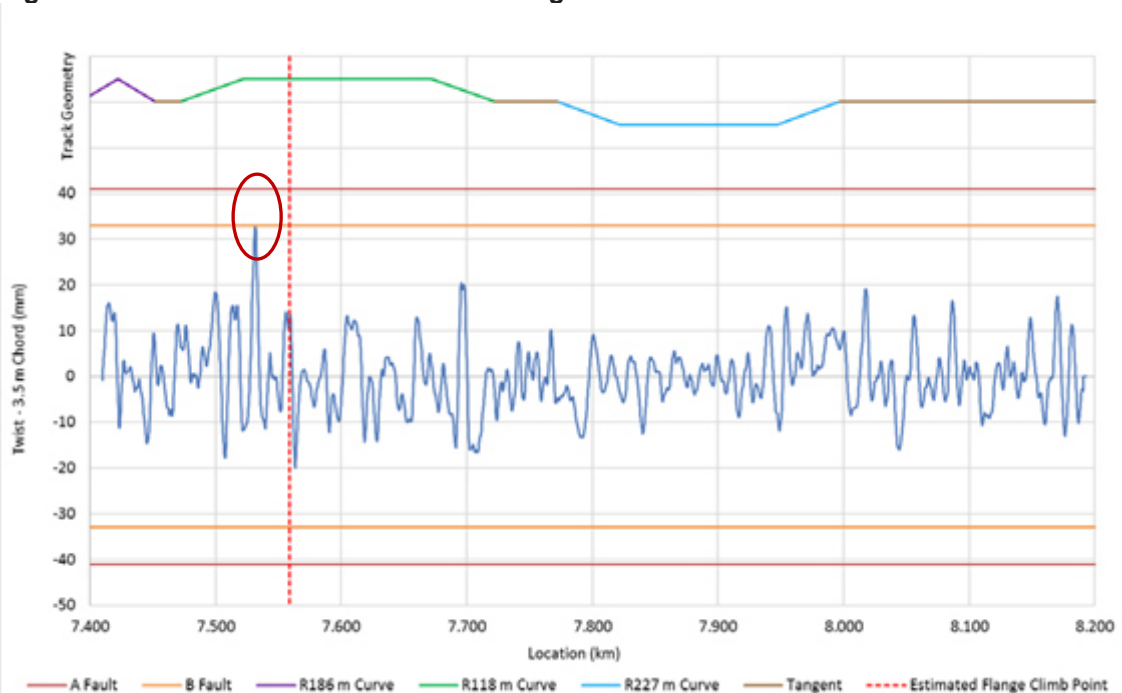
Figure 24: Measured track short twist through the Rushall curve

The short twist (3.5 m chord) in track geometry (circled) coincided with the maximum Nadal Index circled in Figure 23. This figure is plotted in the opposite direction to Figure 24.
 Source: Institute of Railway Technology (Monash University)

The peak in Nadal Index occurred where there was an in-phase²⁷ lateral alignment variation towards the inside of the curve and out-of-phase²⁸ variations in left and right rail ‘top’, leading to the track twist. The combined effect of a change in lateral alignment towards the inside of the curve and the partial wheel unloading associated with the twist increased the L-to-V ratio to a critical level, increasing the likelihood of flange-climb.

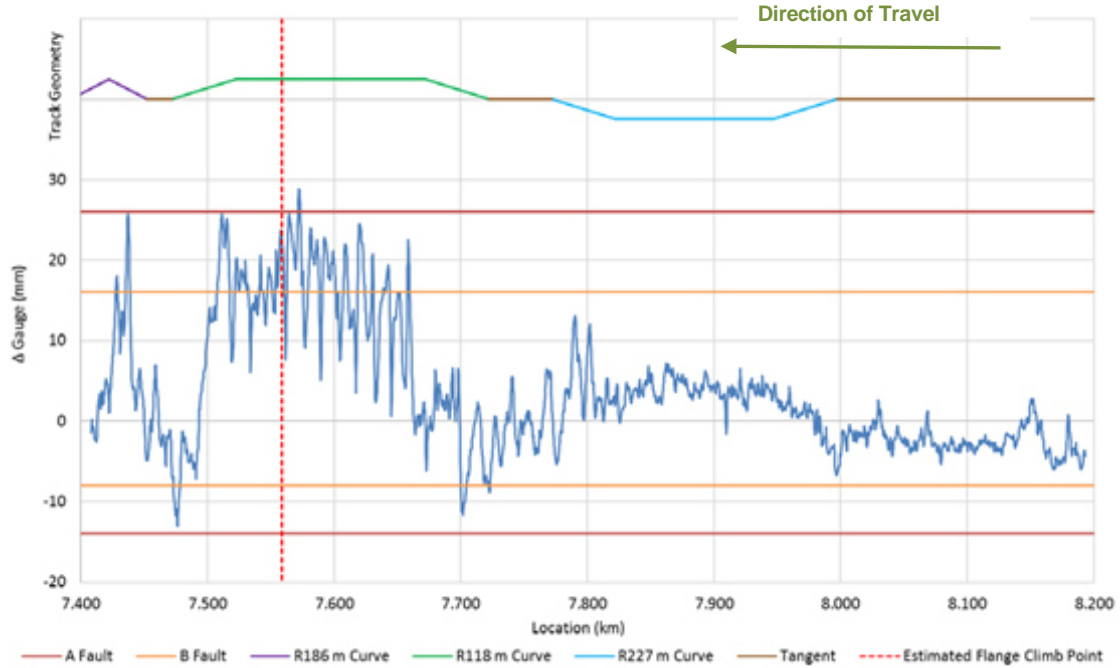
Figure 26: Track gauge through Rushall curve measured after derailment

This diagram shows numerous exceedances of the wide gauge 'B' limit and one 'A' limit exceedance within the Rushall curve. Source: Institute of Railway Technology (Monash University)

The post-incident track measurement also identified a wide-gauge 'A' fault³¹ although the fault was not at the PoFC, and so did not contribute to the derailment.
