# Grounding of the Australian flag training vessel *Wyuna*

Tamar River, Tasmania | 19 October 2000

**ATSB Transport Safety Report**  
Marine Occurrence Investigation  
161  
Final

Navigation Act 1912  
Navigation (Marine Casualty) Regulations  
investigation into  
the grounding of the Australian flag training vessel  
*Wyuna*  
in the Tamar River, Tasmania  
on 19 October 2000

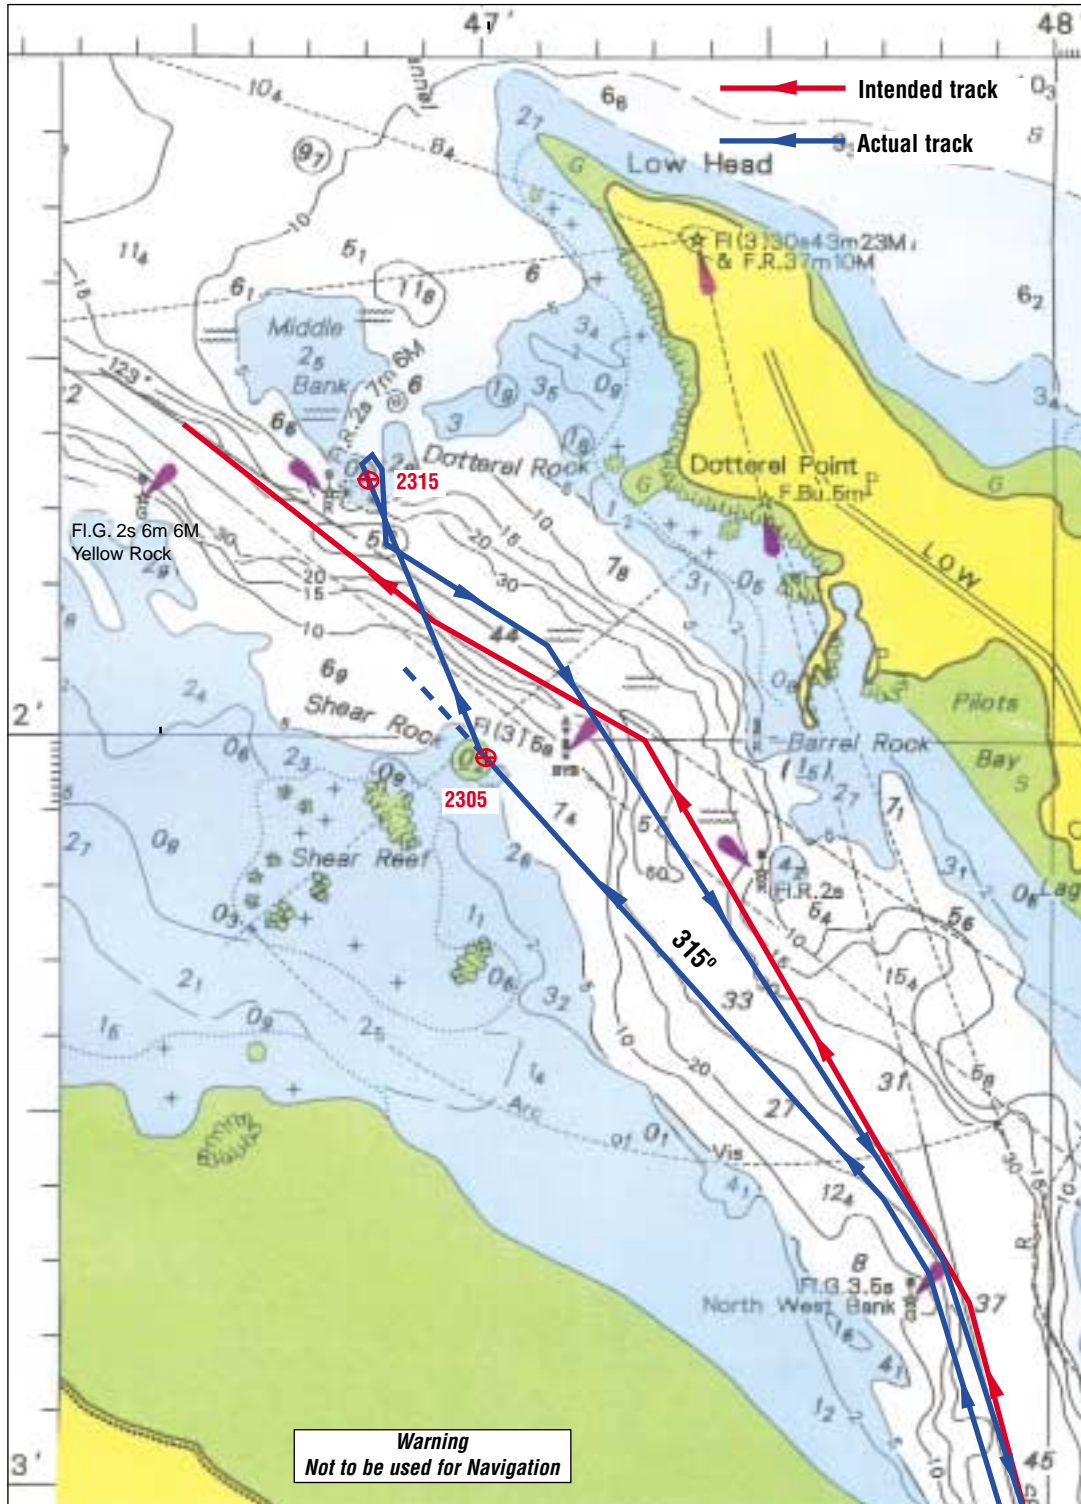
**FIGURE 4:**  
**Chartlet of area including tracks from ECS**

The master remained confident that the ship was safe, not feeling the need to verify the ship's position using the electronic chart. None of the students saw Shear Rock beacon either visually or on the radar and they deferred to the master's instructions, the student 'master' feeling that the master had taken over.

At 2305, *Wyuna* struck the bottom with a prolonged scraping and shuddering. The master stopped the main engines immediately and turned up the brilliance of the ECS. The electronic chart showed Shear Rock beacon was bearing 086° at 150 m. After the initial impact, the vessel continued to touch the bottom as it was pushed across Shear Rock by the tide. About 2 minutes later, *Wyuna* floated clear with the tide carrying the vessel rapidly northward across the channel.

Other evidence, including copies of the ship's documentation, logs, and the passage plan was obtained. Hard copies of the *Wyuna*'s ECS real-time passage were provided to the investigation. This record showed a limited number of time positions. The vessel's course recorder was not operating at the time of the incident and the bridge team did not maintain a bridge movement/bell book. Approximate times of passing beacons have been calculated based on a speed of 8.5 knots (262 m/min).
