Engine malfunction involving Pilatus PC-12, VH-OWS

near Meekatharra Airport, Western Australia, 7 August 2017

ATSB Transport Safety Report
Aviation Occurrence Investigation
AO-2017-087
Final – 31 May 2018

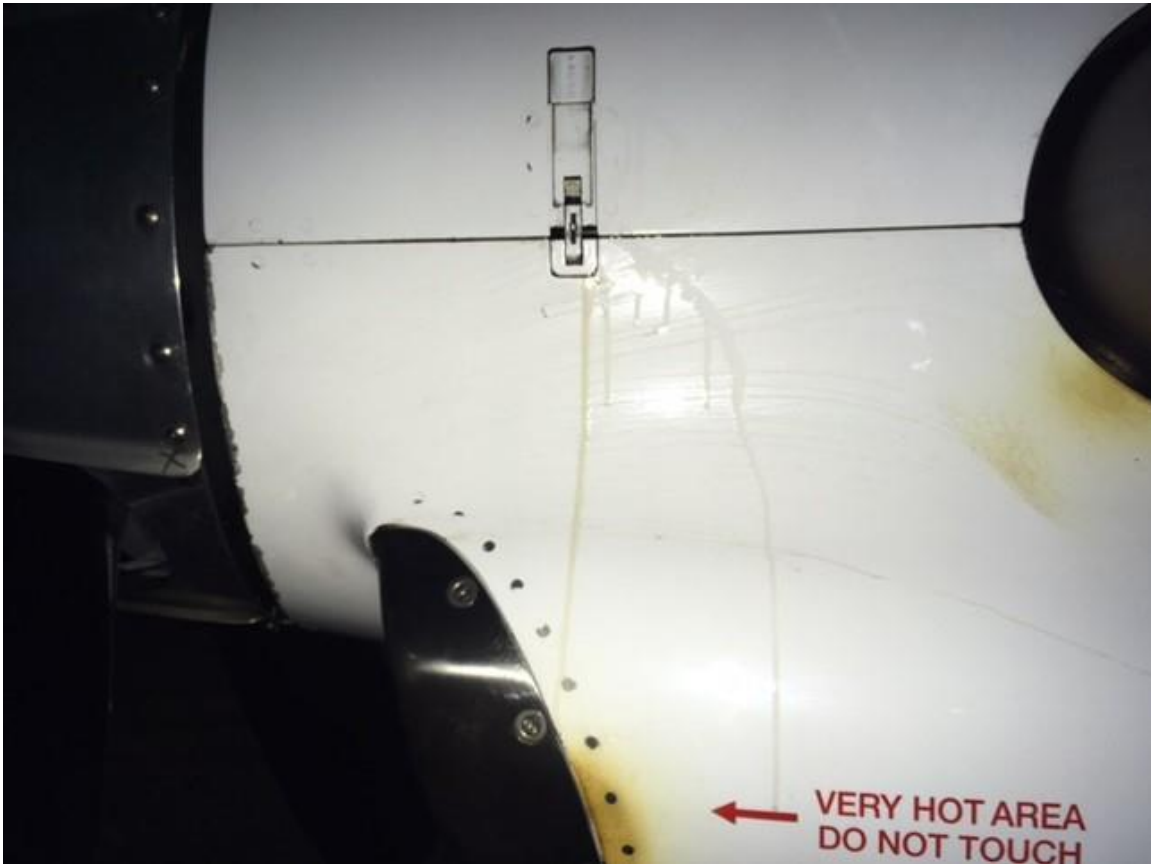
After landing, the pilot checked the aircraft and found oil on the engine cowling (Figure 1) and dripping/pooling on the tarmac. When the engine cowling was opened, a small amount of smoke could be seen coming from where oil had contacted hot engine parts.

Figure 1: Oil on the outside of the engine cowling

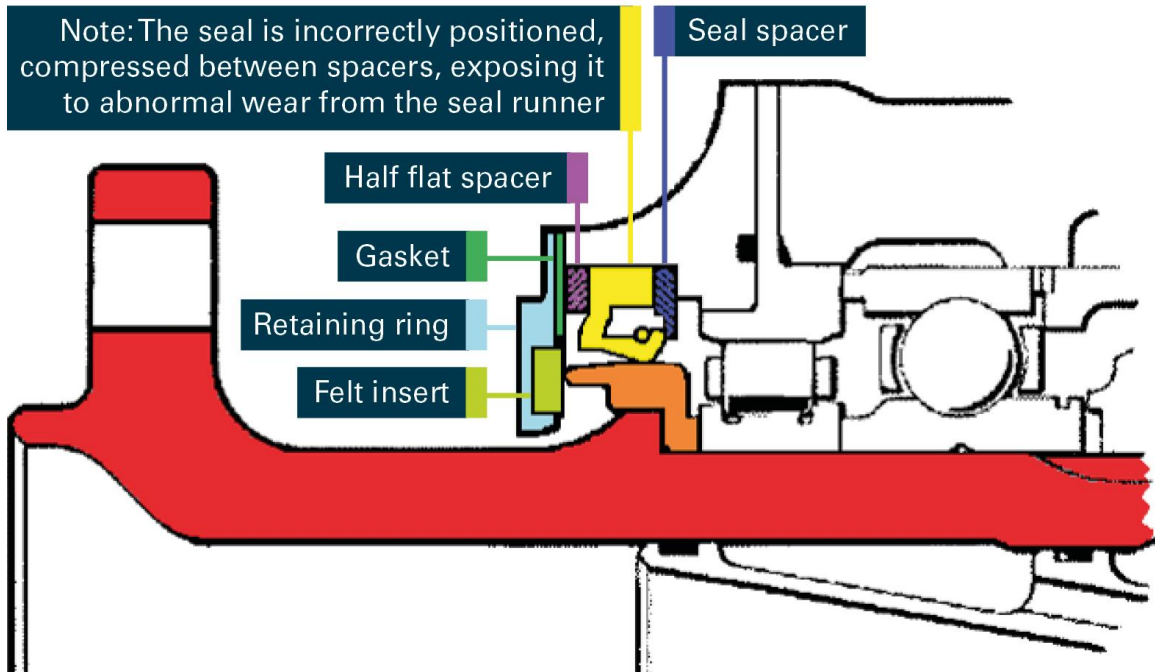
The aircraft operator (RFDS) investigated the incident and identified that the propeller shaft seal had been incorrectly assembled (Figure 2). The seal had been replaced at Jandakot on 6 August 2017 (the day before the incident) after which the aircraft had flown to Meekatharra, a flight of about 1 hour 40 minutes.

Figure 2: Propeller shaft seal assembly at the time of the incident

The oil leaked from the propeller shaft seal assembly because parts of the seal had not been assembled in the correct order. As the half flat spacer had been placed forward (instead of aft) of the seal, the seal was compressed and was pushed against the seal runner (Figure 2). In that configuration, the friction from the rotating seal runner resulted in abnormal wear of the seal allowing engine oil to leak.

- Maintenance engineers have been reminded that the use of memory, IPCs and engineering by comparison, are not suitable methods for conducting aircraft maintenance.
- The engineers have also been reminded to use the EMM and associated diagrams for the maintenance, including the propeller shaft seal assembly.
- Engineer's overtime is being monitored while a more permanent solution for workplace fatigue management is being considered.

- Pratt & Whitney has initiated a manual revision for the IPC to add an illustration of the most current (post service bulletin) configuration of the seal assembly, and amend the EMM to add a caution in the reduction gearbox maintenance practices section.

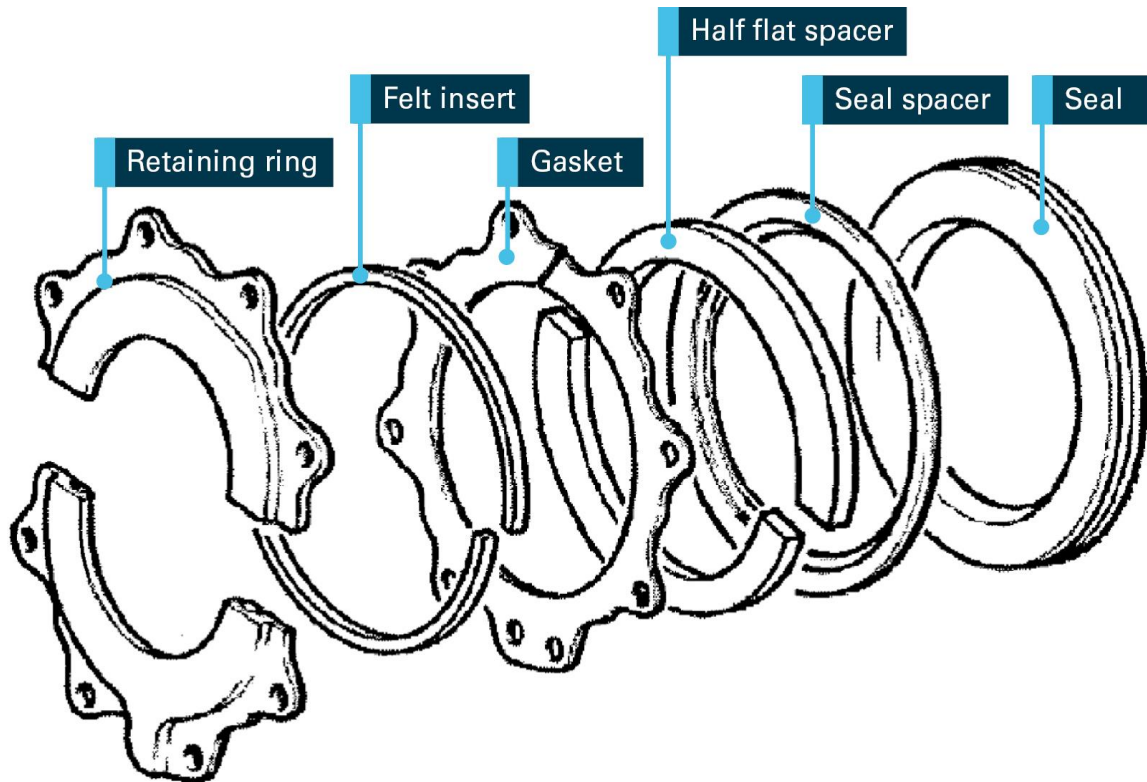
When replacing the seal, the engineer assembled the parts in the order that he recalled from disassembly, and the diagram in the engine manufacturer's, Pratt & Whitney Canada (P&WC), illustrated parts catalogue (IPC). He recalled that the half flat spacer was located forward of the seal—the same as the IPC (Figure 3). After replacing the seal, he ran the engine and no oil leaks were evident.

Figure 3: Propeller shaft seal assembly parts diagram in the IPC

When assembling the propeller shaft seal, the engineer had used the indicative diagram in the IPC instead of the diagram in the EMM, which showed the correct order of parts. He did refer to the EMM but did not notice that the assembly procedure and diagram in it were different to the diagram in the IPC. He also relied on his memory to recall the order in which the parts were removed, which may have been affected by fatigue associated with longer working hours and disrupted sleep.

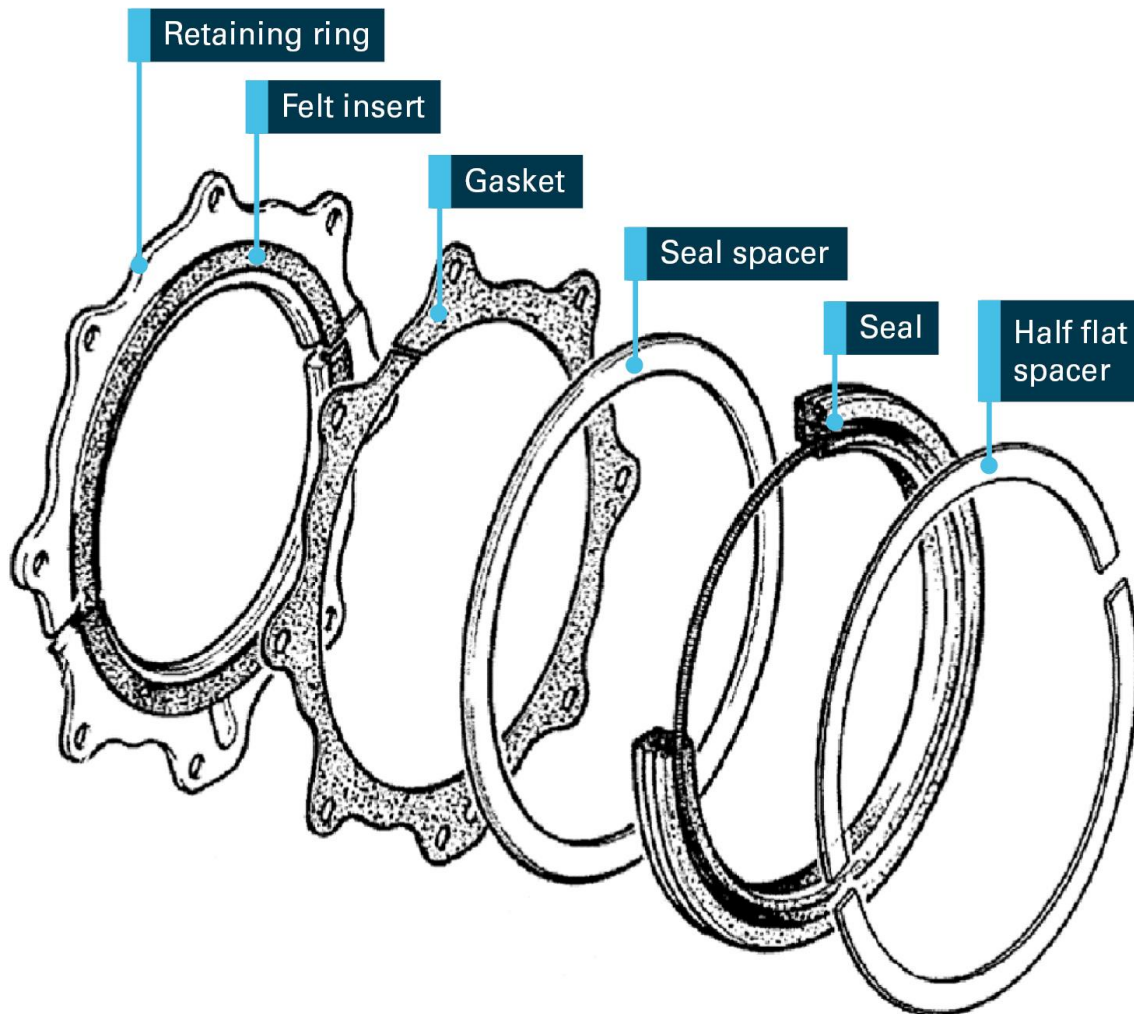
The RFDS investigation found that the IPC was not intended to be used for seal replacement nor did it show the correct order of parts in the seal assembly. Only the P&WC engine maintenance manual (EMM) was intended to be used for maintenance, including propeller shaft seal replacement. The diagram in the EMM showed the half flat spacer correctly located aft of the seal (Figure 4). The EMM assembly procedure permitted the positions of the seal and the seal spacer shown in Figure 4 to be interchanged. In both configurations however, the half flat spacer was to be installed aft of the seal. The engineer had referred to the EMM but had not identified the discrepancy between the seal assembly diagrams in the IPC and the EMM.

Figure 4: Propeller shaft seal assembly diagram in the EMM
