Engine pylon cracking involving Boeing 747-438, VH-OJT

Hong Kong SAR, People's Republic of China, 5 October 2016

ATSB Transport Safety Report
Aviation Occurrence Investigation
AO-2016-148
Final – 6 June 2018

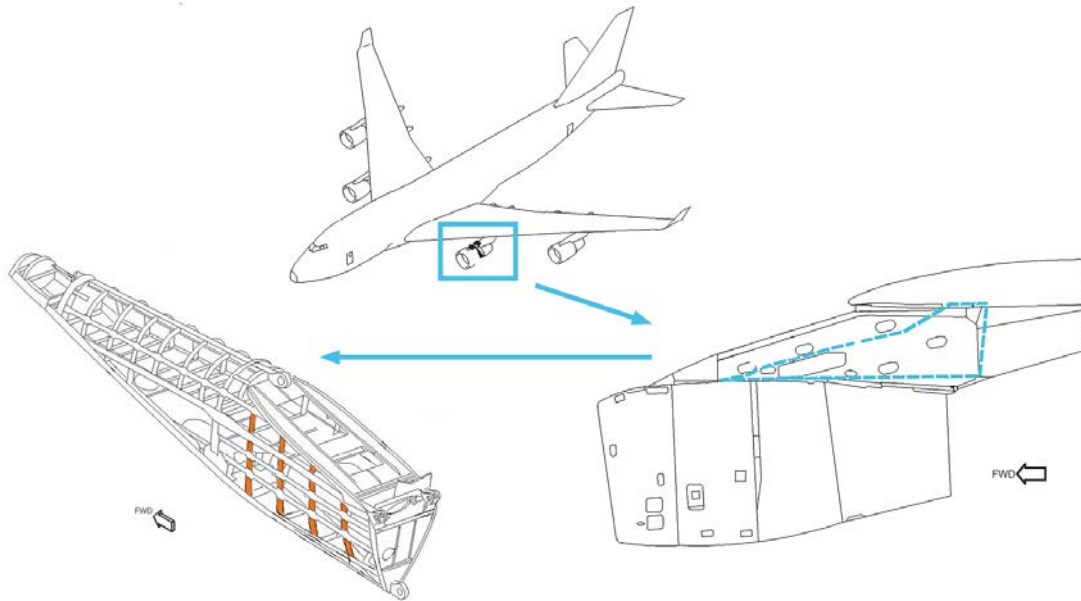
On 5 October 2016, a Qantas-operated Boeing 747-438 aircraft, registered VH-OJT (Figure 1) was undergoing routine maintenance at a contracted repair and overhaul facility in the Hong Kong Special Administrative Region (SAR) in the People's Republic of China. Inspection of the No. 2¹ engine pylon identified cracking of four outboard strut ribs from within the torque box of the pylon (Figure 2).

Figure 2: Boeing 747 engine pylon showing the location of the cracking (highlighted)

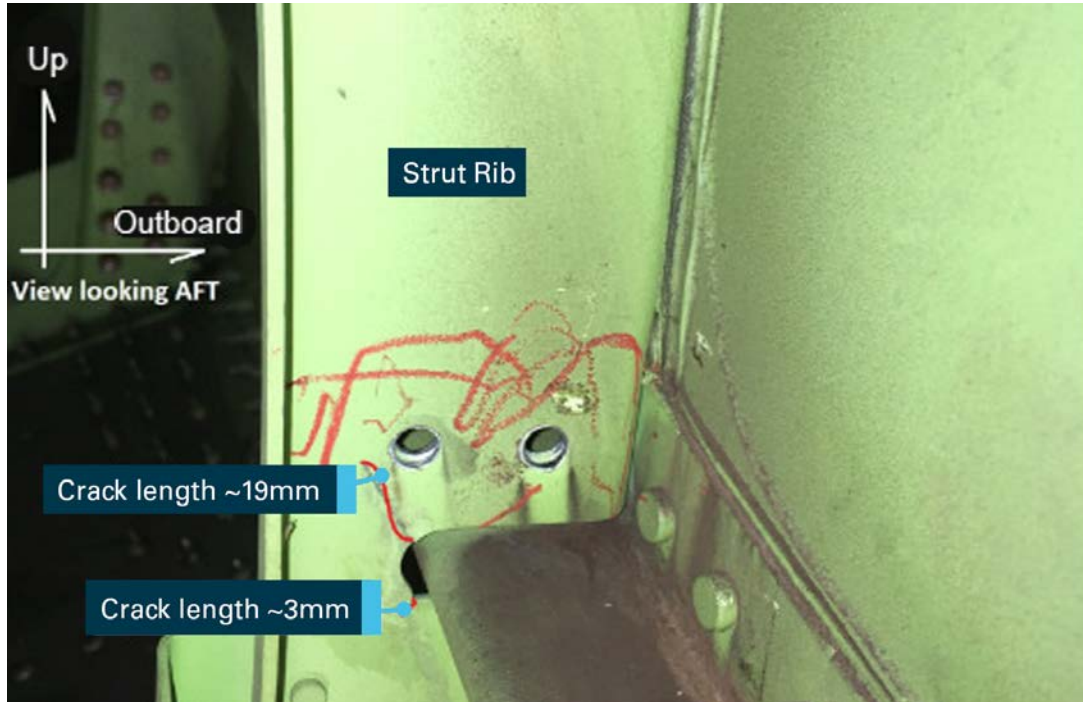
Following removal from the aircraft, four cracked outboard strut ribs were sent to Boeing for metallurgical examination and fracture analysis. The examination confirmed that five cracks had developed in the strut ribs, all emanating from the rib cutaway region, ranging in length from 3—19 mm (Figure 3 to Figure 5). Boeing’s report³ contained the following detail:

- SEM analysis of the fracture surfaces confirmed that each strut rib had striations and crack-progression marks consistent with fatigue cracking. No evidence was found of ductile tearing or plastic deformation at the crack origins, which might otherwise suggest that the fatigue cracking had initiated due to excessive vibration or torque loads from a transient engine event.

Figure 3: A strut rib in-situ within the No. 2 pylon with two cracks identified

- The fatigue cracking in four outboard strut ribs in the No. 2 engine pylon is likely to have developed from exposure to vibratory loading within the pylon during normal engine operation over the aircraft's service life.
- The extent of fatigue cracking in the ribs did not affect the structural integrity of the pylon for all certified load cases, which meant that the aircraft's safe operation was not affected.

Following technical advice from Boeing, the No. 2 engine was removed from its wing installation to allow access to the pylon and removal of the cracked strut ribs. The aircraft was repaired and, after completing the maintenance visit, it was returned to regular passenger service. The cracked ribs were sent to Boeing's facilities in the United States for specialist metallurgical examination.

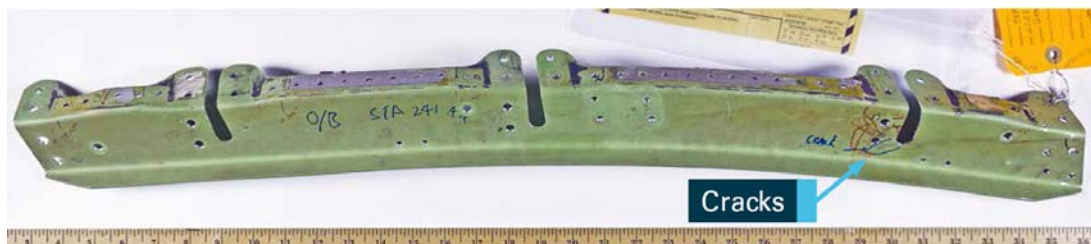
Figure 4: The strut rib from Figure 3 after removal from the pylon

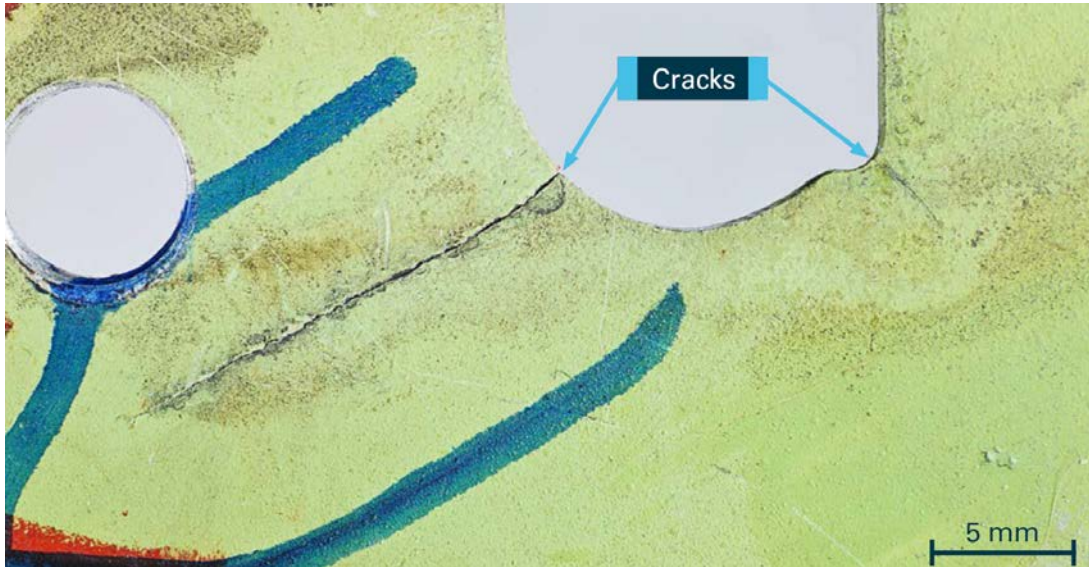
Figure 5: Close-up of the cracking in the cutaway region shown at Figure 4
