# Collision between the container ship *Beijing Bridge* and fishing vessel *Saxon Onward*

Tasman Sea, about 3 NM south-east of Gabo Island, Victoria, on 23 January 2018

**ATSB Transport Safety Report**  
Marine Occurrence Investigation  
339-MO-2018-002  
Final – 20 July 2018

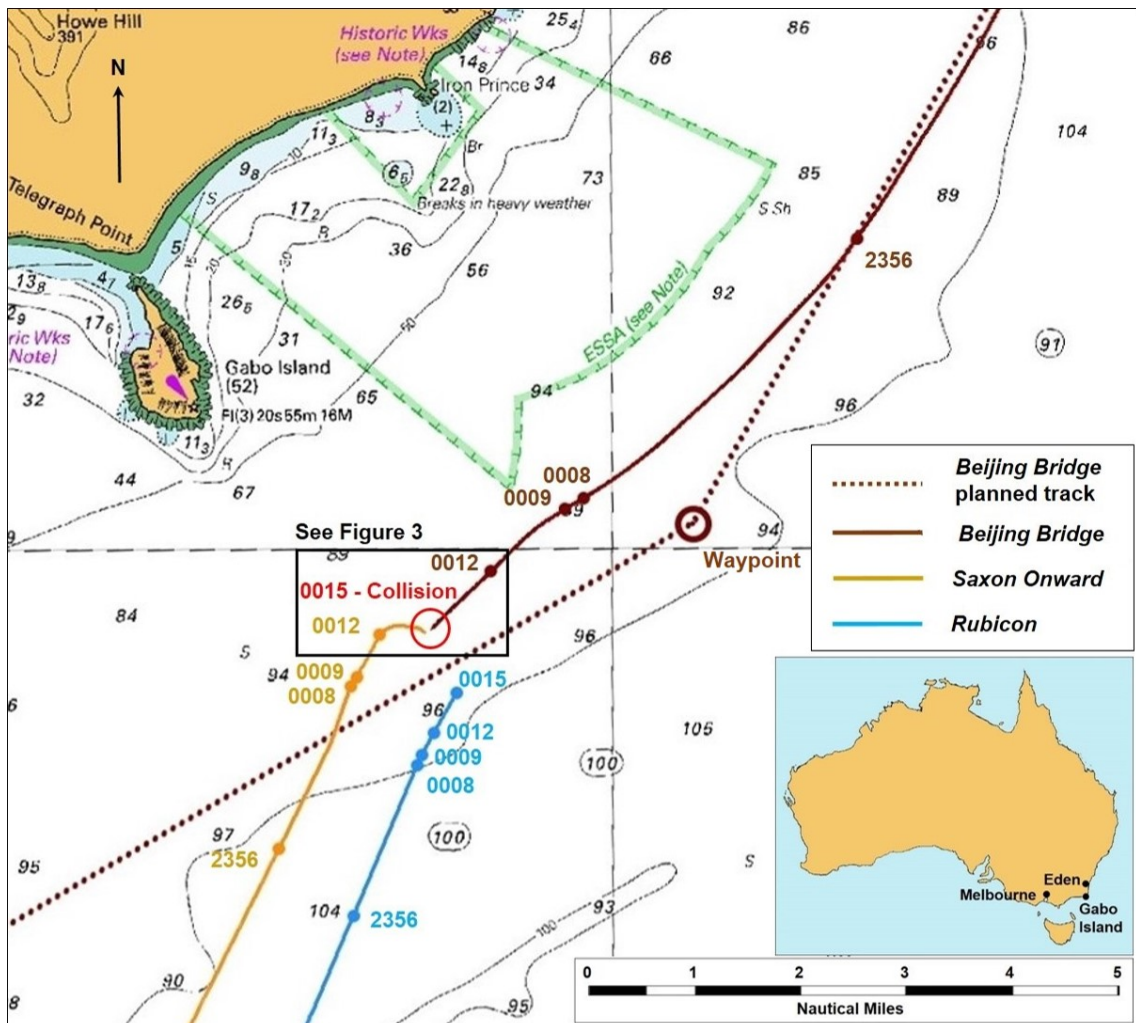
**Figure 2: Section of navigational chart Aus 395 showing times of key events**

At about 2356 (Figure 2), with *Beijing Bridge* now on a heading of 216°, the OOW commenced a course alteration to starboard about 3.2 NM in advance of a planned course alteration position (waypoint). Over the next 10 minutes, the OOW made a succession of small heading alterations that took the ship further to starboard, away from the planned track.

- *Beijing Bridge's* planned alteration of course, to starboard, executed in advance of the passage plan waypoint, placed the ship in a developing close quarters situation involving risk of collision with *Saxon Onward*.

- *Beijing Bridge's* subsequent alteration of course was neither substantial nor made in good time and was inconsistent with the master's standing orders, company procedures and the International Regulations for Preventing Collisions at Sea, 1972, as amended, (COLREGs). The action failed to remove the ship from the existing close quarters situation and increased the risk of a collision.

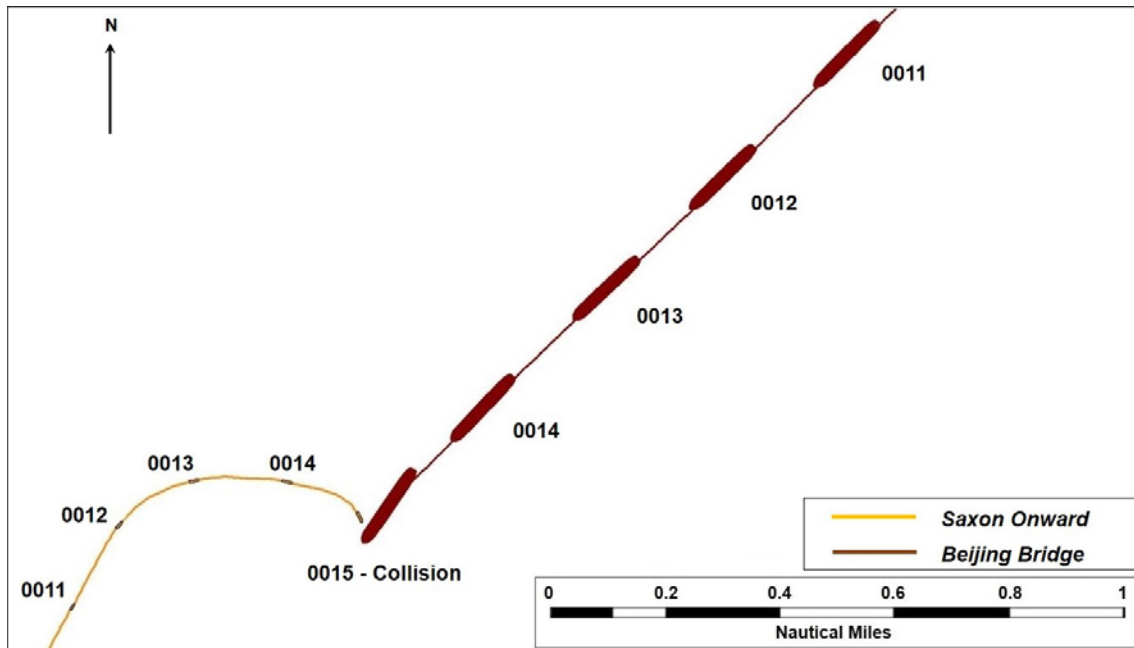
Figure 3: Section showing detail of collision

By about 0008, *Beijing Bridge* was steady on the new course with a heading of 241° and was about 0.75 NM to starboard of the ship's planned track with *Saxon Onward* fine on the ship's port bow. About a minute later, the OOW<sup>4</sup> altered the ship's heading to port with the intention of passing between the two trawlers and increasing the distance at which *Saxon Onward's* closest point of approach (CPA)<sup>5</sup> would occur. The ship eventually settled on a heading of 228° at about 0012 with *Saxon Onward*, now on the ship's starboard bow.

Shortly after, *Saxon Onward's* watchkeeper commenced a rapid turn to starboard at a distance of about 1 NM from *Beijing Bridge*.

In response, *Beijing Bridge's* OOW altered the ship's heading to port from 228° to 225° and flashed the ship's Aldis lamp<sup>6</sup> at *Saxon Onward* followed by a long blast on the ship's whistle. Woken by the whistle, the ship's master called the OOW on the bridge telephone to find out what was happening and was told that he was needed on the bridge. The OOW then continued to sound long blasts on the ship's whistle. At about 0014, the OOW changed the steering over from autopilot to hand steering and placed the wheel hard to port.

Meanwhile, on *Saxon Onward*, the watchkeeper realised that the trawler was in danger and shouted to alert the skipper and crew. At about 0015, as the skipper arrived in the wheelhouse, *Saxon Onward* collided with *Beijing Bridge* (Figure 3). The trawler's port bow impacted the ship's starboard side in the region of cargo hold number 3, about 94 m aft of the ship's bow. As the trawler then scraped down the ship's side, the skipper stopped the engine and the crew mustered in the wheelhouse. The trawler heeled over sharply to starboard and took on some water before it righted itself, passed the ship's stern and drifted away to the north-east.

- *Saxon Onward's* alteration of course to starboard was made in response to the head-on situation that the watchkeeper assessed the vessel to be in. The alteration, while substantial, was not made in sufficient time to have a positive effect on the situation and resulted in the collision.

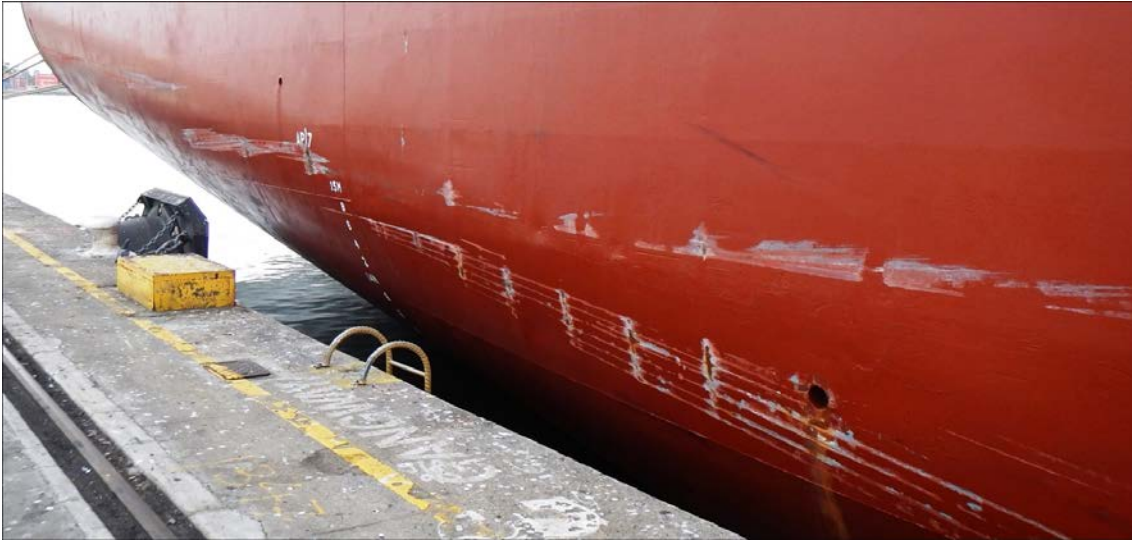
**Figure 4: *Beijing Bridge* showing surface damage to the hull on the starboard side**

*Beijing Bridge* berthed at Melbourne later that night and was attended by Australian Maritime Safety Authority (AMSA) surveyors the next day (24 January). The ship sustained minor damage, including indentations to the hull and scratch marks down most of the ship's starboard side (Figure 4). *Beijing Bridge* was detained while the authorities conducted inspections and collected evidence before being released to continue its voyage on 25 January.

Deadweight (summer):	65,038 t (4,738 TEU)
Summer draught:	13.5 m
Length overall:	294.12 m
Moulded breadth:	32.2 m
Moulded depth:	21.8 m
Main engine(s):	Hyundai MAN B&W 8K98MC-C MK6
Total power:	29,413 kW
Speed:	21.5 knots
Damage:	Minor damage to starboard side shell plating

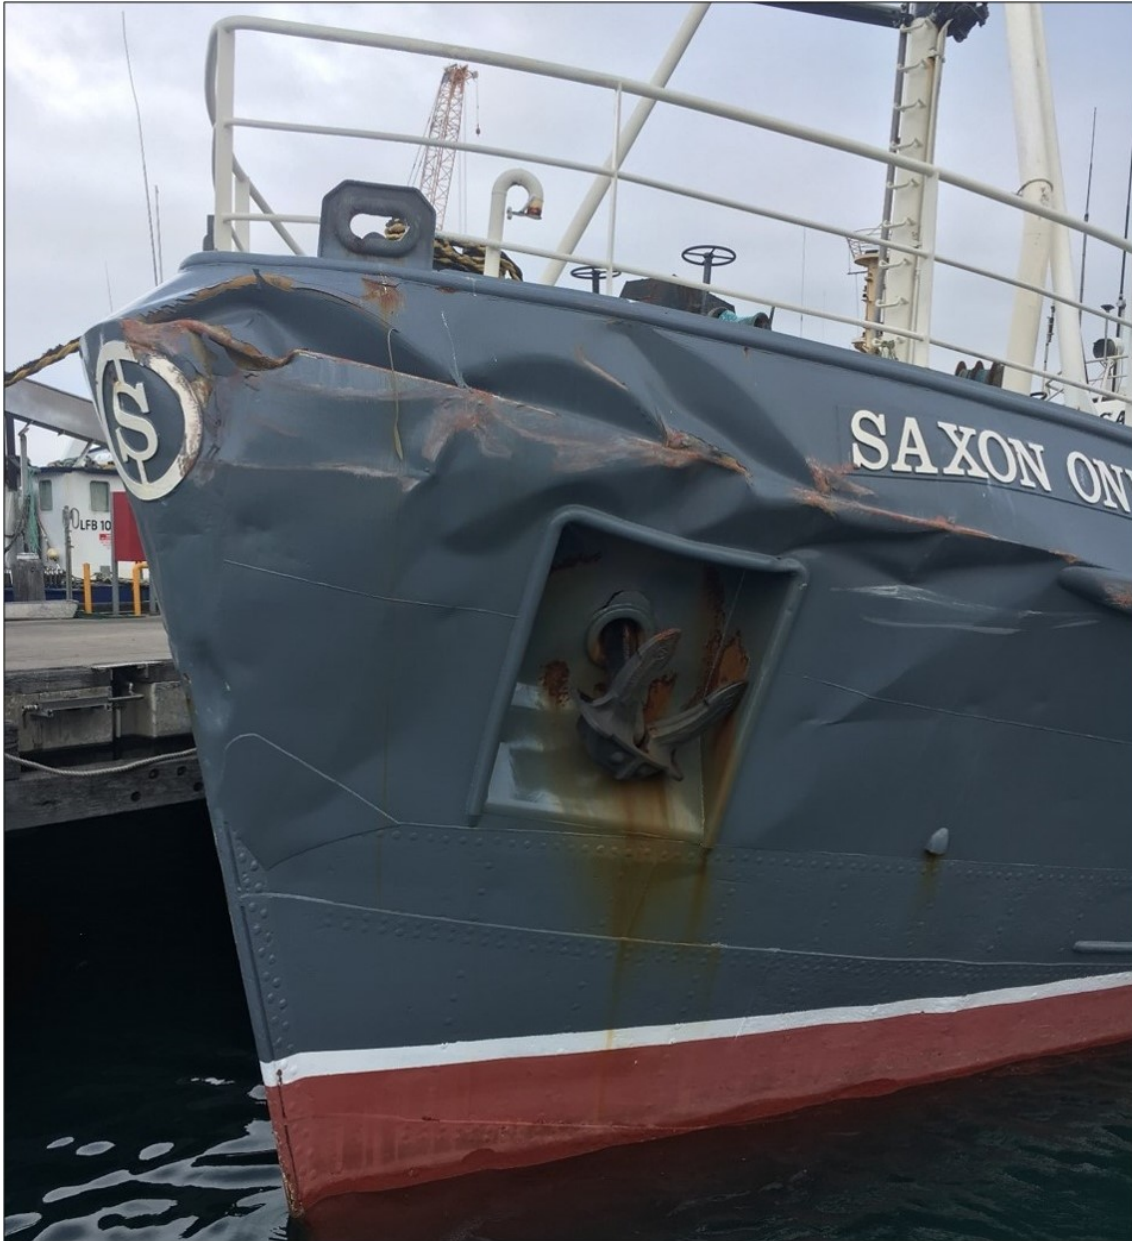
**Figure 5: Saxon Onward, alongside in Eden**

*Saxon Onward* arrived safely in Eden at about 0600, six hours after the collision and was attended by AMSA later that afternoon. The trawler sustained substantial damage to the port bow (Figure 5), structural cracks and displacement of the port side A-frame arm and structural damage to deck fittings. The trawler also lost a net overboard and sustained seawater damage to an auxiliary engine, a generator and to cabin fittings.

Name:	<i>Saxon Onward</i>
IMO number:	5314987
Call sign:	VJT5748
Flag:	Australia
Classification society:	N.A.
Ship type:	Fishing vessel - Trawler
Builder:	Grimsby, United Kingdom
Year built:	1960
Owner(s):	Seafood Specialists, New South Wales, Australia
Manager:	Voyager Seafoods, New South Wales, Australia
Gross tonnage:	209.8
Length overall:	32.16 m
Moulded breadth:	7.03 m
Moulded depth:	3.81 m
Main engine(s):	Cummins K-38
Total power:	464 kW
Speed:	11 knots
Damage:	Structural damage to port bow, A-frame, deck fittings and water damage to cabins and generator.
