# Flight below minimum altitude involving Boeing 777, ZK-OKN

23 km SSW of Brisbane Airport, Queensland, 18 November 2017

**ATSB Transport Safety Report**  
Aviation Occurrence Investigation  
AO-2017-113  
Final – 26 June 2018

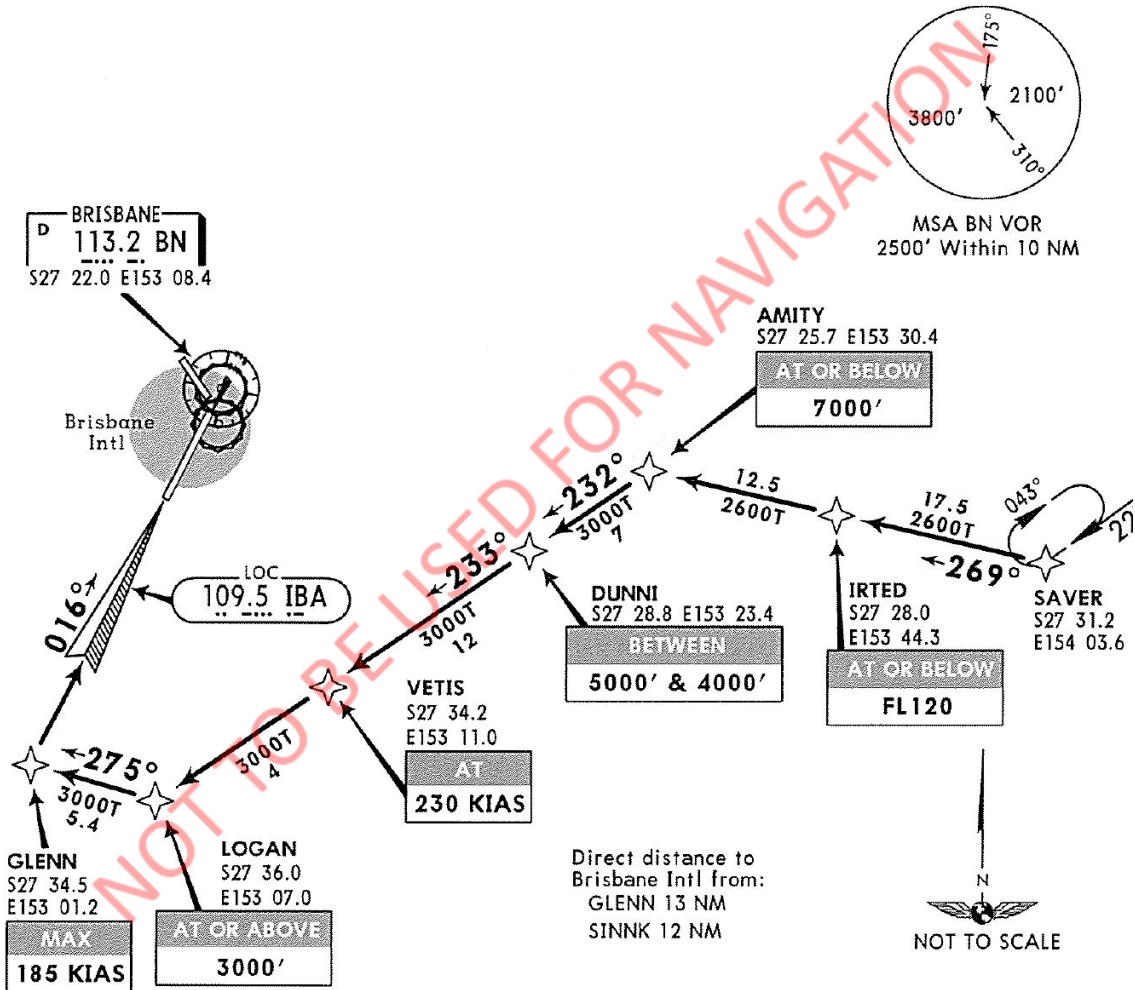
Figure 1: An extract of the Jeppesen SAVER1A chart

Prior to commencing the descent, the aircraft was cleared to conduct a SAVER1A standard arrival procedure for an ILS approach to runway 01 (Figure 1). The flight crew reprogrammed and re-briefed the arrival before commencing the descent.

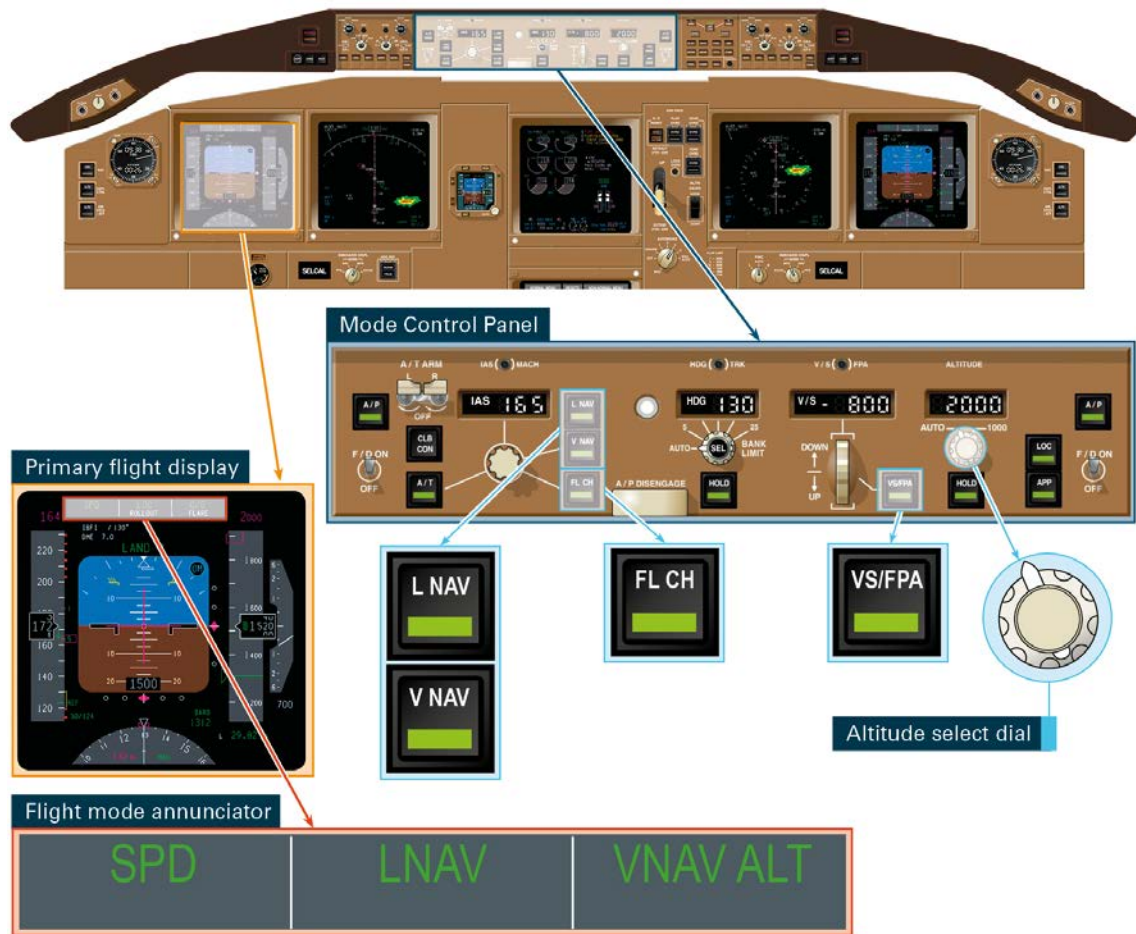
**Figure 2: Flight deck panels identifying the mode control panel with associated controls, and the primary flight display with the flight mode annunciator expanded.**

The aircraft's quick-access recorder (QAR)<sup>5</sup> provided information on the aircraft's flight parameters, autoflight system altitude targets, and autoflight system modes. During the descent, the aircraft was being controlled by the PF through the use of an autopilot, with flight profile changes being achieved through selections on the mode control panel (MCP) (see Figure 2). Under normal procedures, the flight crew were required to verify autoflight system mode changes, such as those selected on the MCP, had been activated through the required mode being displayed on the flight mode annunciator (FMA). The FMA, located just above the primary flight display (see Figure 2), displayed the active flight modes for, from left to right, the autothrottle, roll and pitch.

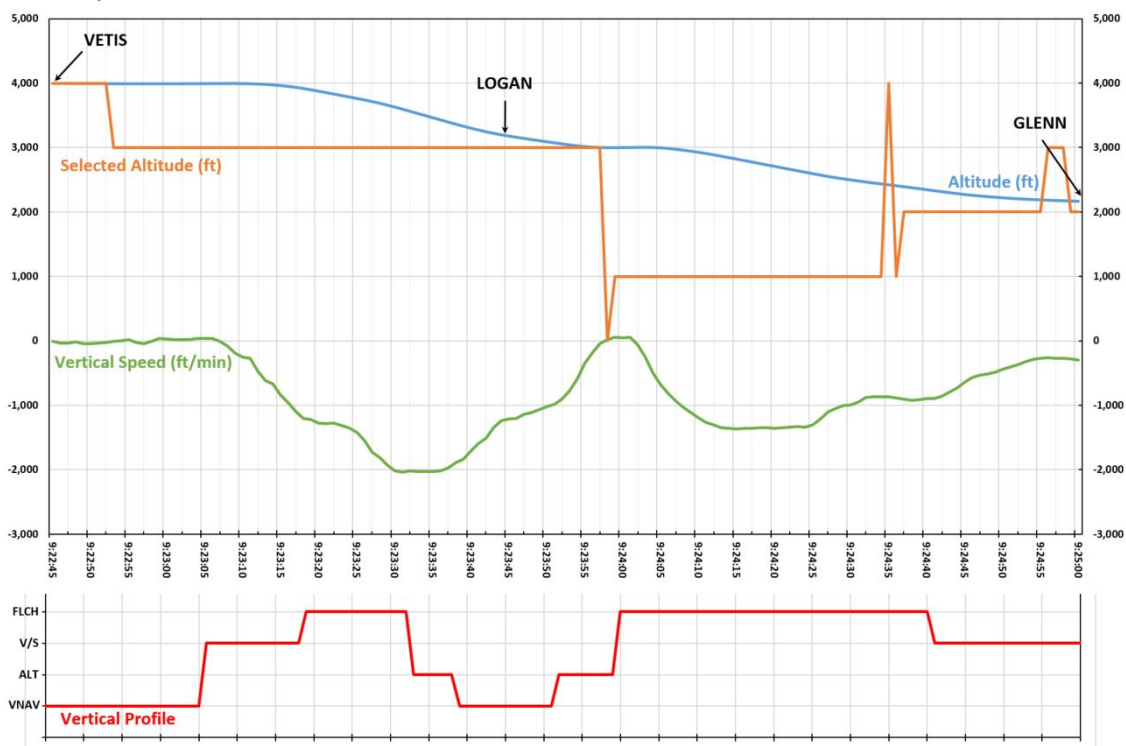
**Figure 3: Flight data for the period 0922.45 (at about VETIS) to 0925.00 (just before GLENN).**

Shortly after passing VETIS, at 0922:45, and while maintaining 4,000 ft, ATC cleared the aircraft to descend to 3,000 ft and for the ILS runway 01. The PF selected 3,000 ft in the MCP altitude window (see Figure 3 at 0922:52) and pressed the altitude selector<sup>7</sup> to initiate further descent. The PF later observed that the altitude selector was probably not properly pressed. As a result, the expected flight mode change did not occur and the aircraft did not commence the descent as expected. The QAR data recorded the autoflight pitch remaining in the VNAV mode, however, the

flight crew later reported that the VNAV mode changed from VNAV PTH to VNAV ALT. The PF reported that this pitch mode change was unexpected and unfamiliar. The flight crew operations manual stated the following with respect to the pitch mode entering VNAV ALT:

In response, and with the intent of ensuring that the aircraft did not get high on the desired descent profile, the PF selected the V/S<sup>8</sup> mode, and then the FLCH<sup>9</sup> mode, to initiate the descent. The aircraft commenced descending and at 0923:33 the autoflight system commenced reducing the rate of descent to capture the cleared altitude of 3,000 ft—indicated by the ALT<sup>10</sup> mode activating. Shortly after, and as the aircraft passed through LOGAN, the autoflight system transitioned back into the VNAV mode and then the ALT mode.

As the aircraft was turning towards GLENN, and maintaining the cleared altitude of 3,000 ft, the PF selected 1,000 ft in the MCP and then the FLCH mode with the intent of continuing the descent further. About 5 seconds later, at 0924:03, the aircraft commenced descent from 3,000 ft. At 0924:14, as the aircraft had passed 2,850 ft, ATC instructed the aircraft to maintain best speed, and at least 180 kt until 5 NM final. The PM acknowledged the instruction.

At 0924:35 the PF raised the MCP target altitude to 2,000 ft and changed the flight mode to V/S. At 0924:50, ATC alerted the aircraft that it was cleared to 3,000 ft and that it was descending through 2,200 ft, which was acknowledged. The aircraft levelled at about 2,000 ft and maintained that altitude until it intercepted the glideslope for the ILS. The aircraft landed at 0929 without further incident.
