# Unsafe proximity and radar vector below minimum vector altitude involving a Boeing 777-31HER, A6-EBU, and two Boeing 737-838s, VH-VXS and VH-VYE

Melbourne Airport, Victoria | 5 July 2015

**ATSB Transport Safety Report**  
Aviation Occurrence Investigation  
AO-2015-084  
Final – 6 August 2018

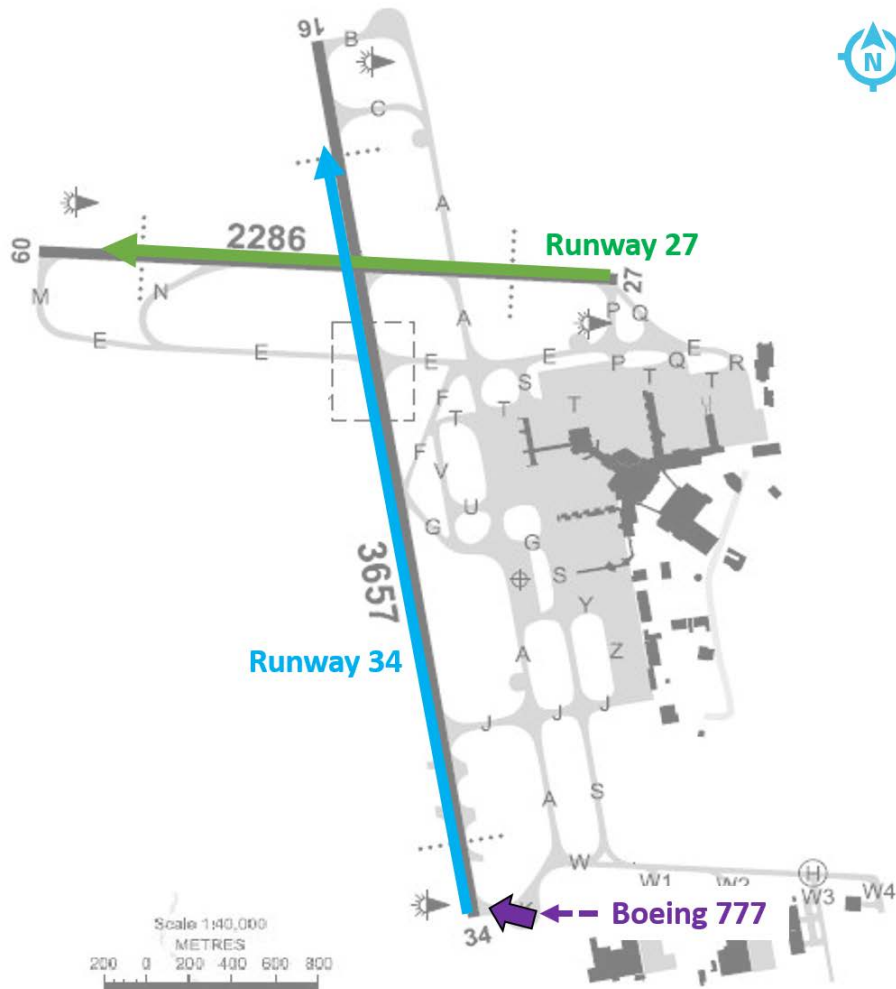
**Figure 1: Melbourne Airport diagram with runways 27 and 34 indicated (green and blue respectively) and the location where the B777 entered runway 34 indicated by a purple arrow**

The coordinator expressed concern that the departing B777 was still occupying runway 34 and that a runway separation standard would not be maintained with the arriving VYE.<sup>9</sup> Receiving what he deemed an unsatisfactory response from the tower OJTI, the coordinator then instructed the trainee tower controller to send VYE around.<sup>10</sup> At the same time as the trainee tower controller instructed the flight crew of VYE to go around, at 1811, a runway 34 occupancy caution activated in the Tower because the B777 was still on runway 34 and VYE was less than 15 seconds flight time from the threshold.<sup>11</sup> Two seconds later, the caution upgraded to a warning as VYE was now less than 10 seconds flight time from the threshold descending through 500 ft and the B777 was still on the runway, passing taxiway FOXTROT (Figure 2). At that time, VXS was less than 1 NM (2 km) from the runway 27 threshold climbing through 1,100 ft.

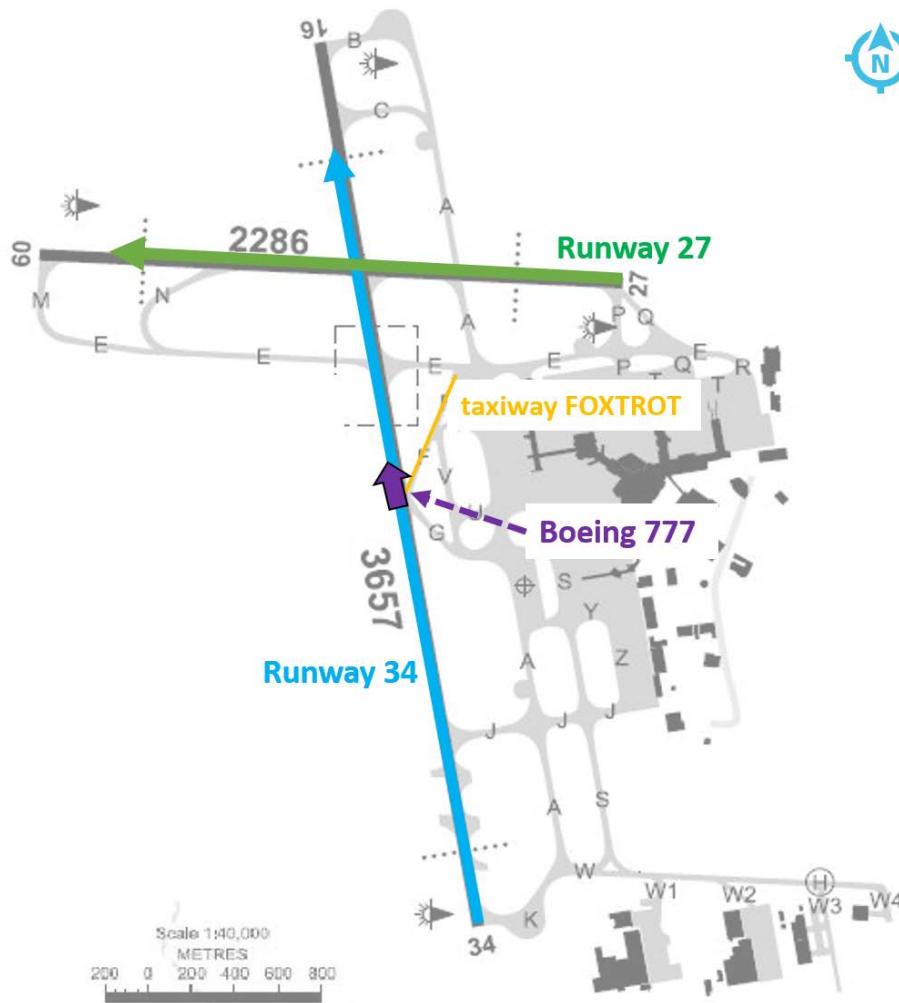
**Figure 2: Melbourne Airport diagram with runways 27 and 34 indicated (green and blue respectively), and the location of the B777 (purple arrow) passing taxiway FOXTROT (yellow) at 1810:34**

Seconds later the flight crew of VYE reported that they had commenced the go-around. Surveillance data showed that the B777 was still on runway 34, south of the intersection with runway 27. The trainee tower controller then advised the flight crew of VYE that a B737 (i.e. VXS) was going around on runway 27 but used the incorrect runway identification – runway 34 instead of runway 27.

At 1810:43, as VYE flew over the threshold of runway 34, surveillance data showed the aircraft climbing through 600 ft with the B777 still on the runway, still south of the intersection with runway 27, with VXS less than 0.3 NM (0.6 km) from the threshold of runway 27 climbing through 1,200 ft.

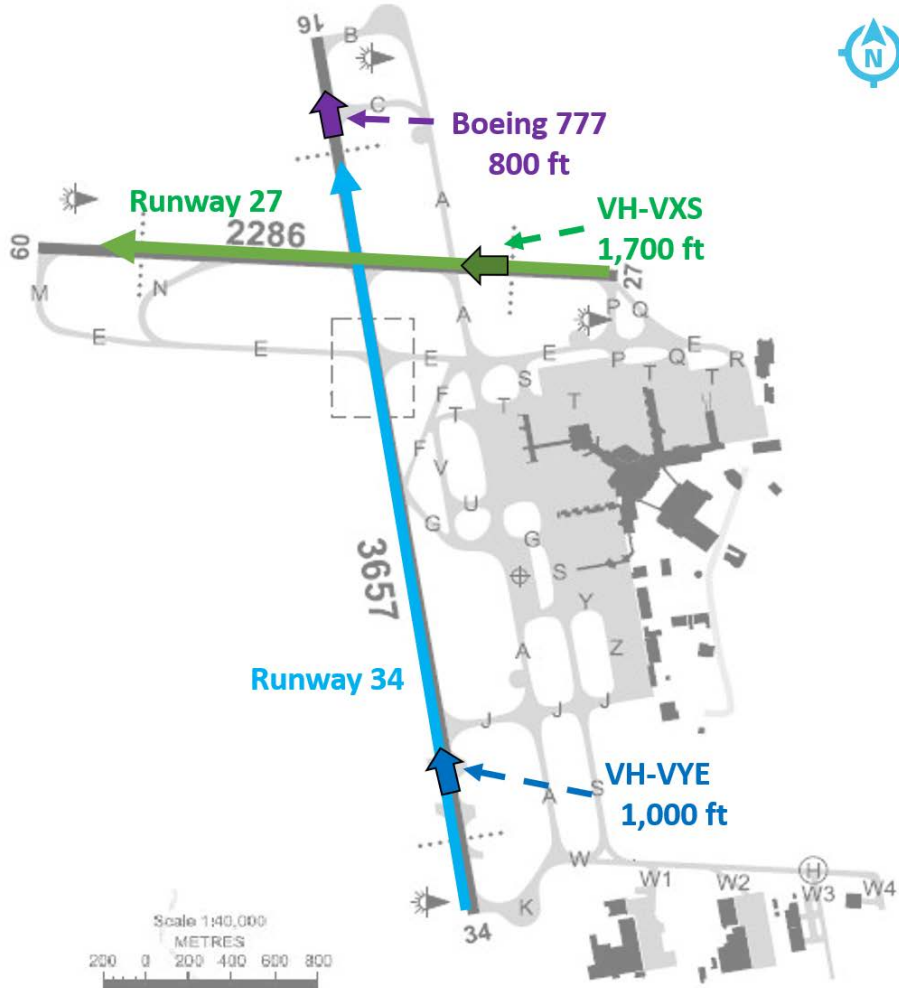
Nine seconds later at 1810:52, as VYE left 1,000 ft on climb overhead runway 34 (Figure 3), the trainee tower controller was instructed to tell the flight crew to turn right onto a heading of 360° while the aircraft was below the minimum vector altitude (MVA) of 2,000 ft.<sup>12</sup> At that time, surveillance data showed the B777 north of the runway 27 intersection climbing through 800 ft and VXS overhead runway 27 climbing straight ahead through 1,700 ft. Shortly afterwards, the trainee

**Figure 3: Melbourne Airport diagram showing the location and height of the B777 (purple), VH-VXS (green) and VH-VYE (blue) at 1810:52**

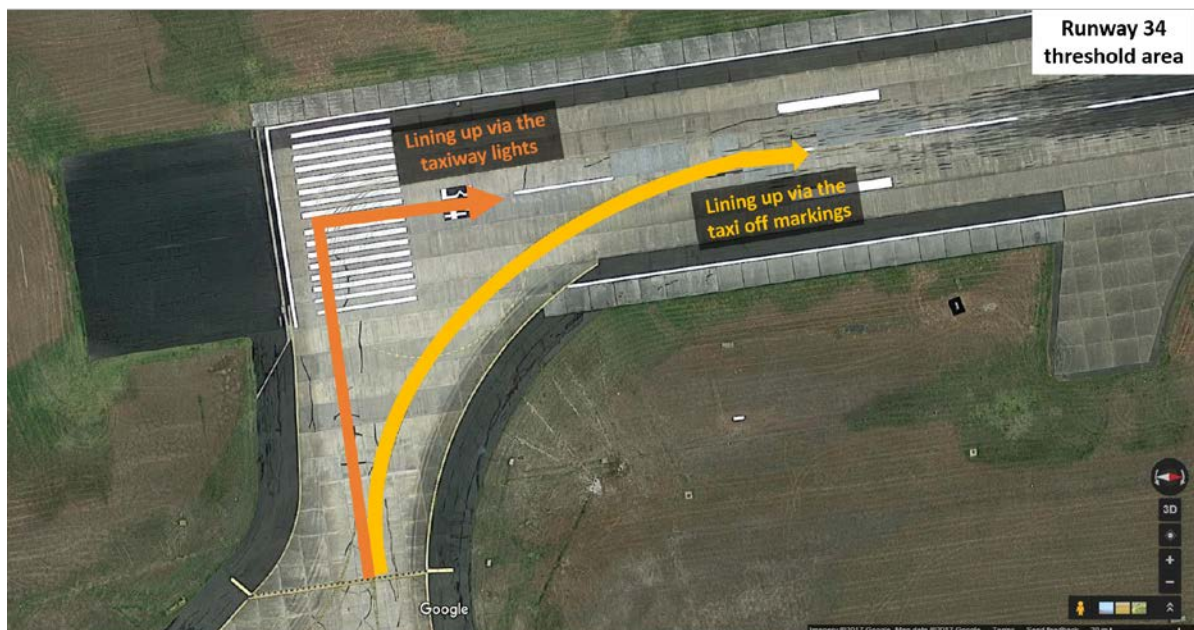
A senior Tower controller reported that, during the day, most aircraft line up on runway 34 by following the runway 16 taxi-off markings (in yellow on Figure 4), entering the runway via a curve. Some aircraft also follow this path at night, but some follow the taxiway lighting onto runway 34, resulting in a 90° turn to line up in the departure direction (in orange on Figure 4).

**Figure 4: Threshold of runway 34 at Melbourne Airport, showing the curved line-up track in yellow, and the track in orange that follows the taxiway lighting**

The trainee tower controller and the tower OJTI both reported that, when issued with a clearance for an immediate take-off, they had expected the Boeing 777-31HER (B777) to line up via the curved entry to runway 34. The controllers believed that by entering runway 34 via a 90° turn, the B777's take-off was delayed.
