DEPARTMENT OF CIVIL AVIATION

AVIATION
SAFETY DIGEST

No. 6

JUNE, 1956

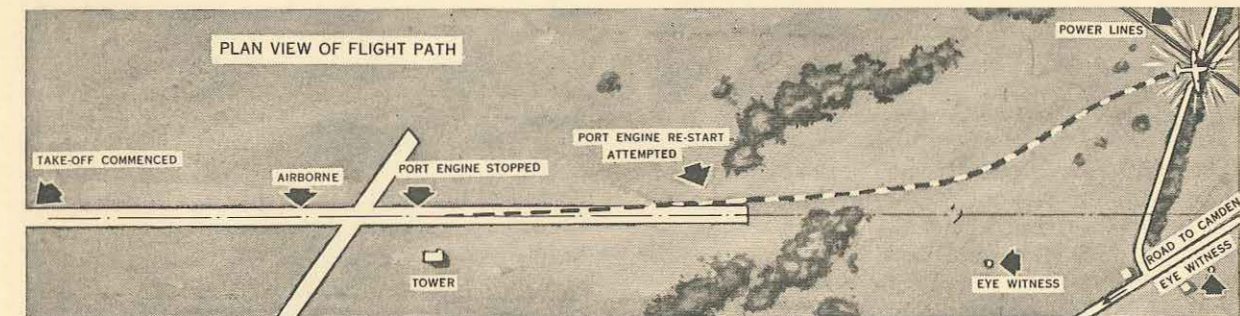
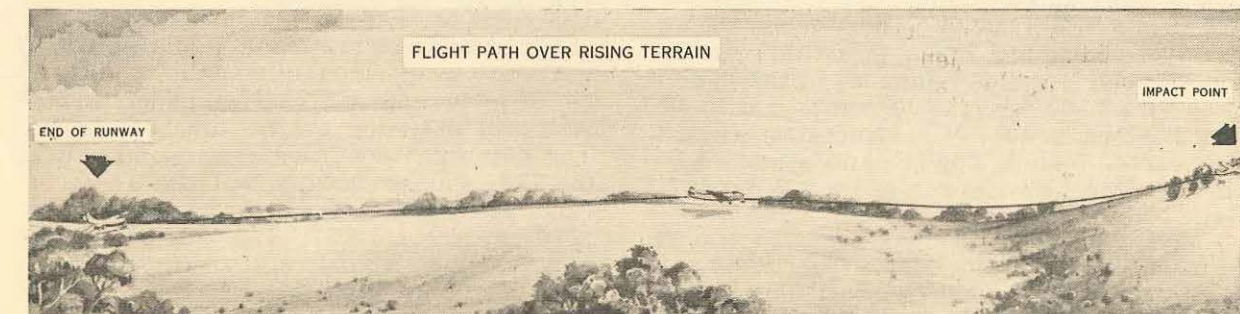
an engine failure in take-off was simulated. The aircraft, whilst operating on one engine, failed to gain sufficient height to clear obstacles in the take-off path and crashed

into a wooden pole at a point some two-thirds of a mile beyond the upwind end of the runway (see diagram of flight path).

the time of failure simulation was probably a little in excess of 78 knots (the minimum safe speed for single-engine flight). Almost immediately the instructing pilot directed that the port engine be restarted and this was attempted, as the aircraft passed the upwind end of the runway, but without success. The aircraft, now very close to the rising ground, flew a weaving course with diminishing airspeed up the undulating slope until, at a point some 3,500 feet beyond the upwind end of the runway, it crashed through trees and struck a wooden pole carrying high voltage power cables. The aircraft fell into a cleared field beyond the pole and was wrecked. There was no fire but the senior examiner who had been undergoing instruction died of injuries soon after the accident, the instructing pilot was seriously injured and the supernumerary examiner escaped with bruises and a shaking. The sketches on page 17 detail the flight path of the aircraft in plan and in elevation.

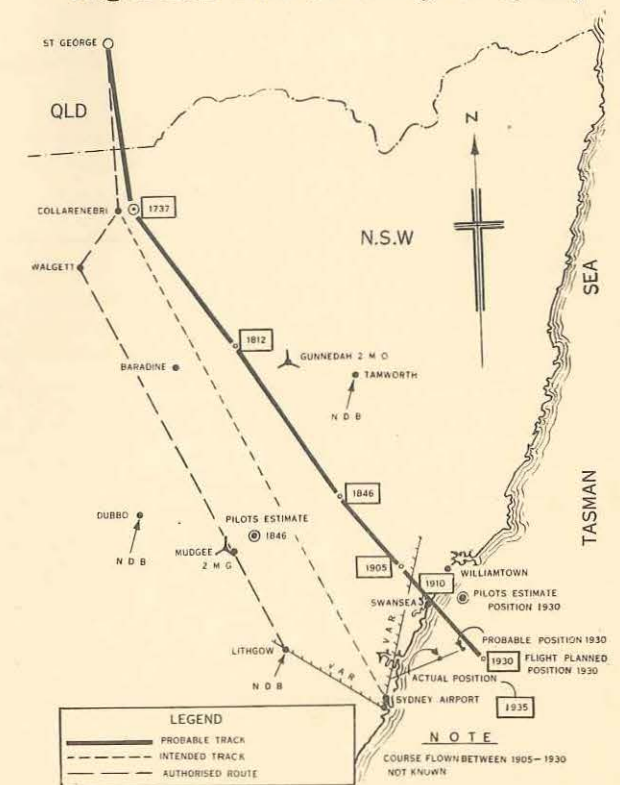
Flight Path from St. George to Sydney

On receipt of the information that the aircraft radio compass was unserviceable air traffic control instructed the aircraft to join the aural leg of the Sydney VAR. This message was passed to the aircraft at 1922 hours which was 3 minutes after air traffic control became aware of the alleged unserviceable ADF and 12 minutes after the aircraft's D/R position abeam of Lithgow. This time lapse was due to difficulty in communicating with the aircraft which, as it is now known, was endeavouring to use VHF beyond the workable range of the equipment. Due to these communication difficulties contact with the aircraft was not made again until seven minutes later—1929 hours—and at 1930 hours it was established that the last positive fix the pilot had obtained during the flight was Collarenebri. On receipt of this information

At 1930 hours the pilot reported that he had fixed his position as 10 miles east of Swansea (60 miles north-north-east of Sydney) by radio compass using Sydney and Belford NDB's. At 1933 hours air traffic control requested information as to whether the aircraft had at any time received the Sydney VAR and at 1934 hours the pilot reported that the aircraft was in the yellow N sector. This was the first time the pilot had intimated this fact to air traffic control despite the fact that he had been receiving these indications for 29 minutes. The aircraft was instructed to intercept the northern visual leg of the VAR and to accomplish this a heading of 225°M was flown. It is estimated that when this instruction was given at 1935 hours the aircraft's position was 40 miles north-east of Sydney (see chart).
