DEPARTMENT OF CIVIL AVIATION

AVIATION  
SAFETY DIGEST

No. 9

MARCH, 1957

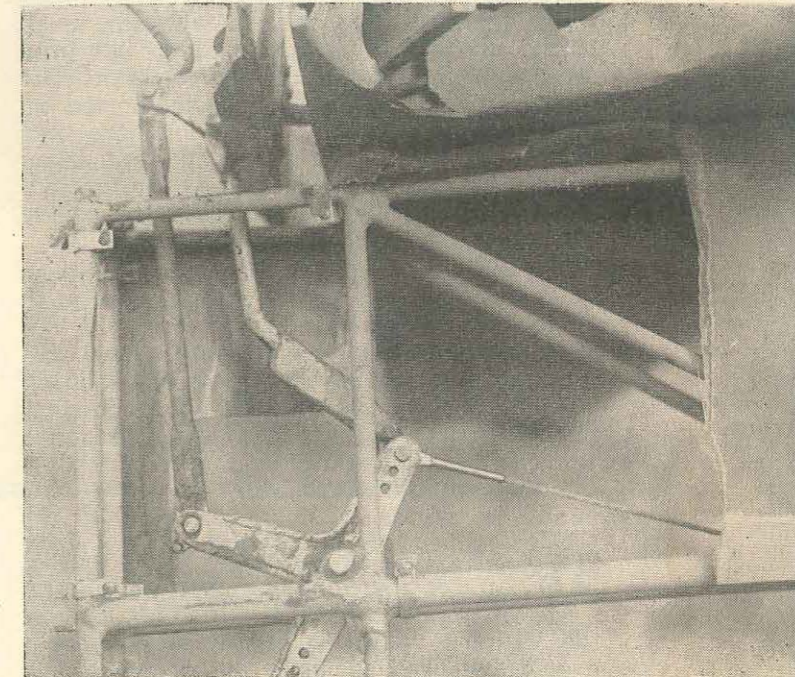
cockpit area there had been no impedence to the use of the controls. The only damage of significance was found in the aft end of the fuselage where it was noticed that the arm of the elevator mass balance had broken just below the weld to the elevator horn and the mass balance was found lying in the bottom of the fuselage. The surface of most of the fracture was bright and in the same area it was noticed that a transverse piece of steel channel, providing a rear mounting for the tailplane, had noticeable wear at a point where it could only have been caused by repeated striking of the mass balance arm, probably over a long period of time. A hole in the fabric of the tailplane undersurface was also noticed and its position and shape strongly suggested that it had been made by the lead mass and arm flying free on impact.

The distortion would probably increase slowly but at an increasing rate and it seems that some final shock (probably the ground impact during take-off) either bent the tube further so that it interfered with the elevator crank, or, cracked the upper circumference of the tube causing it to droop and thereby destroy the timing clearance from the elevator crank.

Illustration of the way in which the mass balance restricted the rotation of the elevator bell-crank.

The cause of the accident was that the pilot was deprived of elevator control when the bending of the mass balance arm allowed the mass balance to interfere with the rotation of the elevator bell-crank.

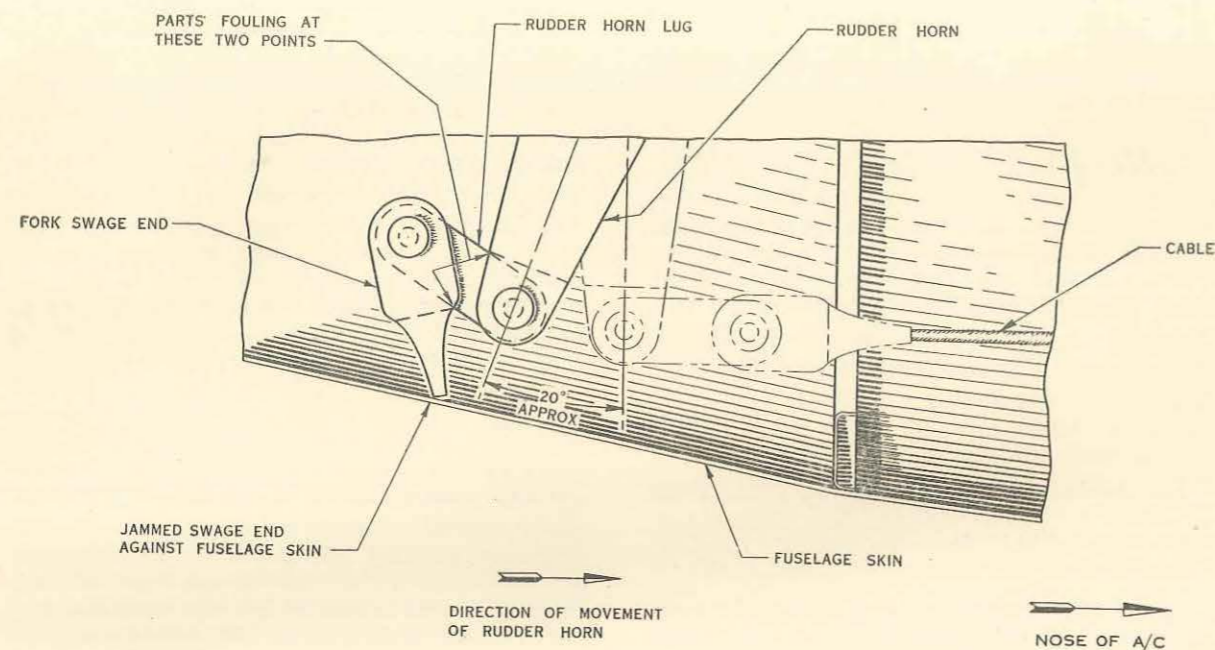
DIAGRAMMATIC SKETCH SHOWING RUGGER HORN LUG, AND FORK SWAGE END JAMMING BETWEEN RUGGER HORN AND FUSELAGE SKIN.

hinge attachment bolts but no check cables were available at Cairns. The company's chief maintenance inspector for Queensland, who is based at Brisbane, was then contacted and his approval was obtained for the aircraft to proceed to Brisbane without rudder check cables. Thereupon, the engineer at Cairns cut the broken cables off the fork swage ends but did not remove these ends or the rudder horn lugs, to which the fork ends are attached, from the rudder horn (see accompanying sketch). On the following day, the aircraft flew via several ports to Brisbane where the chief maintenance inspector cleared the aircraft to proceed without the cables to its home base at Melbourne. The jamming of the rudder occurred at the next port of call.
