Commonwealth of Australia

# AVIATION SAFETY DIGEST

No. 11  
SEPTEMBER 1957

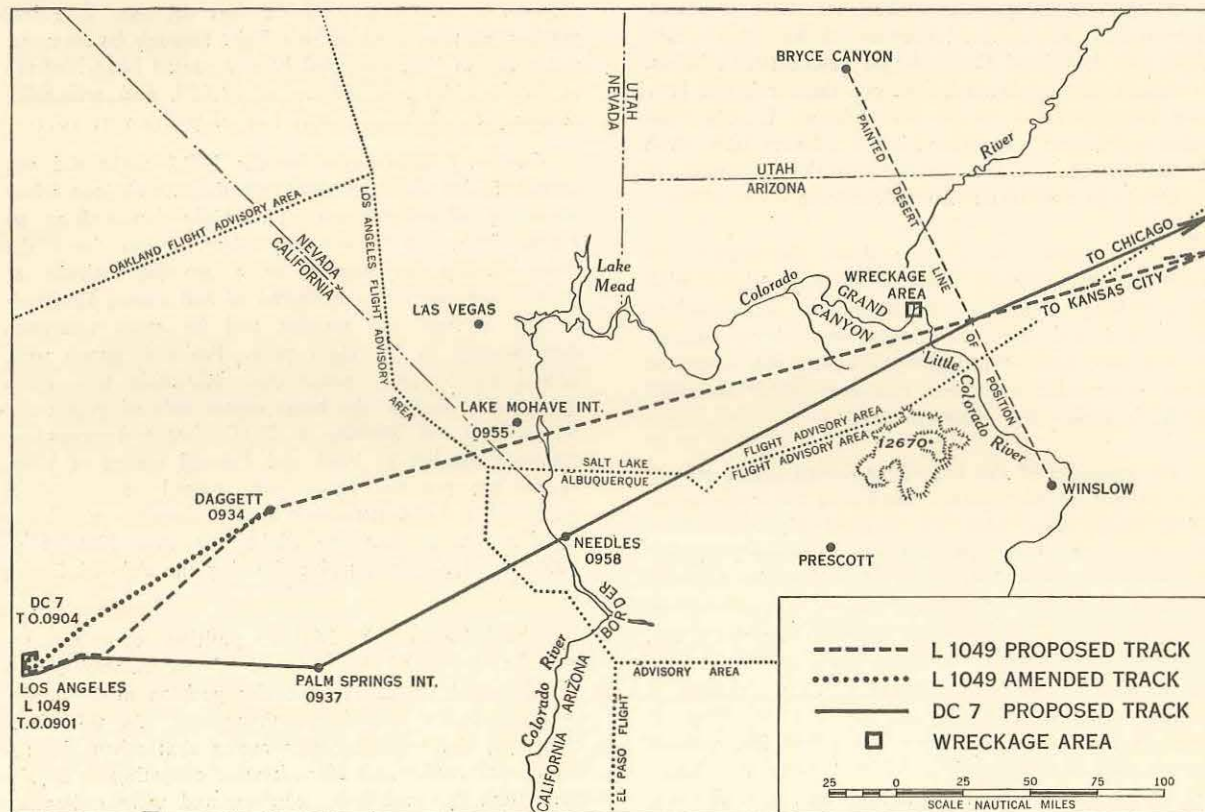
The collision ripped open the fuselage of the Constellation and caused its empennage to separate almost immediately. This aircraft then pitched down and fell on a short forward trajectory to the ground. These factors suggest that the collision occurred in space over a position just west of the Constellation wreckage site. Most of the DC.7 left outer wing separated during the collision and its horizontal stabilizer was probably struck by pieces torn off the Constellation. It is believed that the DC.7 fell less steeply, probably on a turning path, to the ground.

The angle between the aircraft at the instant of impact was found to be approximately 25 degrees relative to their longitudinal axis. The DC.7 left wing was above the L.1049 relative wing plane, or the DC.7 was rolled approximately 20 degrees right wing down relative to the L.1049. The aircraft were orientated such that the vertical distance between their empennages was less than that between their nose sections. The difference as an angle was between 5 and 10 degrees. These aircraft attitudes were obtained from damage studies. They describe relative attitudes and do not necessarily reflect the orientation of the aircraft with respect to the ground.

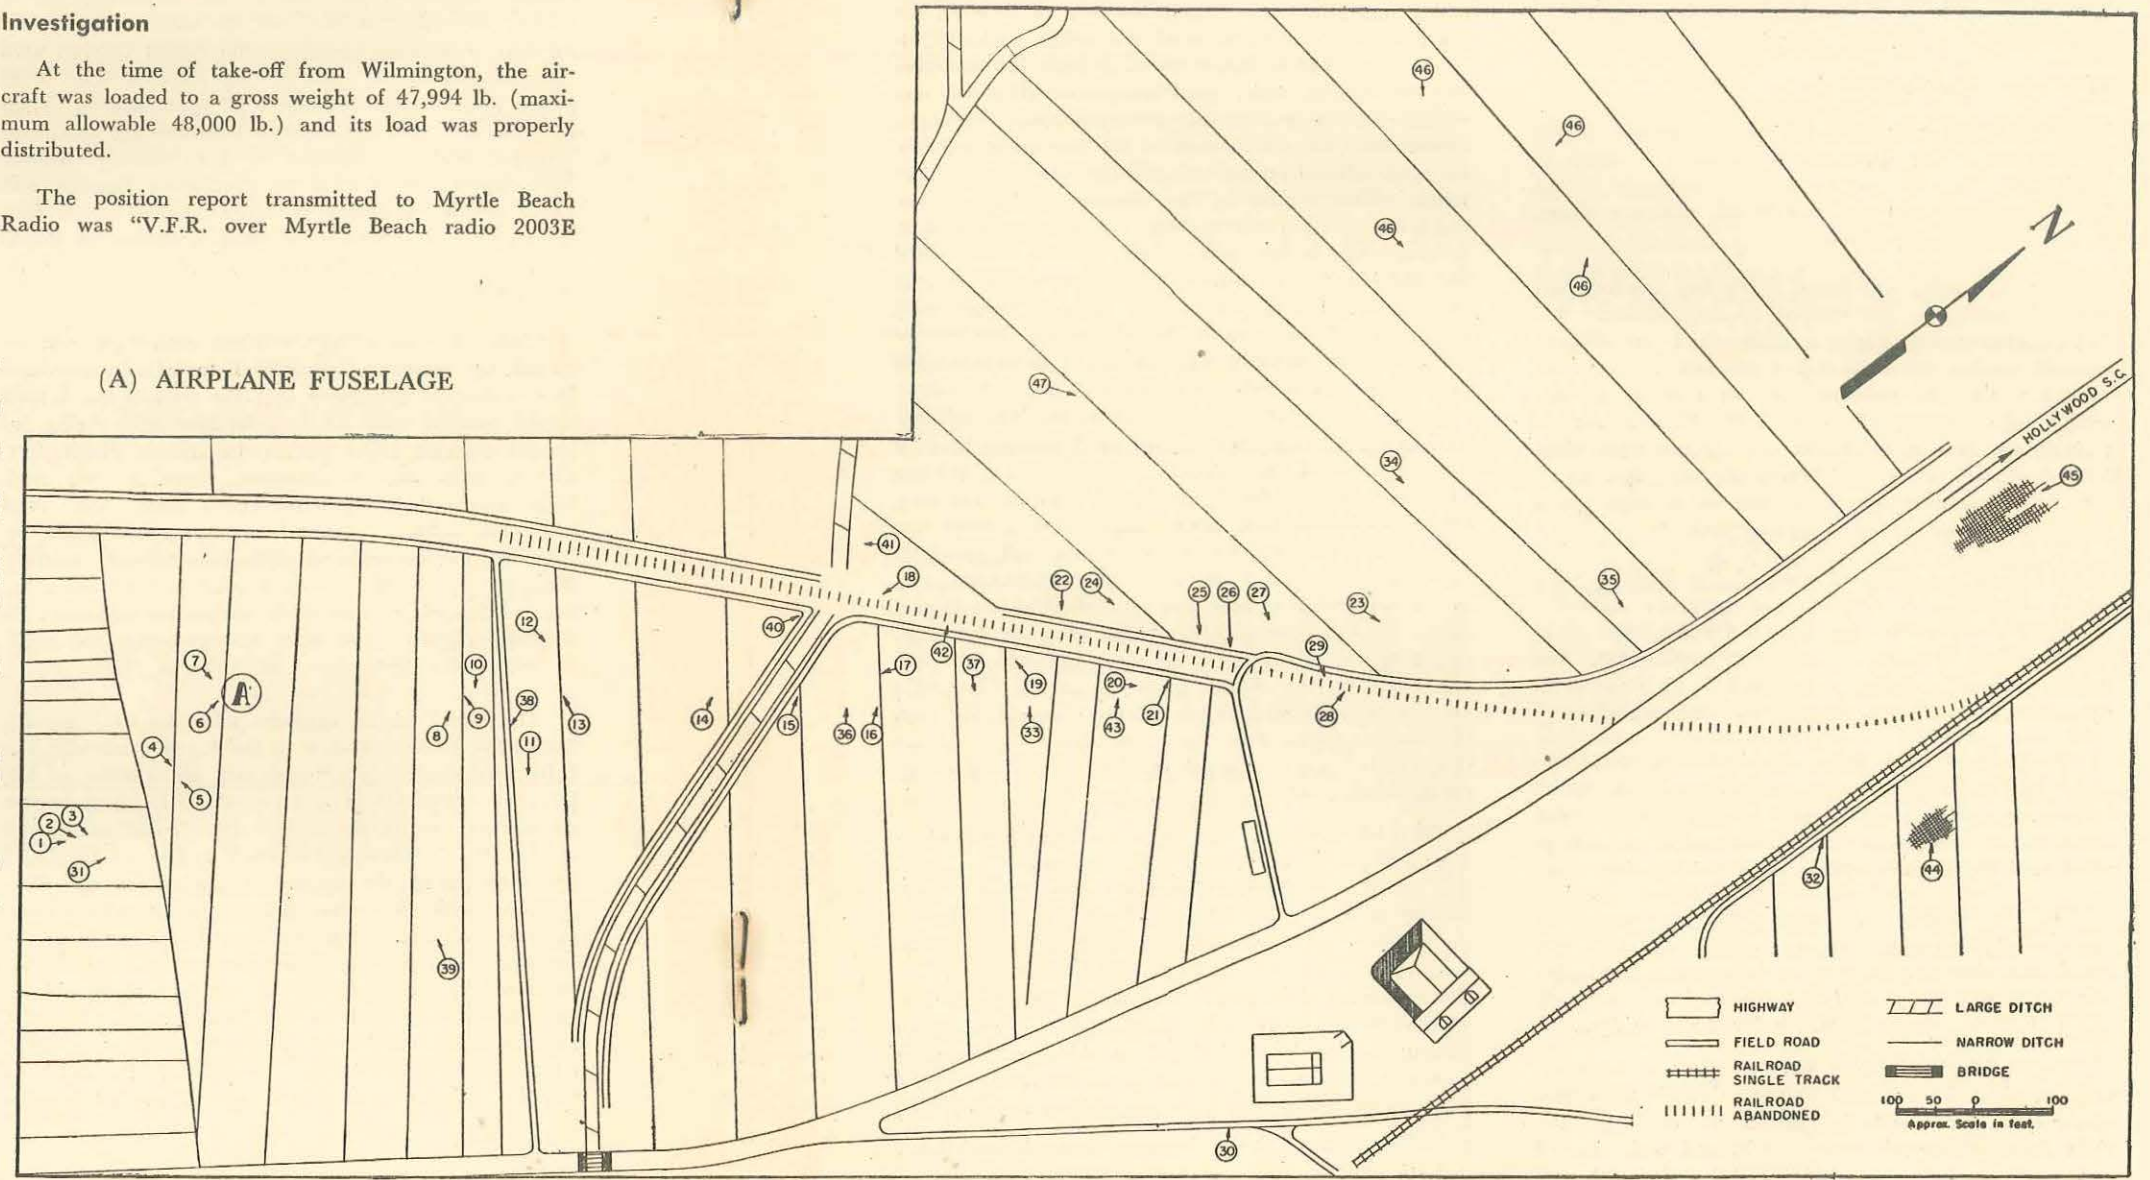
| 18. Left Stabilizer, 7 feet of Left Elevator V Tab, Piece of Red Filter Anti-Collision Light Found on Inboard Side of Outboard Hinge Bracket | 42. Captain's Notebook (usually carried in shirt pocket) |
| 24. Piece of Elevator Tab and Piece of Skin Unknown Oily Marked 24 | |
| 25. Jepco Chart No. 19 and 20 and Piece of Stringer Bulb | |

Nine pieces of the right horizontal tail were recovered. These accounted for the surfaces except for the portion of elevator between the third and fourth hinges from the tip. Examination of the stabilizer damage disclosed tension failures of the upper spar caps and stringers and compression buckling of those on the lower surface just outboard of the attach angles. Outboard of the failure line there were dents and scratches on the leading edge, skin tears, and diagonal skin wrinkles caused by the rearward-acting loads. The right elevator was severed at each of the four hinge stations, the most inboard failure being in line with the stabilizer failure. The portion of the elevator inboard of the fourth hinge from the tip was recovered at the main wreckage site in two pieces, both severely accorioned and flattened from inward-acting loads, indicating that they remained attached to the elevator torque tube through the fuselage until ground impact. The end of the spring tab cartridge was still bolted to its mounting bracket in the accorioned piece of elevator leading edge, but the cartridge was broken off and missing. The spring tab was torn in two by downward bending just outboard of the control horn. The outer portion (Item 24 in the sketch) had little deformation outboard of the fracture, while the inboard portion was extensively crumpled indicating that it had remained with the main wreckage until ground impact. The spring tab push-pull tube was still bolted to the control horn. At the forward end of the tube the fork end fitting of the spring cartridge shaft was still attached, the shaft having failed from overload. The right elevator trim tab and its controls were intact. Although the bushing required by Item 4 of Airworthiness Directive 47-51-2 was not installed, the idler rotated freely on the hinge bolt.

The left horizontal tail separated from the fuselage just outboard of the attach angles because of compression buckling of the stabilizer lower surface and tension failures of the upper surface. The upper surfaces of the stabilizer and elevator outboard of the second hinge from the tip were severely deformed by impact from an object moving downward. The outline of this damage area conforms closely to the shape of the tip and upper leading edge of the vertical tail. In this area there were numerous scratches in the surface of the skin. A small fragment of the Grimes anticollision light red filter was embedded in the stabilizer between the tip hinge bracket and the closing skin.

The Vee tab\* with its counterweights was still attached and its controls were intact. The tab control cables were broken about three feet inboard of the stabilizer failure.

At the bell crank on the left end of the elevator torque tube the tab push-pull rod end was bent upward and broken off after very extensive deformation. The spring cartridge fork end was broken off from bending loads, with the broken off portions still in the bell crank attachment. The spring cartridge remained attached in the elevator nose section with the shaft bent; this bend in the shaft restricted motion of the plunger on the shaft, resulting in the shaft being free to reciprocate through a small range without any spring load. This spring cartridge bore the stamp "US AIR".

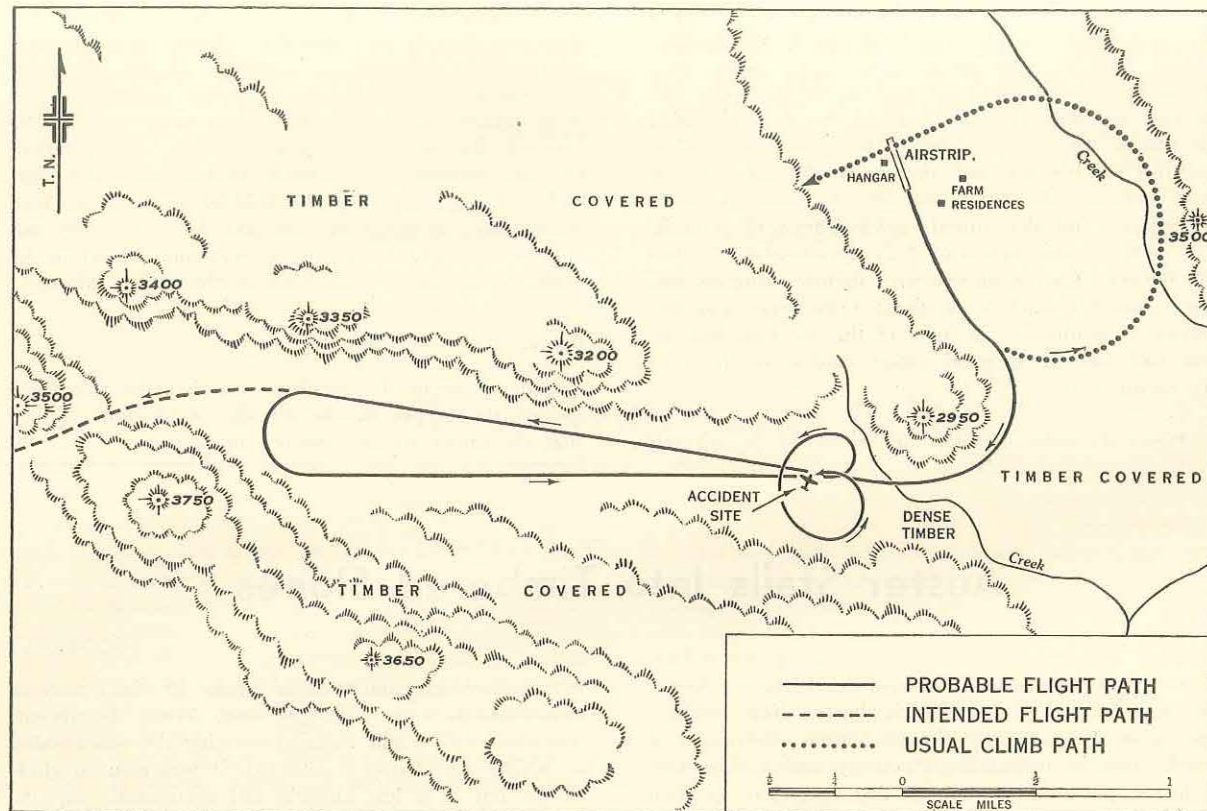
Examination of the fire damaged engine did not reveal any evidence of defect or malfunctioning which might have occurred prior to impact.

descriptions that the aircraft had almost reached the point where it would have crossed the highest terrain on the short route to the pilot's home station. He had hurried away so that he could call at another outstation en-route to his home (and this may well explain the right hand turn onto course) and yet the aircraft was turned about and retraced its track towards the departure strip for some two miles. The only feasible explanation for this is that some unserviceability developed in the aircraft which made it impossible, or at least inadvisable to continue the flight towards the home station.

During the turn the aircraft had dropped so low into the narrow valley it had been following that on its completion, the pilot apparently could not approach the strip direct and had to make for the junction of the two valleys before a left turn towards the strip could be attempted. However before the valley junction was reached, the aircraft apparently spun out of control into the trees from a very low height. There is no known reason why the pilot should voluntarily have turned back, in fact, in the circumstances of his departure, it was most unexpected.
