AVIATION SAFETY DIGEST

Aviation Safety Digest

No. 16 December, 1958

Prepared in
the Division of
Air Safety Investigation

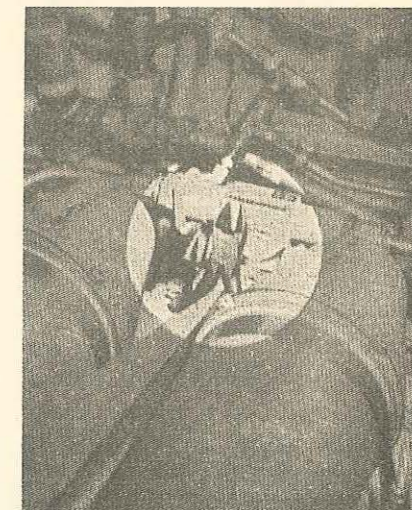
handles of a pair of diagonal wire cutting pliers were hanging down

over the T-shaped actuating arm located between the steering actuating cylinders in the forward wheel well. It's the simple things that count. So no matter how simple it may seem, count those tools after a job."

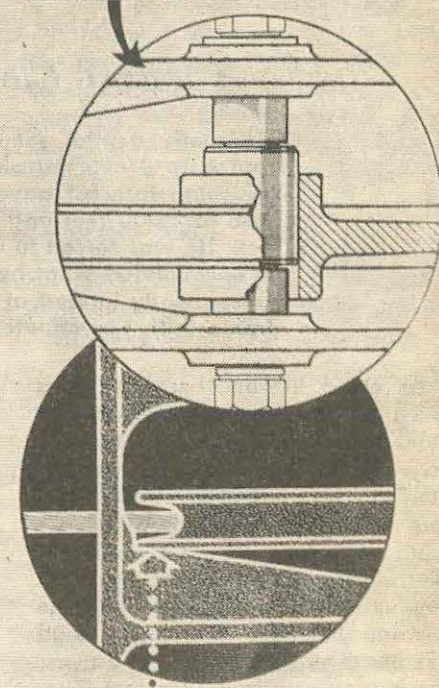
Slipped pulley, wearing against bracket, cause of excessive friction in control system.
