# Aviation Safety

DIGEST

№ 19, SEPTEMBER 1959

CONTENTS	Page
Wooden Aircraft — The Vital Need for Inspection	1
Guess and Live — If You're Lucky	3
Altimeter Error	4
Pilot Saturation	6
Ambassador Accident During Flapless Take-Off	8
Glider Presents New Hazard for Car Owner	10
Flying a Tethered Glider	11
Track Error Plus	12
Tower of Babble	15
Confusing Conspicuity	17
Fatal Spin, Twin-Engine Beechcraft, Arkansas, U.S.A.	18
Viscount Stall During Final Approach, Tri-City Airport, Michigan, U.S.A.	20
A Purpose Well Served	23
Overloaded Lodestar Crashes in New Mexico	24
Error in Engine Identification	26
The Unaccountable Blue	28
Jet Blast and Intake Danger Areas

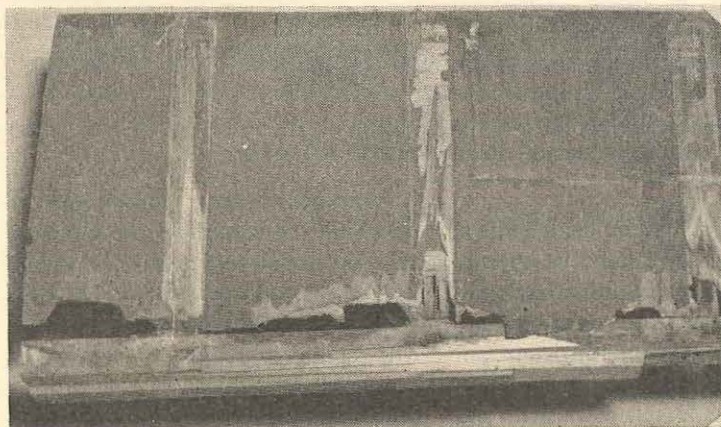
*Deterioration in rear spar Anson aircraft. Note glue line failures and decay of web, stiffeners and spar rail.*

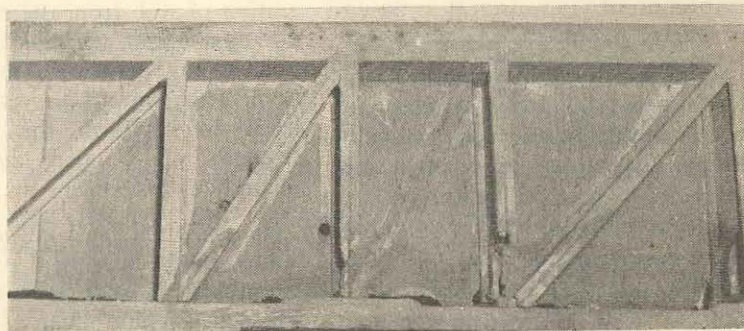
*Interior structure of Avro Anson wing showing severe deterioration. Note complete separation of structural members, opening of splice in lower spar rail and lifting of plywood skin from spar rail.*

all types of wooden aircraft are strongly advised to have their aircraft thoroughly inspected for deterioration at least once during the currency of the Certificate of Airworthiness. This is not just an idle warning. The examples of deterioration pictured here which have been found after quite short periods of operation show that a more frequent inspection than each three years is a very sensible insurance. In the light of our research into this problem we are convinced that the only alternative to prohibition of the operation of these aircraft is to insist on extensive regular inspections.
