# AVIATION SAFETY

# DIGEST

No 26, JUNE, 1961

DEPARTMENT OF CIVIL AVIATION

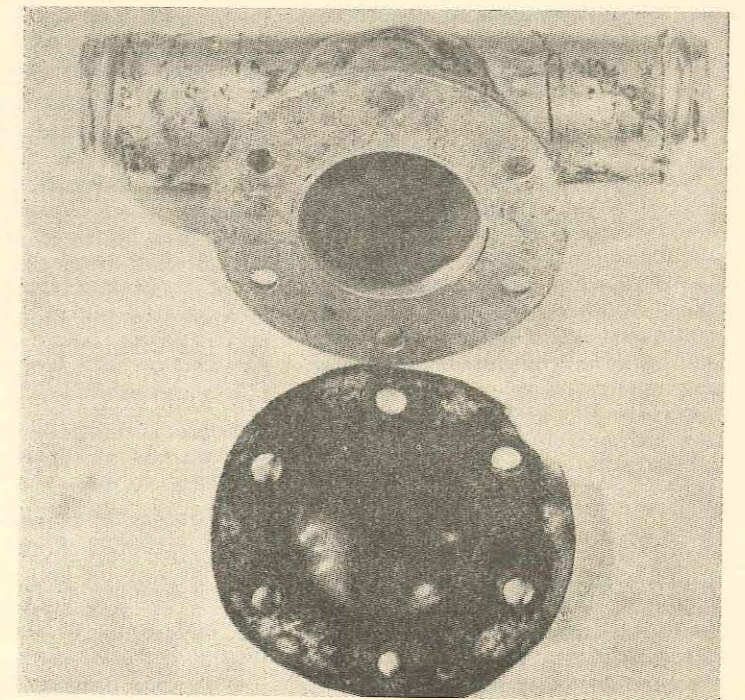
So there was no fuel tank venting. And so, with no way for air to replace the fuel withdrawn from the tank, enough negative pressure was created to collapse the tank.

(Gasket without centre hole prevented fuel tank venting)

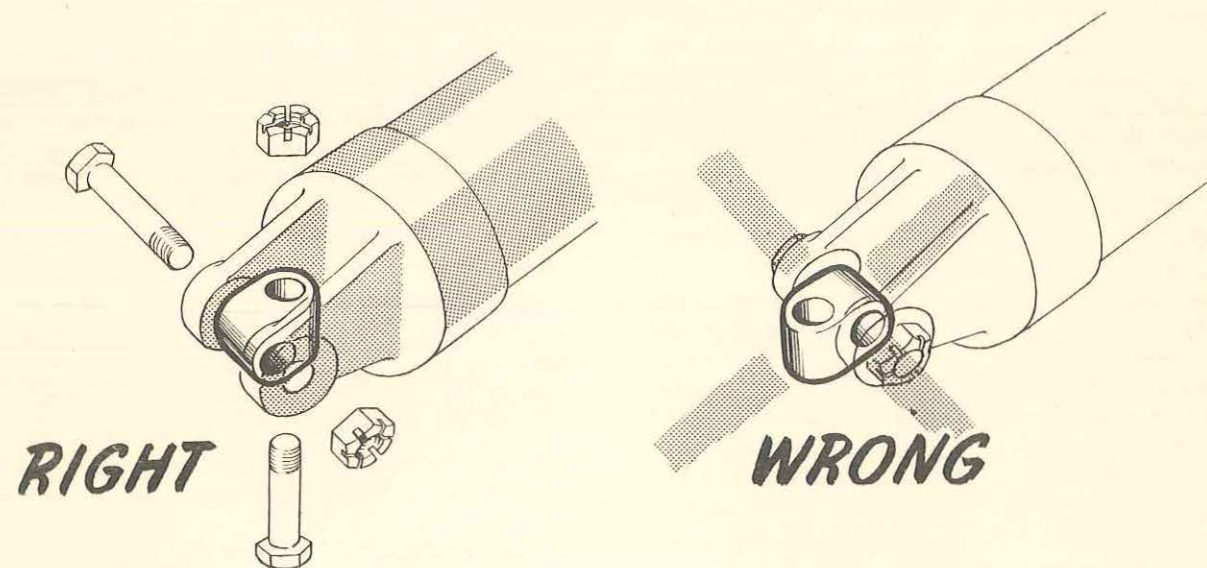
When the landing gear of a transport aircraft was retracted after take-off the "intransit" red warning light remained on. As a visual check indicated that the main wheels were retracted the flight proceeded to destination. Subsequent inspection revealed that the main wheels had locked up normally, but although the nose wheels appeared to have retracted it had not completed its full movement and the nose wheel doors had remained open. The position of the actuating ram had been inadvertently altered by reversal of a universal joint fitting during maintenance, with the result that the ram piston bottomed before the nose wheel locked up.

The aircraft had been laid up for maintenance work, during the course of which the nose wheel actuating ram had been disconnected at its anchored end purely for the purpose of checking a suspicion of looseness in the attached bracket. Unfortunately the universal fitting which permits movement of the ram at its anchored end could be fitted in two ways although only one of which would allow the gear to fully retract. The way in which the ram position was affected by reversal of the fitting during installation can be seen in the diagram.

A number of aircraft of the type concerned have been operating on the Australian register for some fourteen years during which time the particular fitting must have been removed and correctly replaced many times without error. This only proves the inevitability of Murphy's law which rules that if a part can be installed incorrectly someone will install it that way.

Apart from reminding us of the ubiquity of Murphy, and the obvious necessity for extra care with fittings which can be installed incorrectly, this incident reflects the need for close supervision and expert check inspections of all work, particularly those odd jobs that are done whilst major work is being performed on other sections of the aircraft.
